COGNE ROCKFALL EMBANKMENT - Pt. 2 (MAINTENANCE) CRETAZ, VALLE D'AOSTA

ROCKFALL PROTECTION - 3 YEAR MAINTENANCE VISIT

Product: Reinforced Soil Embankment System

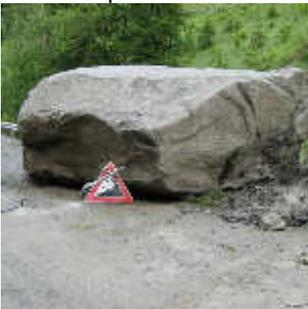
Fig 1. One of the rock masses that fell onto the road

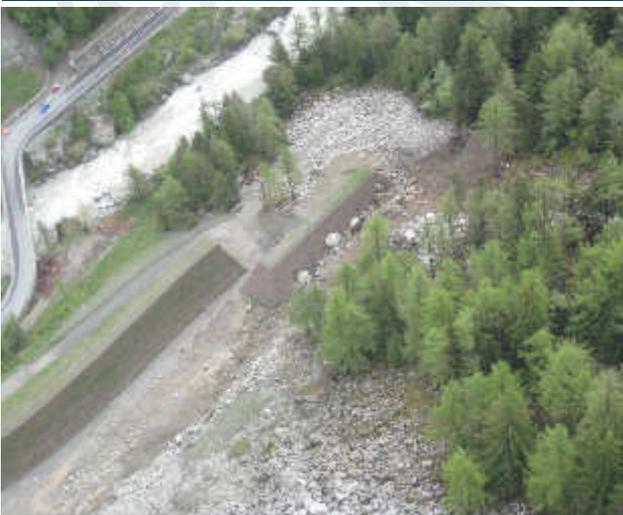
Fig 3. General view of the two embankments in July 2008 after the collapse of a cascade of blocks (>1000 tons)

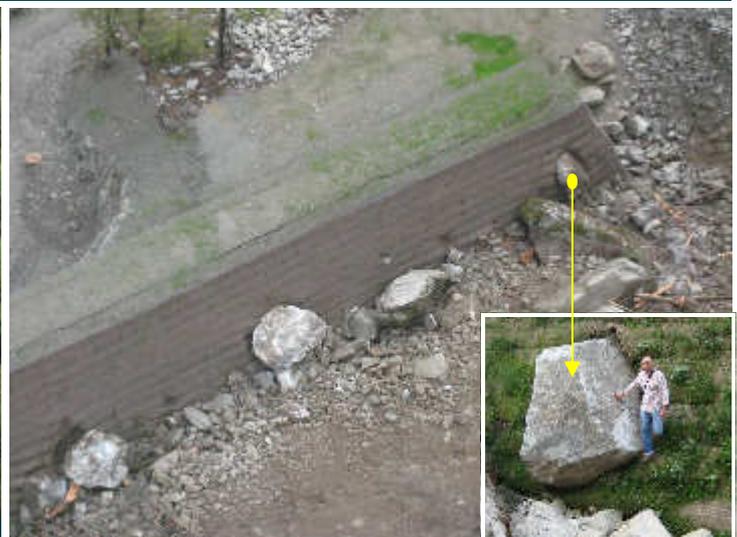
Fig 4. Close-ups of some of the blocks which struck the embankments

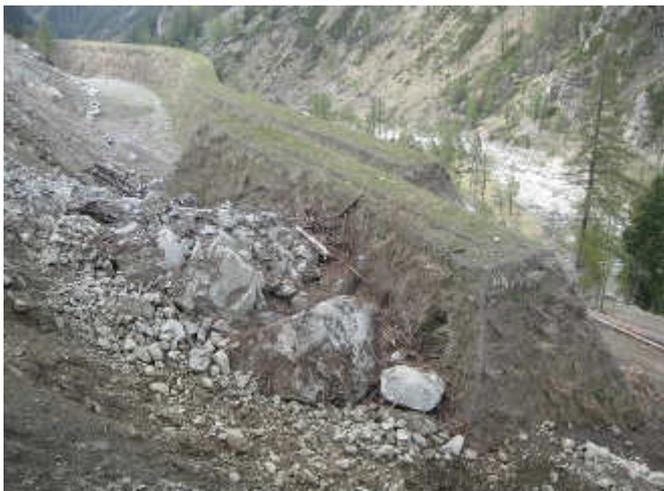
Fig 5. The up-slope embankment showing accumulated rockfall and avalanche debris material, viewed before maintenance works

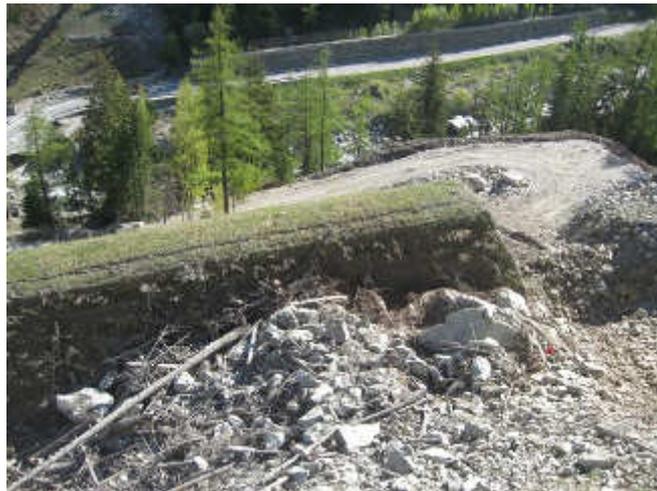
Fig 6. The up-slope embankment showing accumulated rockfall and avalanche debris material, viewed before maintenance works

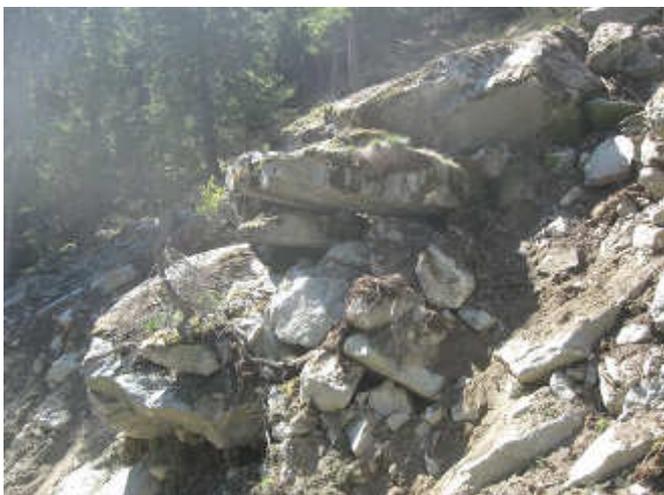
Fig 7. Source zone high on mountain (rocks < 10m x 6m x 4m)

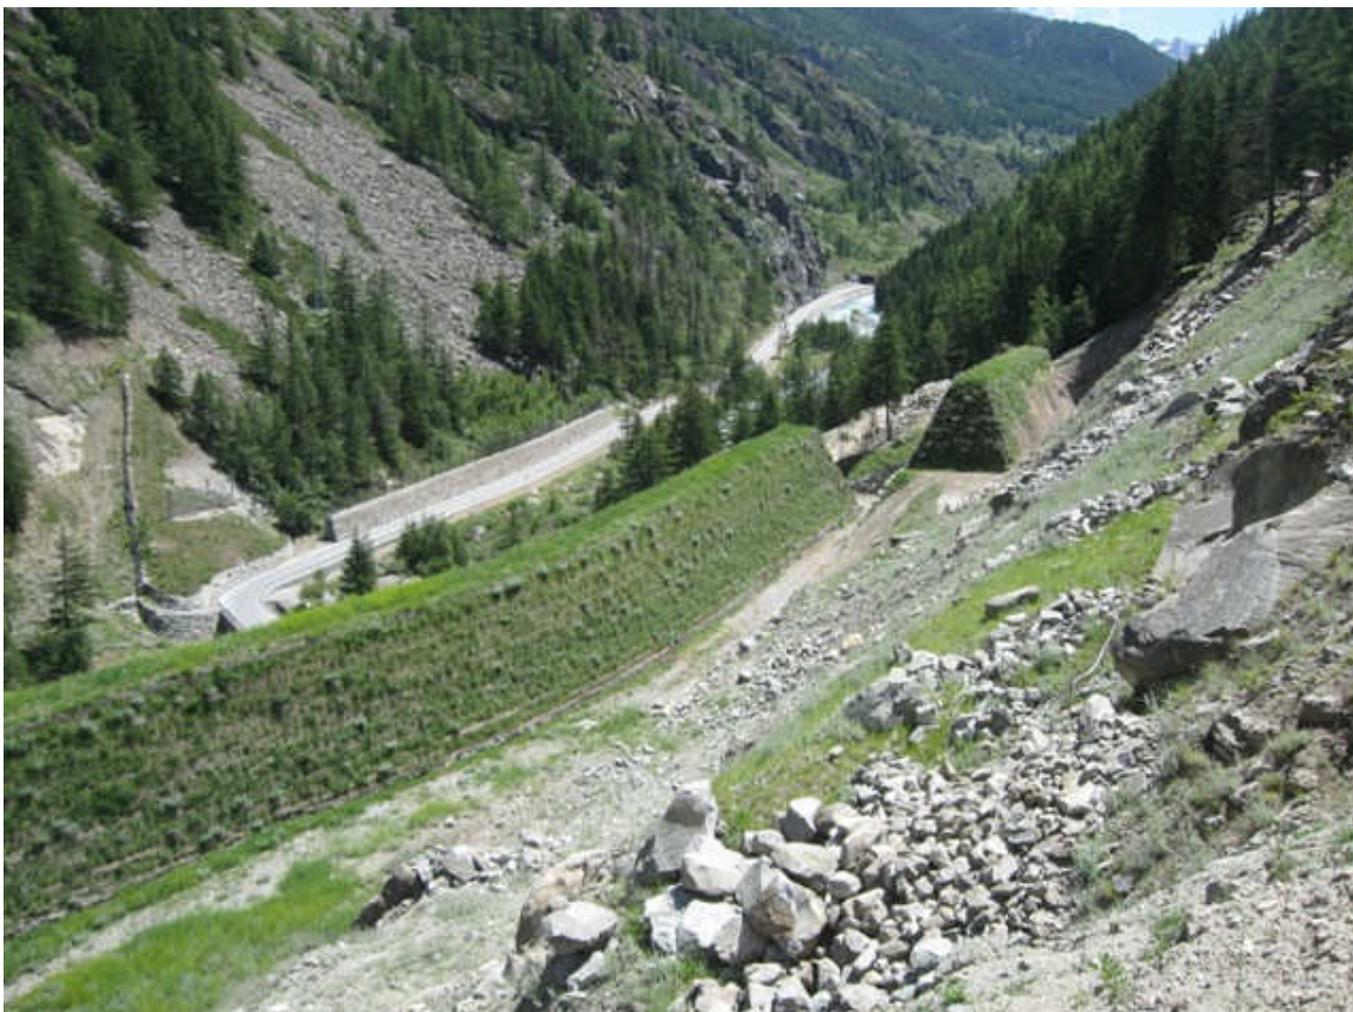
Fig 11. View of the both embankments showing the excellent condition of the structures following the maintenance work and the successful establishment of vegetation, even on the up-slope (shady side) ~70 degree face of the embankment.

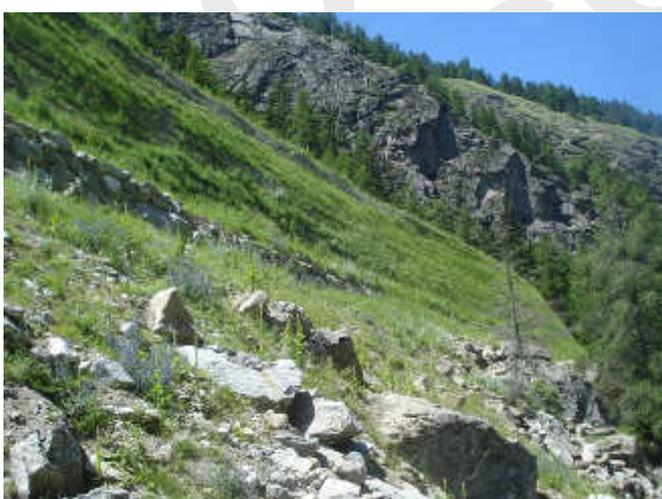
Fig 12. Far view of the main/down-slope embankment showing the discrete vegetated front face of the 11.5m high structure.

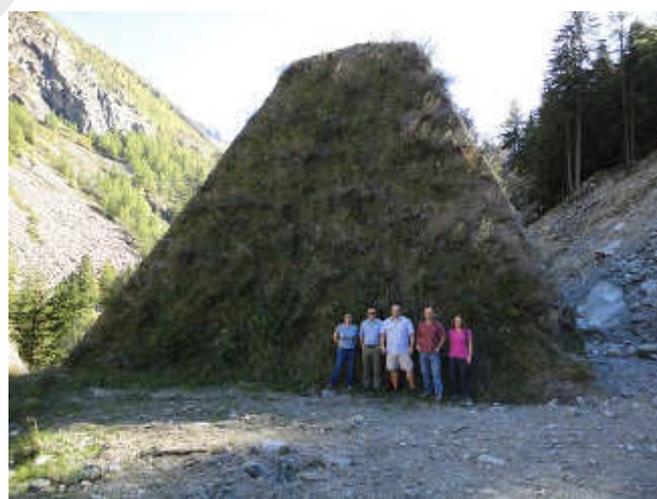
Fig 13. View of up-slope embankment showing the undeformed condition following the completion of maintenance works.
