# PAVEMENT STRENGTHENING AT NADIA - KAPADWANJ - MODASA ROAD

## NADIA-KAPADGANJ-MODASA, GUJARAT, INDIA

### Asphalt Pavement Reinforcement

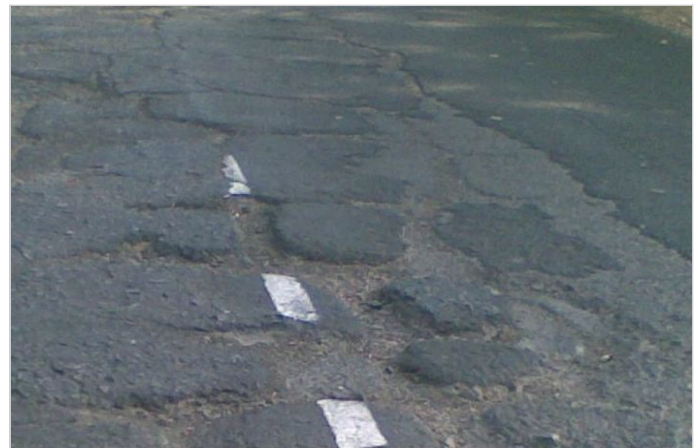
Nadia-Kapadwanj-Modasa road stretch was subjected to severe problem of series of interconnected cracks. Due to the increased traffic, the existing pavement section was not able to survive for its initial design life. It was observed from the site that the existing pavement had cracks developed on the surface which had further deteriorated into large potholes.

Photo 1: Before construction- cracking on the surface

Current pavement was needed to be repaired by placing an asphalt layer to increase the load carrying capacity of the pavement section. However the ability of asphalt to withstand tensile stress is limited. So there were chances of fatigue and reflective cracking in the surface course. To avoid this type of cracking, geosynthetic reinforcement are introduced between new overlay and the existing pavement.

For reinforcing the pavement, geogrid made of fiber glass yarns called MacGrid® AR V5 was suggested to be provided at the interface of the BUSG and BM layer. For ensuring proper adhesion of the MacGrid® to the surface, tack coat is applied over the BUSG layer before laying the MacGrid®.

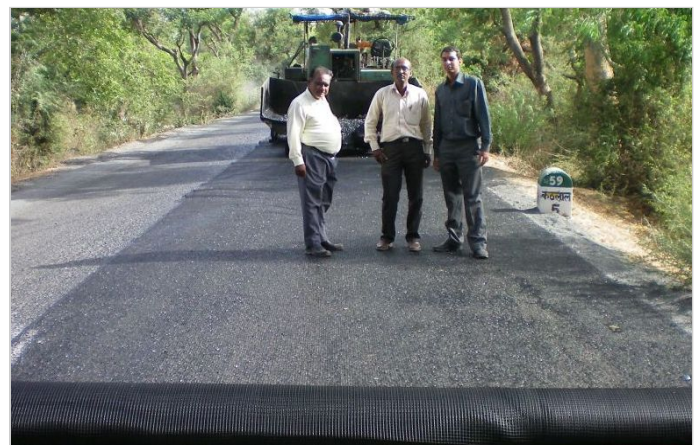
Photo 2: Laying of MacGrid® over BUSG layer

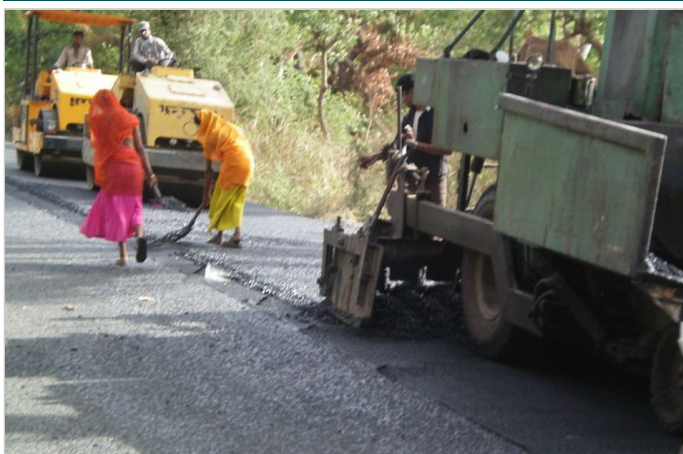
Photo 3: Laying of 20mm thick SDBC layer

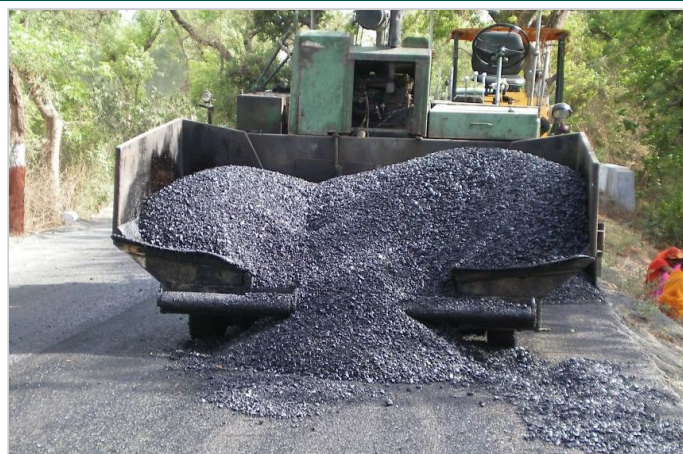
Photo 5: Laying of 75mm thick BM layer

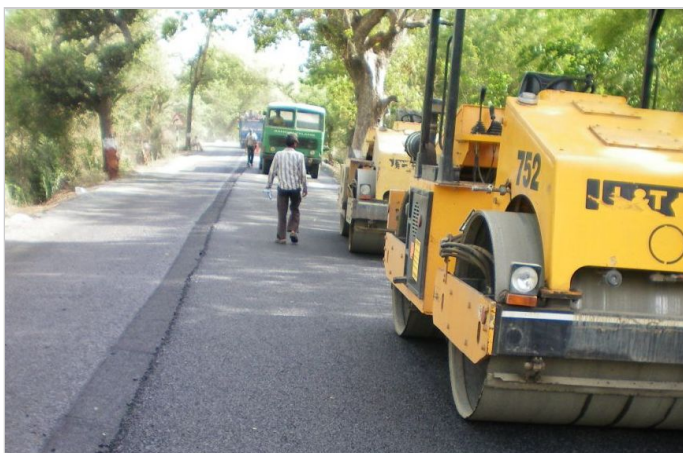
Photo 5: Completion of construction

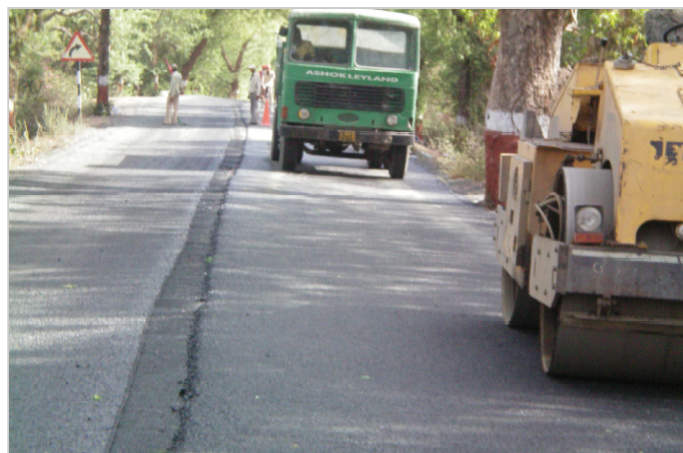
Photo 6: Completion of construction
