DURABLE GABION RETAINING STRUCTURE FALLS ROAD, BALTIMORE, MD, USA

RIVER BANK PROTECTION

Product: Gabions

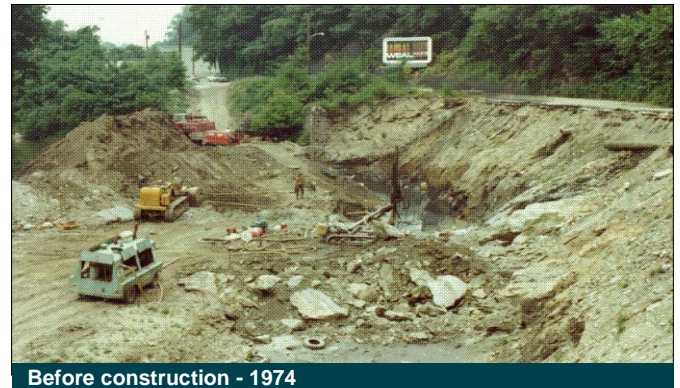
Before construction - 1974

Falls Road in Baltimore, MD runs parallel to I83 - Jones Falls Expressway. In one location, Falls Road had been washed-out by the swollen river flowing adjacent to it. A robust, economic and free-draining retaining structure was required to reinstate the highway, and protect it for the future. The structure would also have to direct the river around a curve.

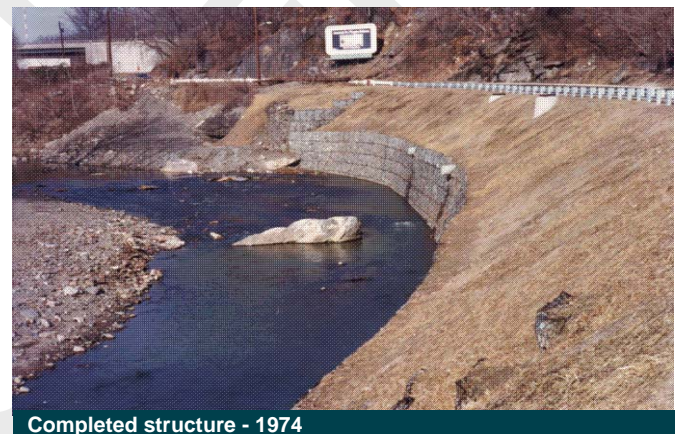
Completed structure - 1974

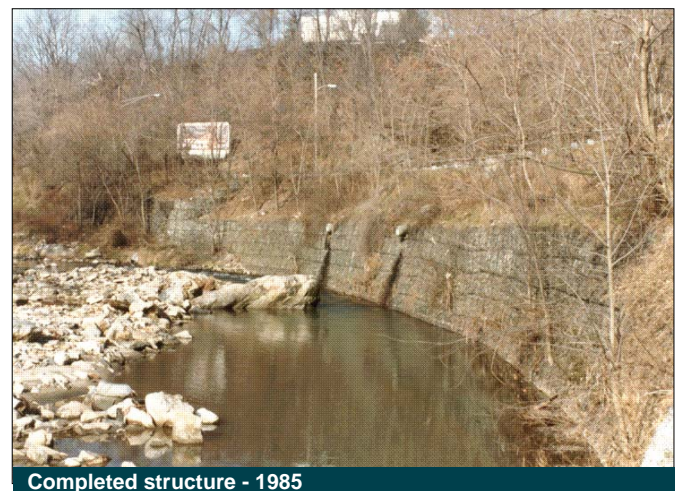
Completed structure - 1985

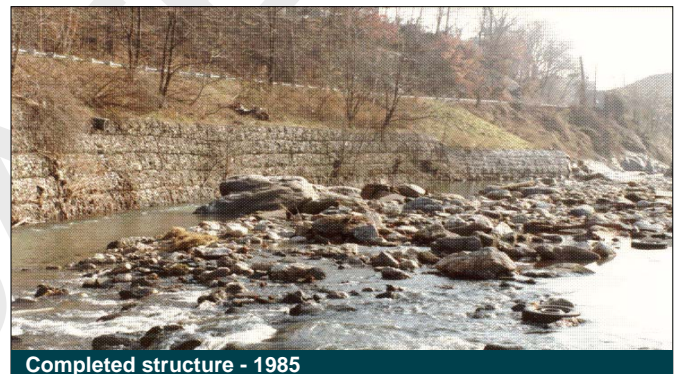
Completed structure - 1985

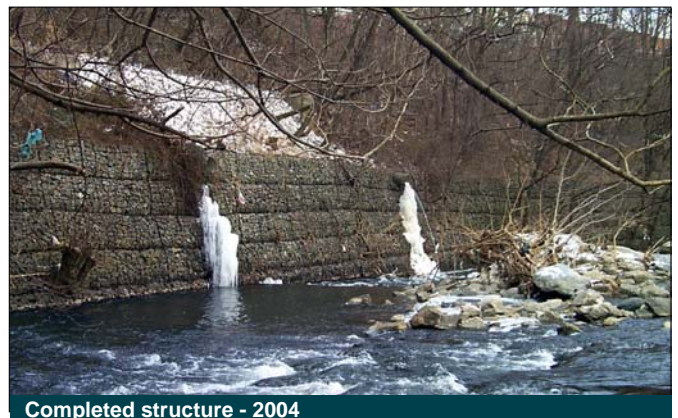
Completed structure - 2004

In 2004, 30 years later, Maccaferri revisited the gabion retaining wall. Samples of the PVC coated mesh were taken. Laboratory tests were carried out on the zinc coating left on the steel under the PVC, and the residual properties of the PVC after 30 years of UV and abrasion exposure.

The results were excellent. Only 35% of the initial properties of the PVC had been lost, and the amount of zinc remaining was still superior to the minimum requirement of the project specification. By comparing the 35% loss in PVC properties to recent reference results from accelerated heat aging laboratory tests, the structure has a life expectancy of around 60 years.
