SAFETY IMPROVEMENTS TO HIGHWAY ADELAIDE, SOUTH AUSTRALIA

ROCKFALL PROTECTION - CATCH FENCES

Product: CTR 05/07/B 500kJ - ROCKFALL CATCH FENCE

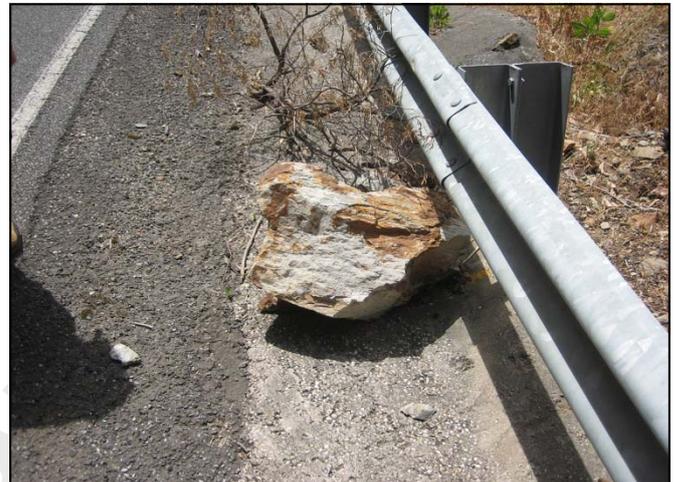
Date: Nov 2007

Evidence of rock detachments

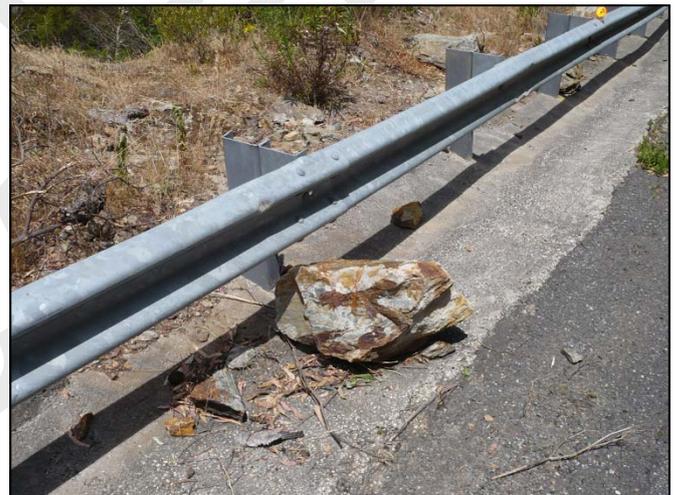
Date: Nov 2007

Evidence of rock detachments

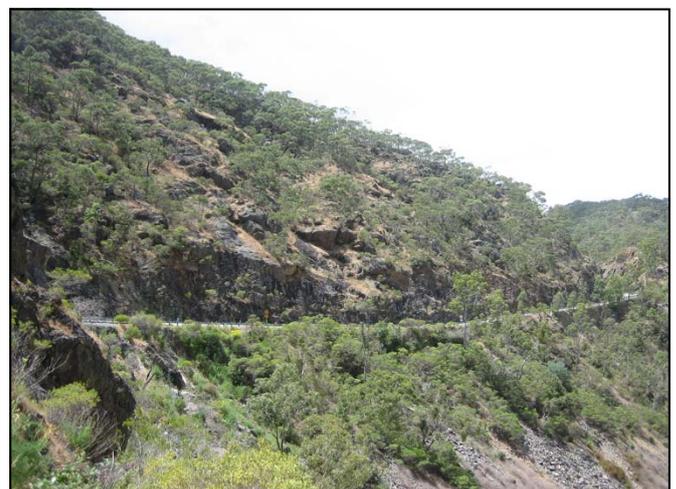
Date: Nov 2007

Gorge Road Cutting

In 1969, the Kangaroo Creek Dam was constructed 8.5km up the valley. Part of this project involved constructing a 5.6km long diversion road adjacent to the reservoir up to 75m above the valley floor. The road has a 6.5m carriageway and an average 1.8m wide shoulder. Cuts immediately adjacent to the road are up to 50m high however the rock faces above them often extend for twice this height. Many of the cuts were constructed without benches and with virtually no support, reinforcement or rockfall control although the kinematic characteristics of the rocks warranted their use.

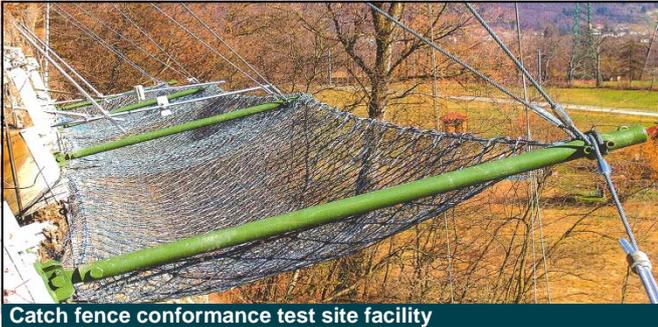
Catch fence conformance test site facility

local topography. This barrier has been full scale tested and certified by the University of Bologna DISTART Department in accordance with the **ETAG 027 Guideline** directions (Falling Rock Protection Kits). The full scale crash test involved a 1610kg boulder impacting the barrier at 25.6m/s. Maccaferri are able to provide flexible rockfall barriers up to 5000KJ (16,200kg boulder travelling at 25.77m/s).

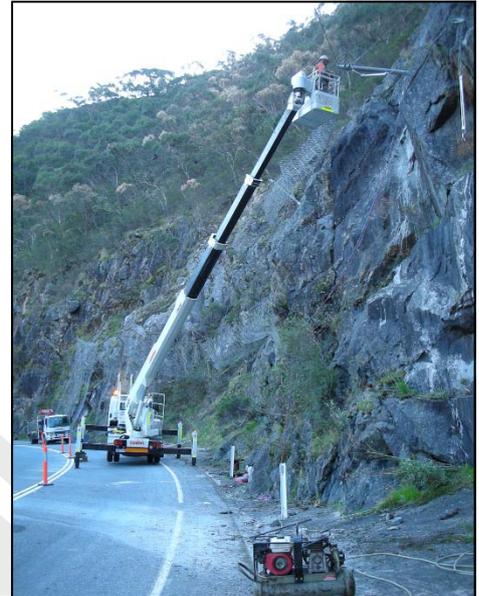
Date: May 2008

During installation

Maccaferri double twisted woven mesh rock fall netting was draped below the barrier to ensure that rocks did not roll out from under it where it crossed low points in the topography. The specifications and location for the barrier and site supervision were provided by Rocktest Consulting. The complex construction work was carried out using boom lifts and roped access techniques by Retaining Wall Solutions in only three days once the drilling was completed.

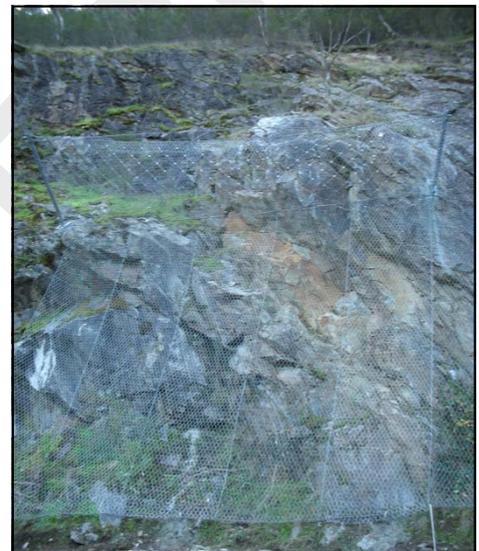
Date: May 2008

Barrier with rockfall drapery netting

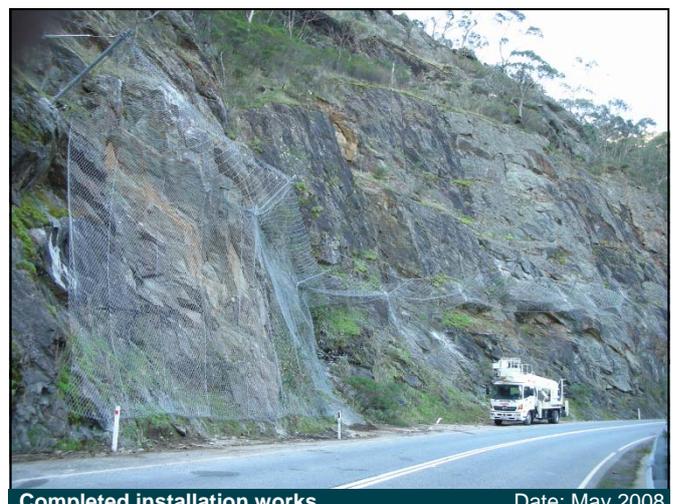
Date: May 2008

Completed installation works

To address the rockfall problem on a particularly problematical section of the road, the State road authority, Department for Transport, Energy and Infrastructure, commissioned a 500kJ Maccaferri rockfall barrier to be installed. The 60m long barrier was installed 5m above the road. Sections of the barrier were 2m and 3m high to suit the
