SCASCOLI GORGE LANDSLIDES BOLOGNA, ITALY

EROSION PROTECTION - ROCKFALL MITIGATION

Product: 1000KJ (MEL) Dynamic Rockfall Catch Fence, HEA Panels, Steelgrid

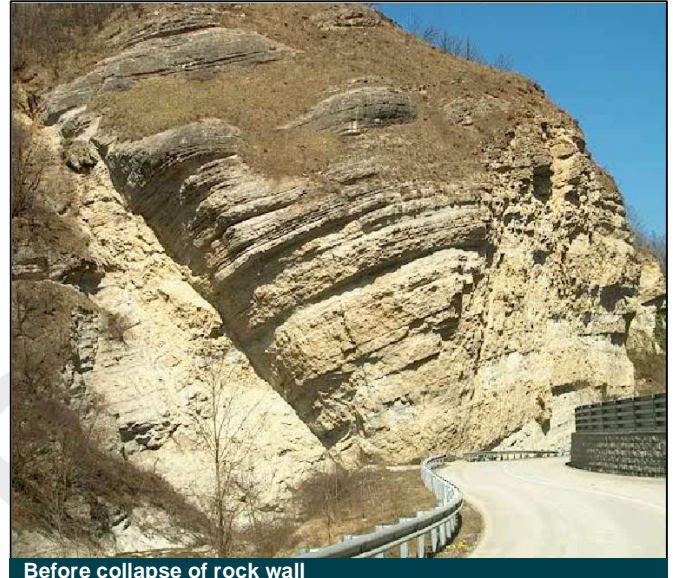
Before collapse of rock wall

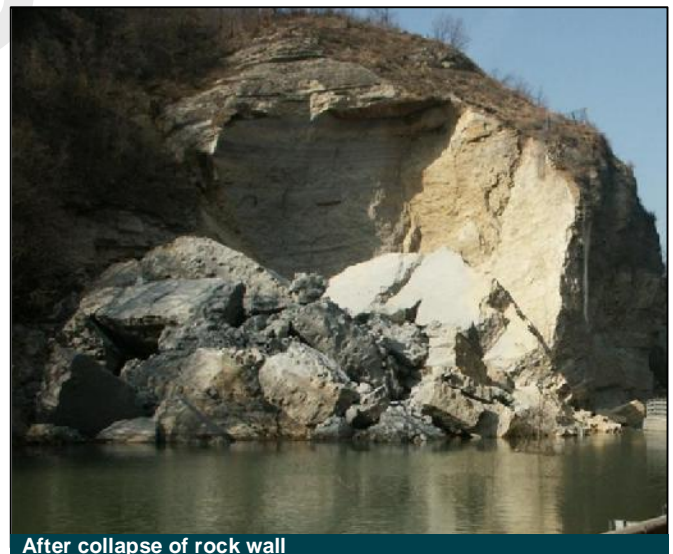
After collapse of rock wall

On the opposite side of the valley to the Scascoli landslide, a huge rockfall of approximately 30,000m³ occurred at Mammellone in March 2005. The landslide obstructed the River Savena in the valley below.

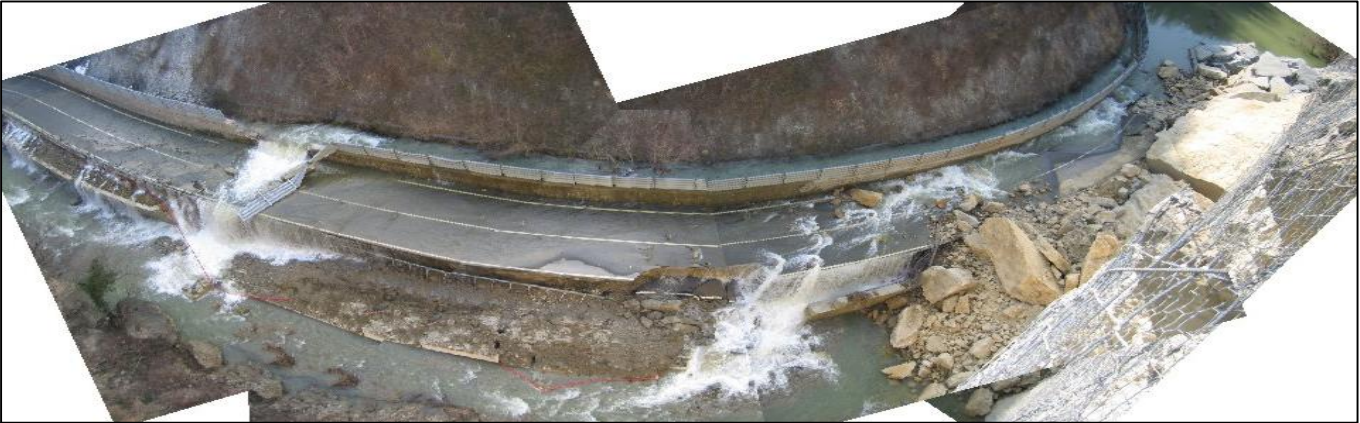
Panoramic view of road just after collapse of rock wall

Following the rockfall, the River Savena eroded the toe of the large landslide and triggered a new faster landslide phenomenon of approximately 8,000 m³. After 15 days, the valley floor was devastated by erosion and rockfalls and hundreds of metres of road had been destroyed.

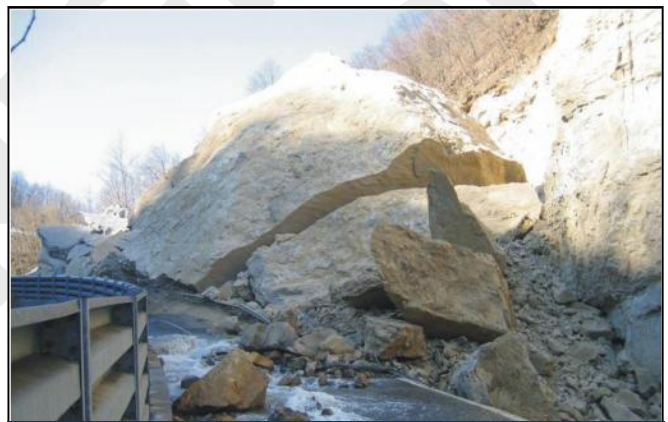
Close-up of road after collapse of rock wall

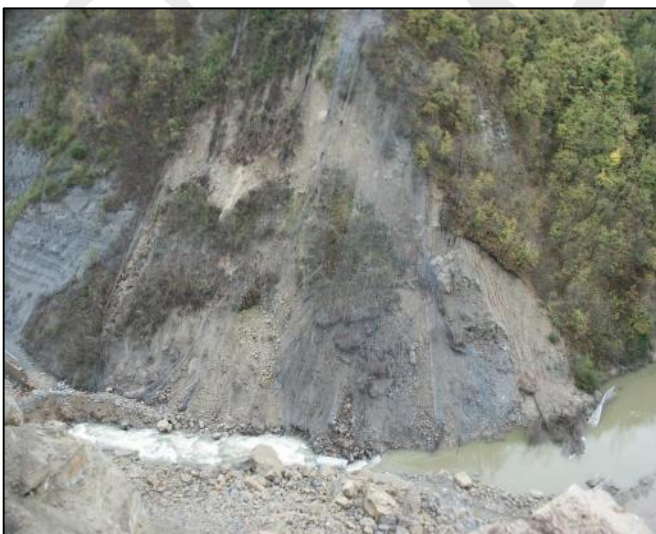
Panoramic view of the road 15 days after the rock fall with the soil landslide before remedial works.

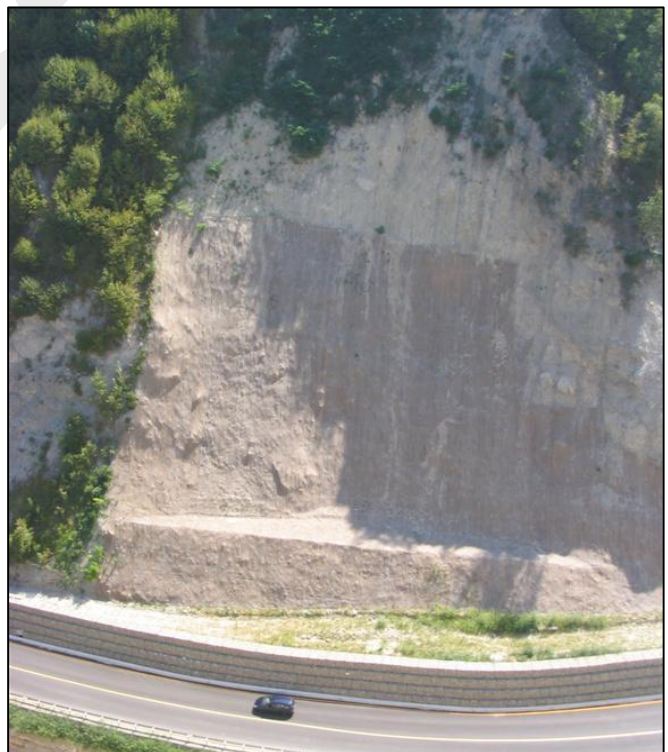
Landslide on right hand side of River Savena after the remedial works

The works on the debris flow/landslide on the right-hand slope of the gorge, included the removal of the unstable body and consolidation of the failure surfaces where there were outcrops of loose soil and weathered rock masses. Consolidation was achieved with lightweight soil nailing using 3m - 6m long, 430 N/mm² steel bars, installed at a frequency of 1 nail per 12 m² of surface area. Soil outcrops on the slope were stabilised by double twisted steel wire mesh, with a heavily galvanised Galmac coating for durability. The mesh was used in conjunction secondary steel cables and with Biomac biodegradable matting to prevent erosion due to surface water run-off and encourage the regrowth of vegetation. In areas where greater restraint was required, for example in the areas with weathered rock outcrops, high tensile steel cable HEA Panels, were installed.

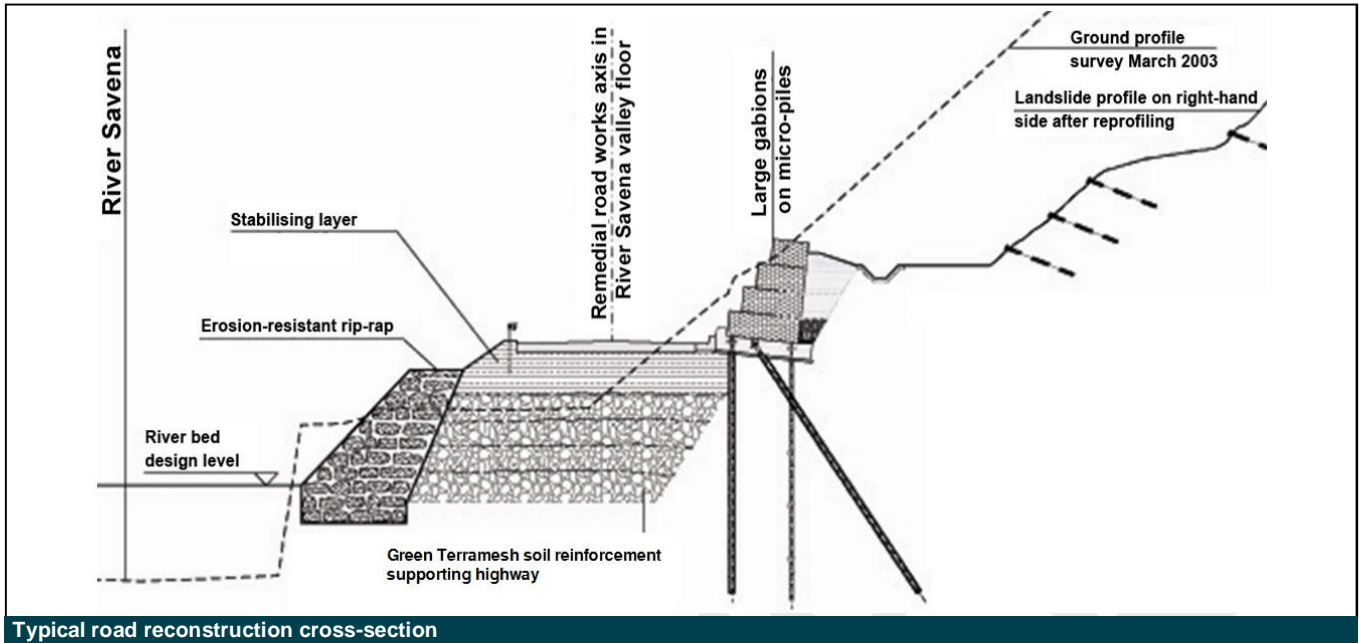
Typical road reconstruction cross-section

The roadway along the valley was reconstructed using Green Terramesh to provide a robust yet flexible structure, able to withstand the small continuous deformations by the large Scascoli landslide. The toe of the Green Terramesh reinforced soil slope, was protected from erosion by the River Savena, by means of rip-rap.

Since the valley floor was very narrow, a single solution using Green Terramesh and gabions, provided both river remedial works and road reinstatement. This was functional from a hydraulic and roadway support perspective, yet are also environmentally compatible. In order to provide local stability of the toe of the large Scascoli landslide the gabion works were founded on micro-piles.

- (a) Remedial works for debris landslide on right-hand side;
- (b) Construction of gabions above road, with micro-pile foundations;
- (c) Construction of road embankment, consisting of suitably crushed material obtained from crushing the landslide debris from the Mammellone 1, compacted and reinforced with Maccaferri Green Terramesh soil reinforcement system;
- (d) Placing of erosion-resistant rip-rap on river bank, consisting of sandstone blocks squared off and saturated with lean concrete;
- (e) Completion of the upper part of road embankment with Green Terramesh;
- (f) Other completion works; black top and wearing course, profiling of river bed, etc.

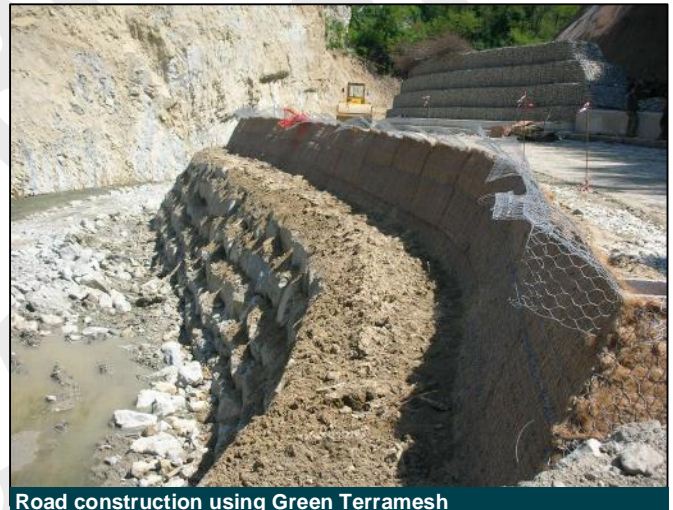
Road construction using Green Terramesh

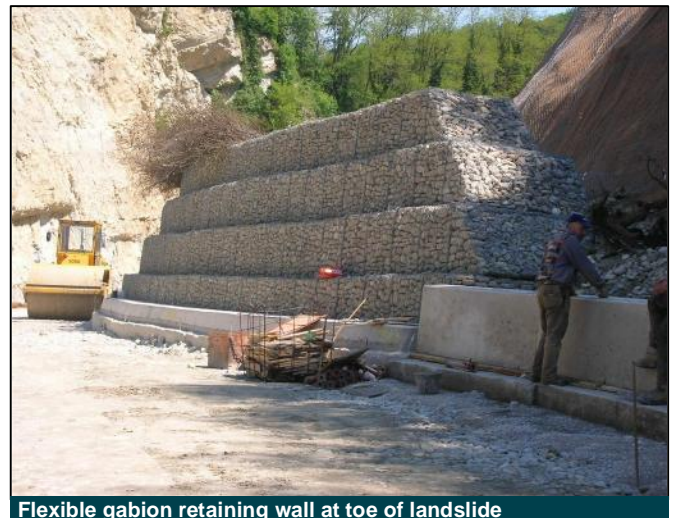
Flexible gabion retaining wall at toe of landslide

The retaining walls on the uphill side of the road, were constructed with gabions, taking into consideration the movements of the large landslide.

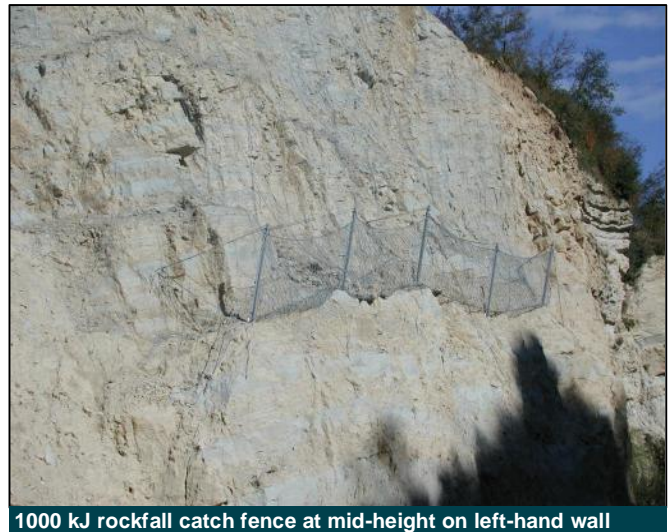
1000 kJ rockfall catch fence at mid-height on left-hand wall

- (a) At one end of the slope, a surface stabilisation layer was installed, to secure the rock masses which it had not been possible to remove;
- (b) At the opposite end of this slope, a Maccaferri 1000 kJ (MEL) rockfall catch fence was installed mid-way up the rock slope, to protect the road from falling rocks of less than 1 m³ in size.
- (c) The upper half of the rock slope was stabilised using high tensile strength Steelgrid mesh to control any falling rock masses and prevent rock debris falling towards the road.

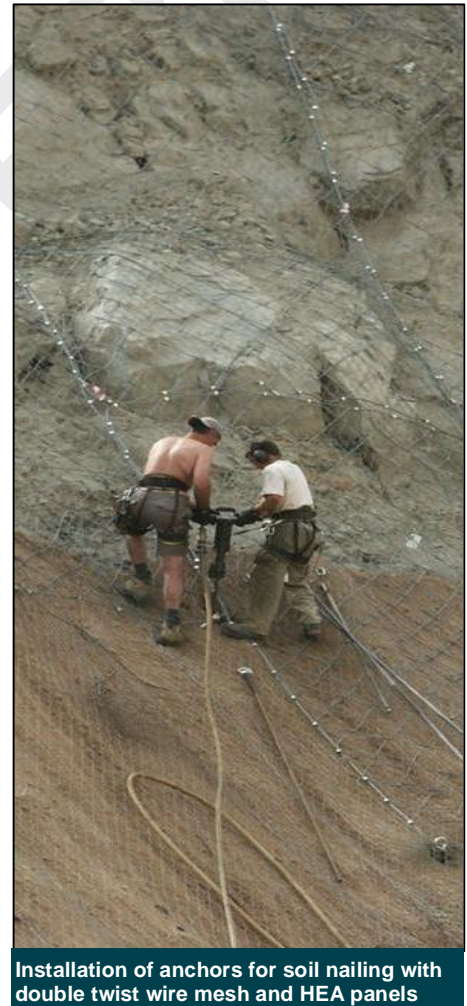
Installation of anchors for soil nailing with double twist wire mesh and HEA panels

final profile of the soil slope using steel bars. Surface stabilisation between the soil nail heads was provided by double twist steel wire mesh and Maccaferri HEA Panels, used in conjunction with biodegradable erosion control blanket, Biomac to encourage regrowth of vegetation.
