ROCKFALL MITIGATION MEASURES FOR HILL SLOPE AT SHRI RAM LAXMAN GAD NAGPUR, MAHARASHTRA, INDIA

Surface Strengthening and Support

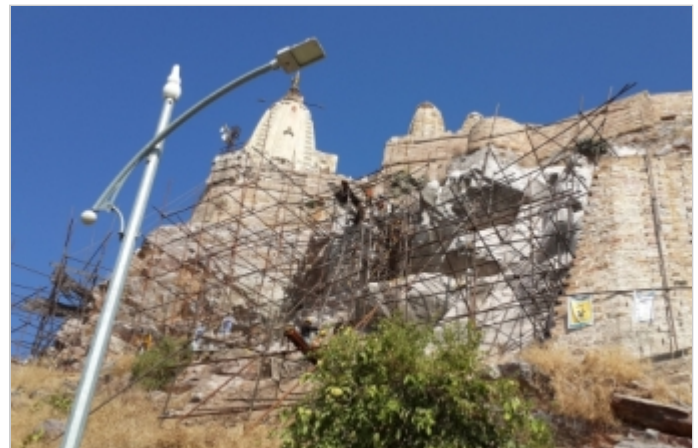
Photo 1: Scaffolding at site for anchoring.

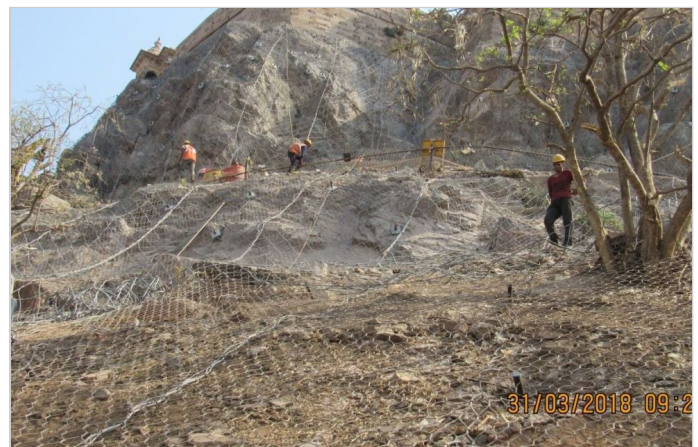
Photo 2: During installation

Selection of rockfall mitigation was done in such a way that the drapery/netting shall be capable of retaining detached boulders of small as well as large sizes. Composite steel mesh reinforced in a single direction (Steelgrid® MO) along with HEA panels were selected as drapery over weathered rock strata. High resistance steel wire mesh geocomposite (Steelgrid® HR) and diagonal wire ropes were provided at locations where surficial instability was less. In addition to this, additional deep anchors (8m long) were selected for an area where deep cracks were present and drainage pipes were provided for effective drainage.

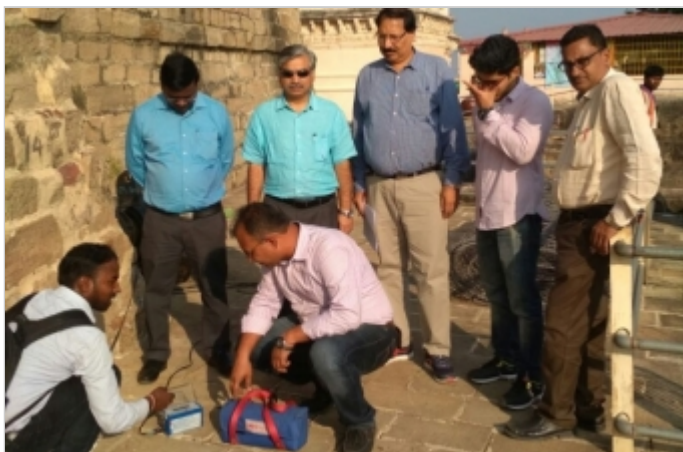
Photo 3: Vibration monitoring in the temple premise

Considering the importance of the temple and concerns of the local people, vibration monitoring was done at various locations in the temple premises using seismograph. Vibrations induced in the temple due to continuous drilling at the base were checked and monitored in the presence of Executive Engineer (PWD Nagpur), Deputy Engineer and other local dignitaries associated with the temple. The evaluation was carried out in all the four directions of the temple.

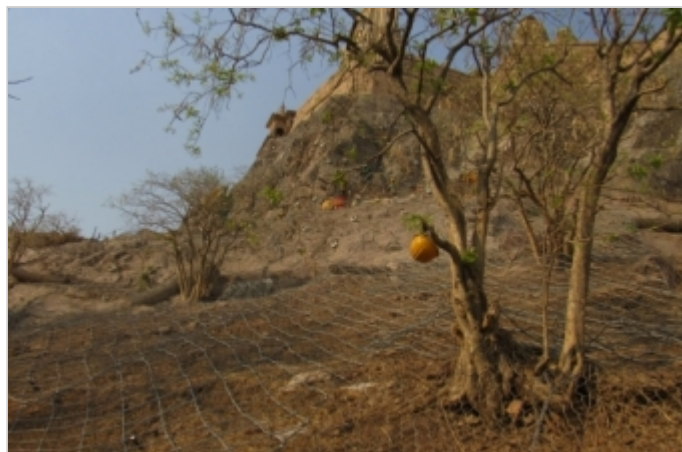
Photo 4: Completed Structure

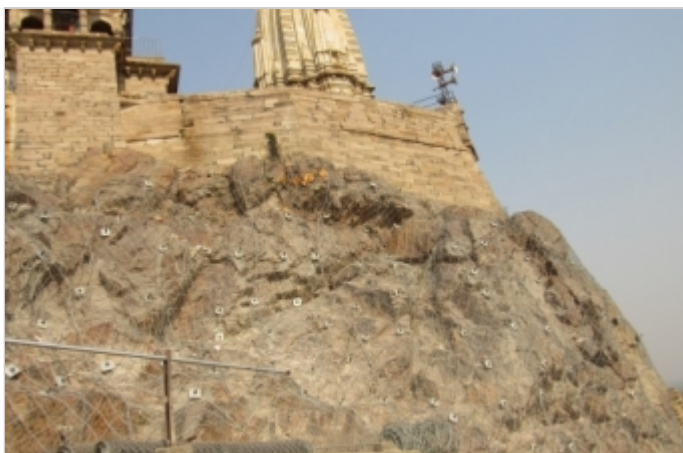
Photo 5: Completed structure

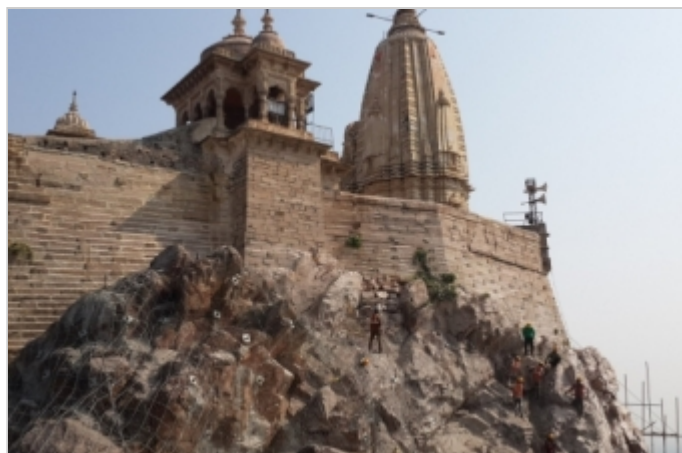
Photo 6: Mesh installation at the back side of temple
