## EROSION CONTROL TRIALS DONE ON RAILWAY EMBANKMENT AT HOSHANGABAD

### HOSHANGABAD, MADHYA PRADESH, INDIA

#### Slope Protection

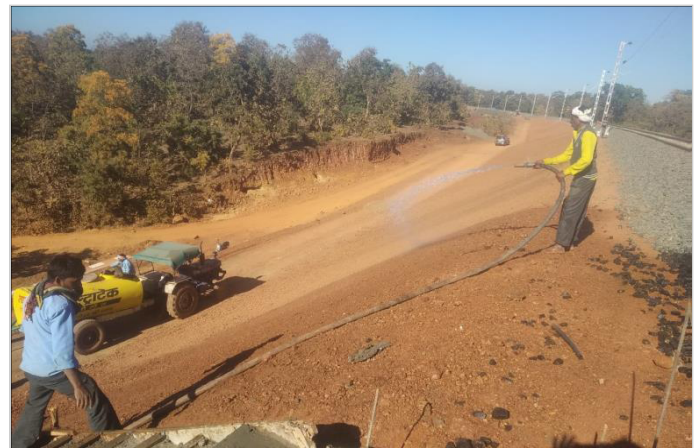
Photo 1: Pre-watering works at site

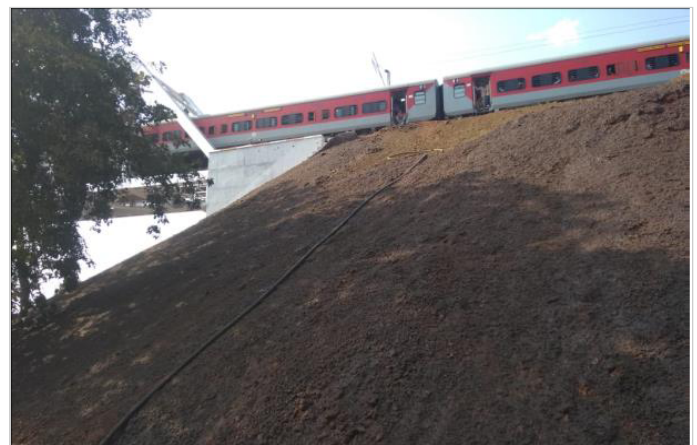
Photo 2: Completion of application of MacGanics

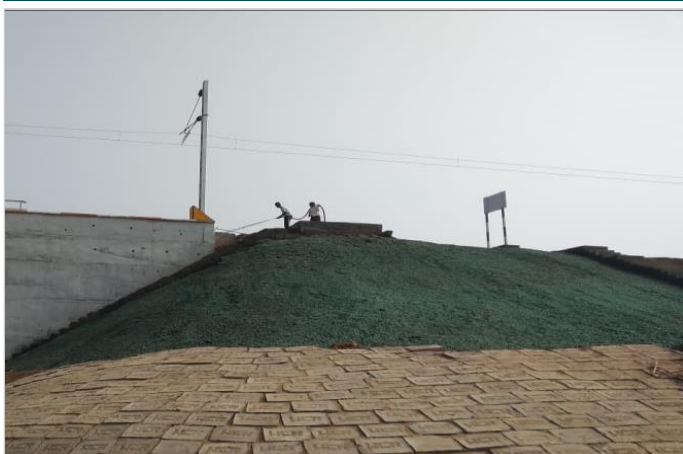
Photo 3: Completion of application of MacFlex

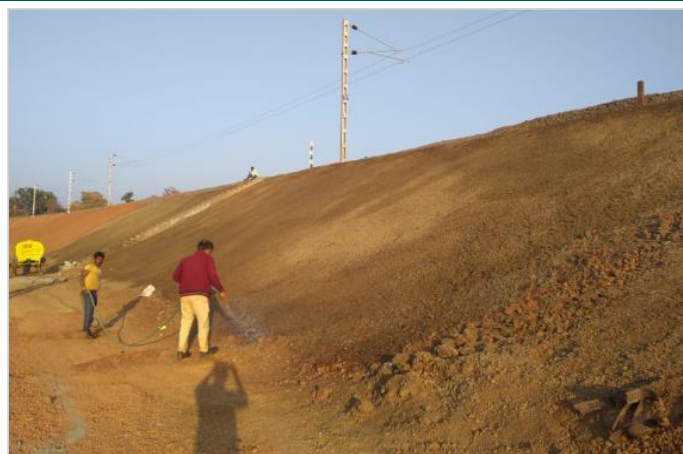
Photo 4: Watering after mulch application

The seed species were selected based on the soil type present at site, pH, climate, type of planting, availability of local seeds and discussions with a horticulturist. The quantities of hydraulically applied erosion control materials, soil amendments were finalized before mixing in a hydroseeder along with seeds and water in a two step process. The slurry obtained after mixing was sprayed over the slope surface and maintenance was done by spraying water on the slope to avoid drying of the material.

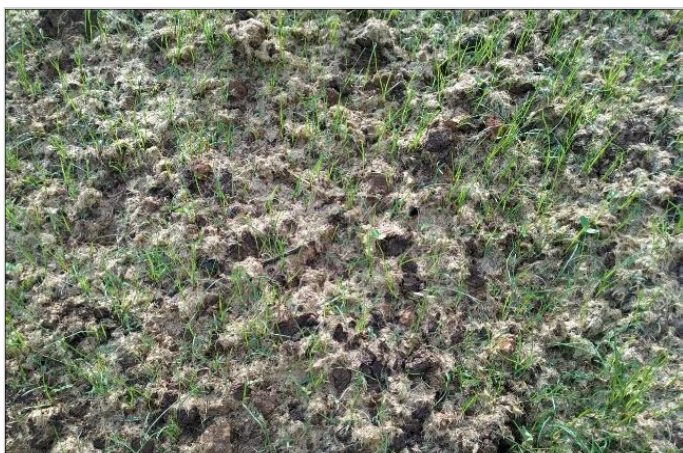
Photo 5: Germination

Soon after the application of erosion control measures at site, the applied systems started showing the performance with respect to erosion control of the embankment slope (i.e. vegetation coverage). Germination started within few weeks and grasses were visible on the treated slope. Proper maintenance of the treated areas was mandatory to ensure the sustenance of the system.

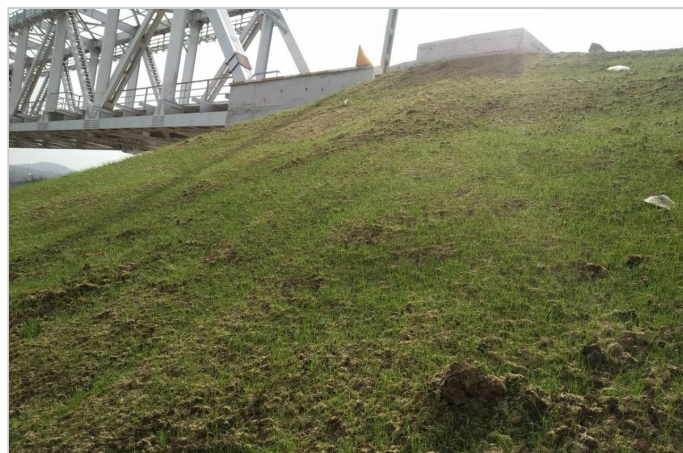
Photo 6: Establishment of vegetation
