# ROCKFALL MITIGATION MEASURES AT PATALGANGA VALLEY, UTTARAKHAND GARHWAL, UTTARAKHAND, INDIA

## Dynamic Barriers

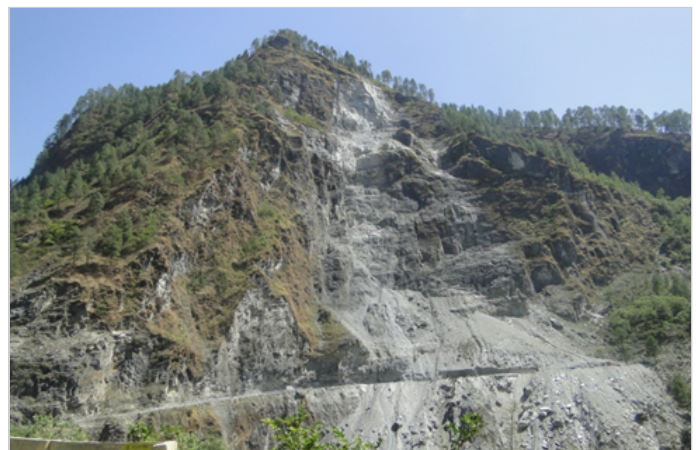
Figure-2. Patalganga landslide

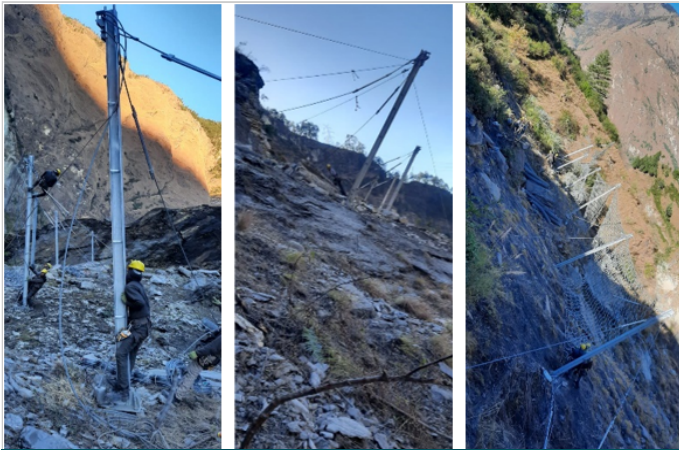
Figure-3. Installation of Rockfall barrier

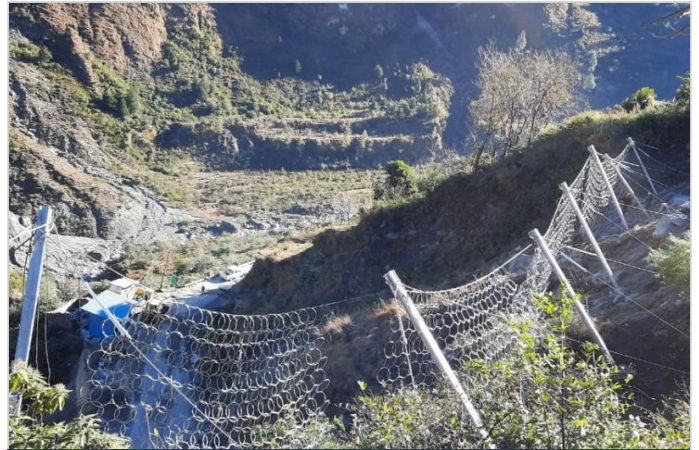
Figure-4. Erection of Rockfall barrier

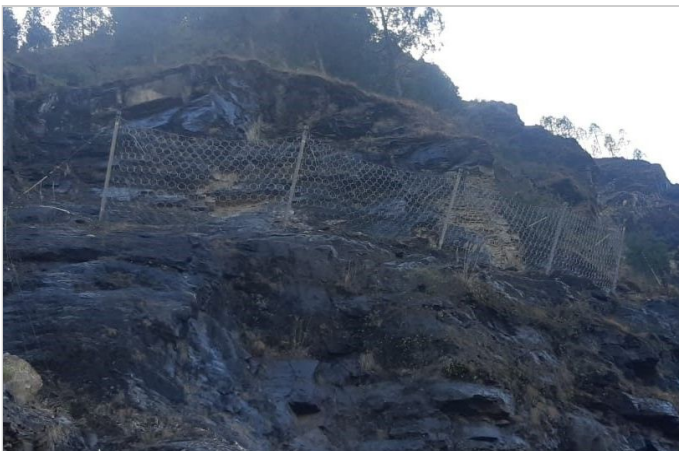
Figure-5. View of installed Rockfall barrier

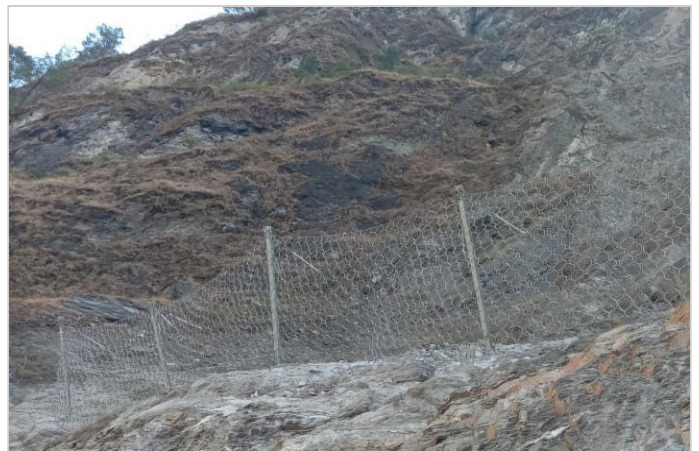
Figure-6. View of installed Rockfall barrier
