DEBRIS FLOW MITIGATION MEASURES NEAR KEDARNATH TEMPLE

KEDARNATH, UTTARAKHAND, INDIA

Debris Flow Barriers

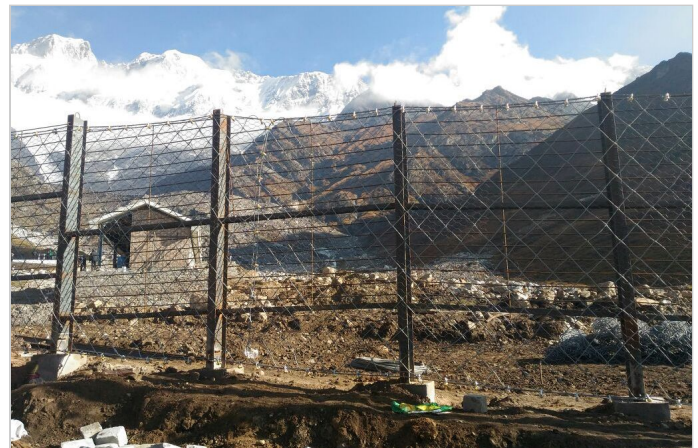
Figure 1. Protection fence with Posts and HEA Panel

Additionally, a protection fence of 3m height and 400m length made up of steel posts and High Energy Absorption (HEA) Panels as intercepting mesh is installed at toe of the slope as second layer of protection against debris flow from base camp to helipad location.

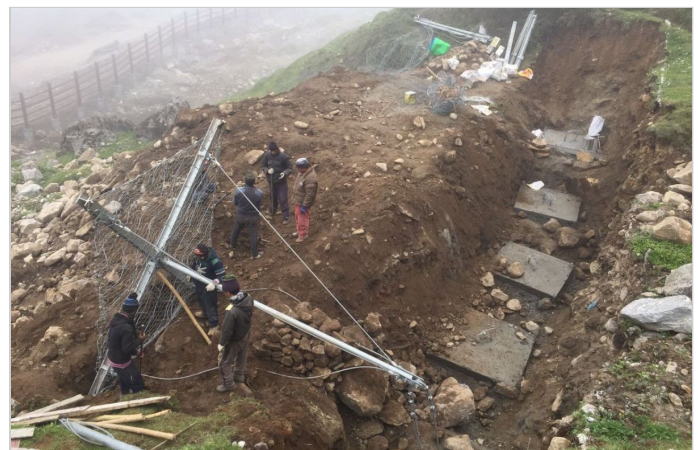
Figure 2. Installation in progress

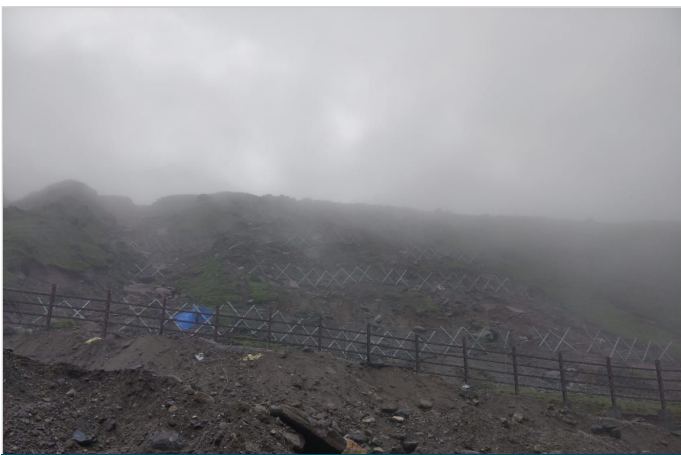
Figure 3. Installed Erdox units & protection fence

Multiple rows of Erdox units of reinforced and unreinforced types were installed to function as debris flow barrier on slope from base camp to the helipad location. Foundation was made of concrete pad embedded into a trench to provide the anchorage to the Erdox units.

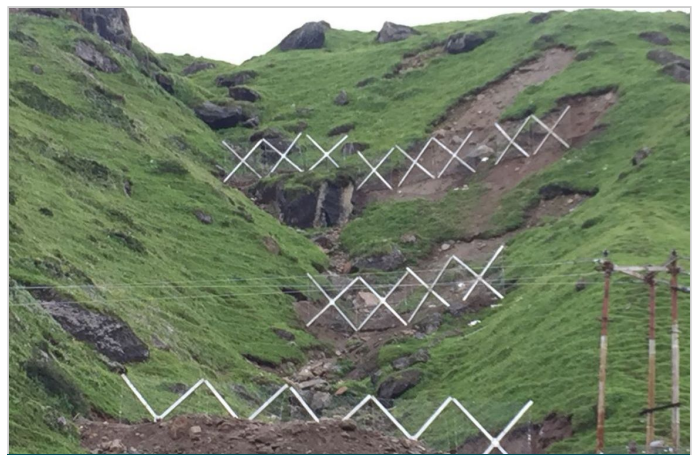
Figure 4. Installed Erdox units

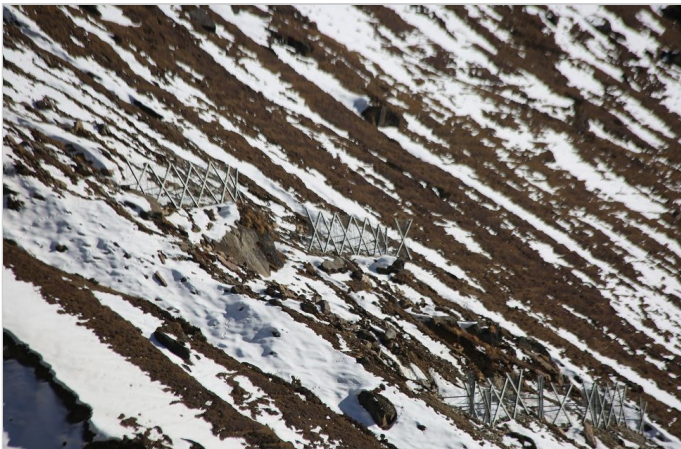
Figure 5. Installed Erdox units (during snowfall)

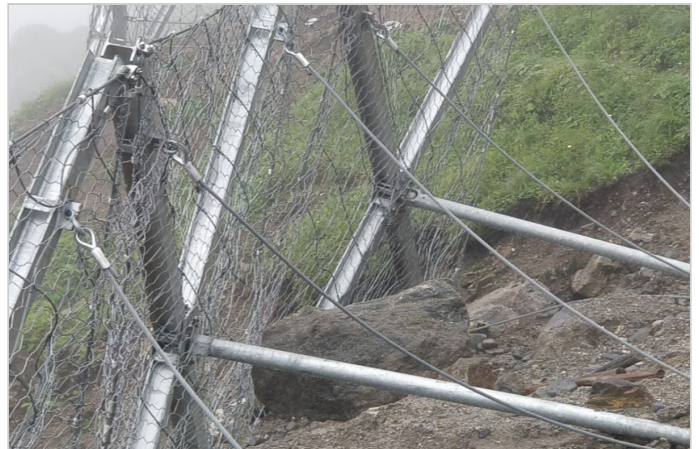
Figure 6. Debris trapped by Erdox immediately after installation

The solution is working effectively since its installation.
