EROSION CONTROL TRIALS DONE ON RAILWAY EMBANKMENT, CHATTISGARH NEAR PATAN VILLAGE, CHATTISGARH, INDIA

Slope Protection

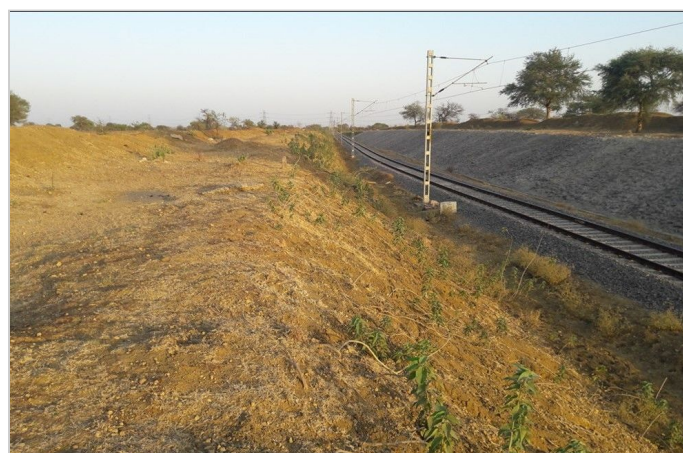
Photo 1: Initial condition of soil embankment

The trial location identified on railway siding bank embankment side slope near Patan Village, Chattisgarh, has been facing soil erosion problems. These soil embankment has been formed by cutting and filling process of soil during the construction of railway track. The erosion has been triggered by erosive agents such as wind, water and gravity. Resultant loss of soil due to erosion has become a matter of serious concern. Unchecked erosion has resulted in cuts, rills or gullies and slide problems.

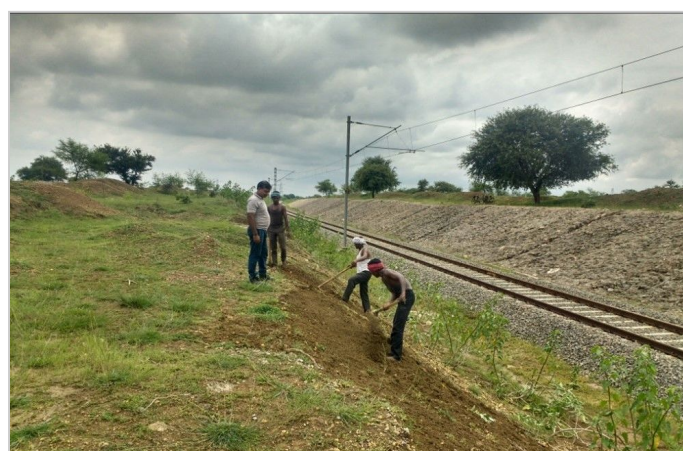
Photo 2: Preparation of slope

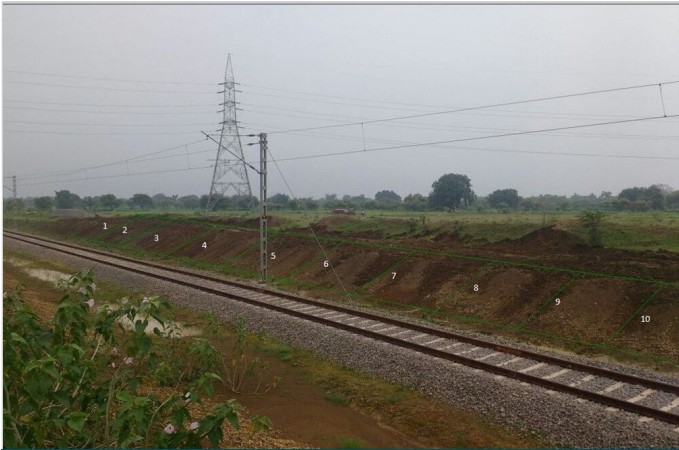
Photo 3: Division of slope into multiple bays

To protect the slope, Maccaferri suggested Hydraulically Applied Erosion Control materials - MacFlex, MacGanics and other agronomic amendments such as AquapHix, Jumpstart, Bioprime & NPK. As part of the trial, project area of 1,000 sqm was selected, split into multiple bays and the above mentioned products along with different combination of seeds are applied on the slope. Agronomic soil tests had been conducted to determine the soil nutrients condition to measure soil's ability to supply essential elements to seeds, to recommend the amendment to improve the soil and to ensure appropriate plant species selection. The solution was decided according to these tests.

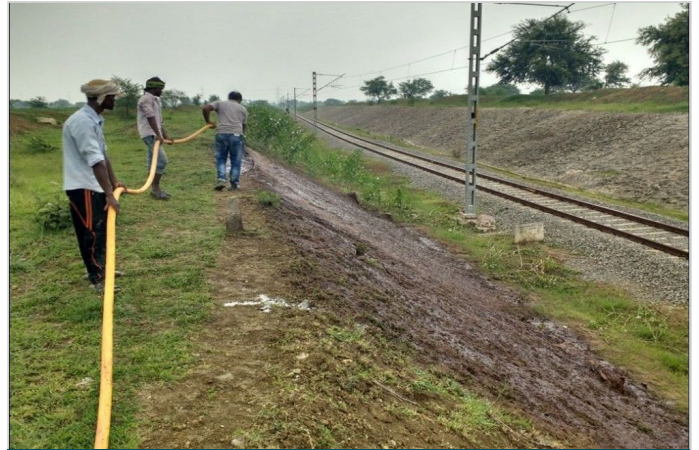
Photo 4: Application of MacGanics

The seed species were selected based on the soil type present at site, pH, climate, type of planting, availability of local seeds and discussions with a horticulturist. The quantities of hydraulically applied erosion control materials, soil amendments were finalized before mixing in a hydroseeder along with seeds and water in a two step process. The slurry obtained after mixing was sprayed over the slope surface and maintenance was done by spraying water on the slope to avoid drying of the material.

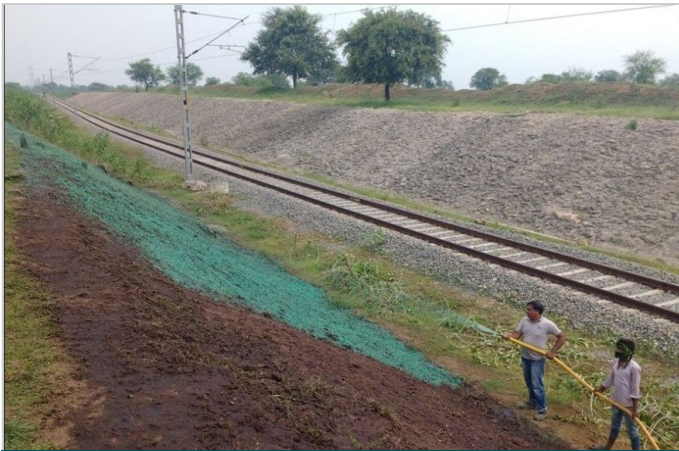
Photo 5: Application of MacFlex

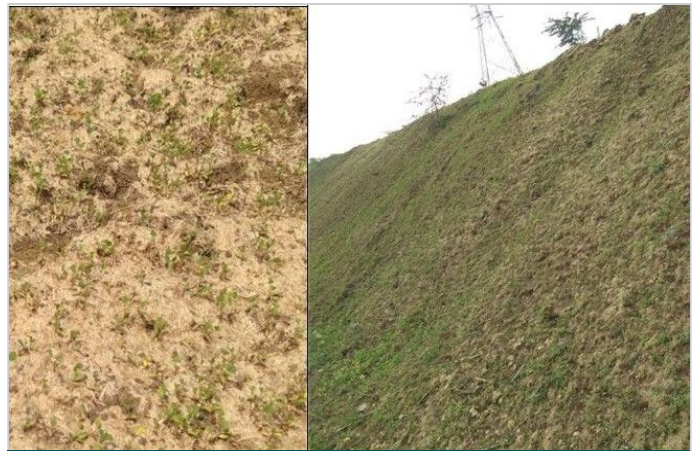
Photo 6: Germination observed (left) and vegetation observed (right)

Soon after the application of erosion control measures at site, the applied systems started showing the performance with respect to erosion control of the embankment slope (i.e. vegetation coverage). Germination started within few weeks and grasses were visible on the treated slope. Proper maintenance of the treated areas was mandatory to ensure the sustenance of the system.
