GABION WALL AT PANCHKARMA AYURVEDIC HOSPITAL TRIVANDRUM, KERALA, INDIA

Mass Gravity Retaining Walls

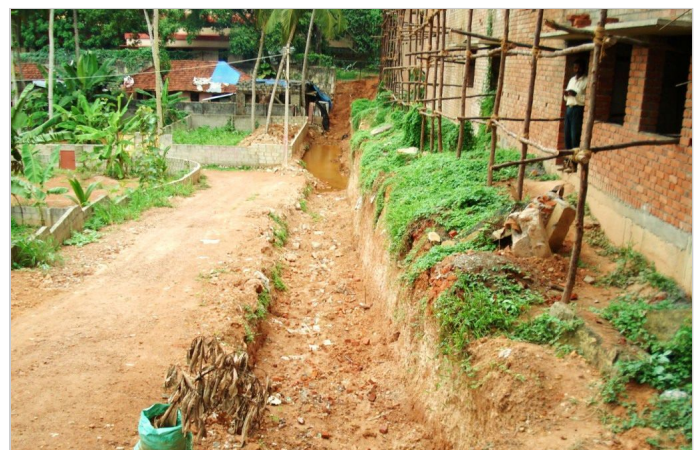
Photo 1: Site before construction

Panchkarma Ayurvedic hospital at Trivandrum was facing seepage of water under the building because of the existence of a pond at the other side of the building. A conventional rigid system can prevent the free flow of water. This will increase pore water pressure on the structure if it is rigid in nature. This in turn will increase the size of structure and increase the cost.

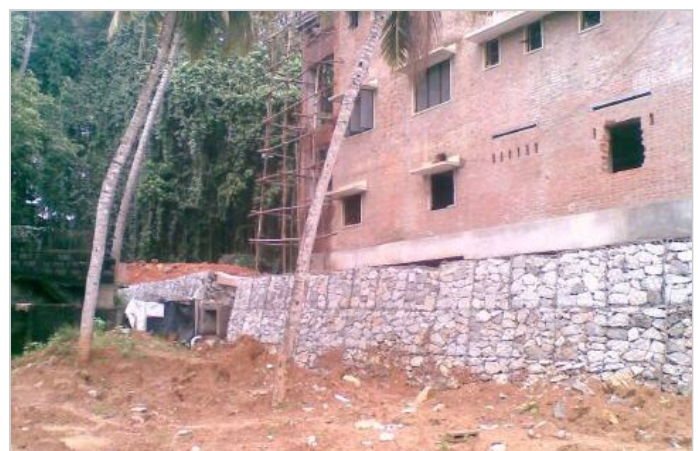
Photo 2: During construction

Considering weak soil parameters and seepage, a flexible free draining structure would be an ideal solution and the same was proposed with gabion wall. Replacement of existing foundation soil with the soil having good characteristics was suggested. A graded filter of gravel and sand was provided for free draining behind the wall along with a geotextile.

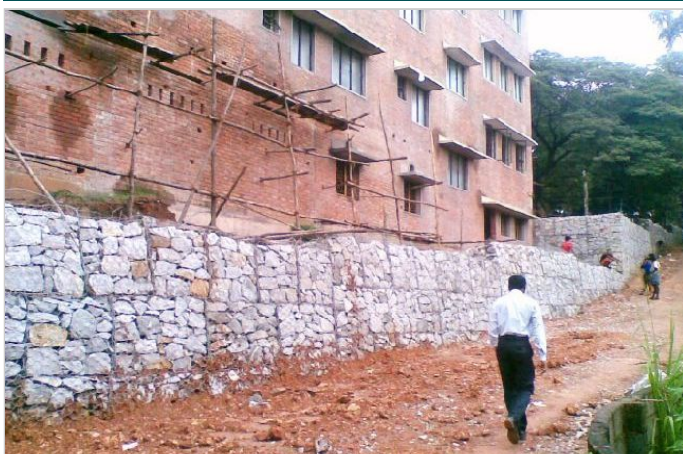
Photo 3: During construction

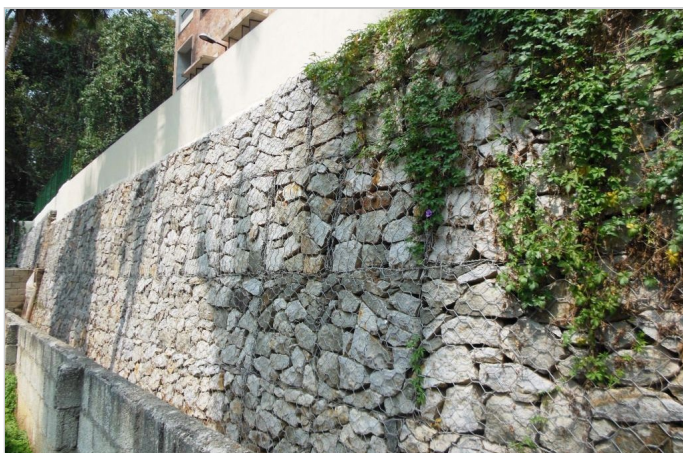
Photo 5: Structure after 2 years

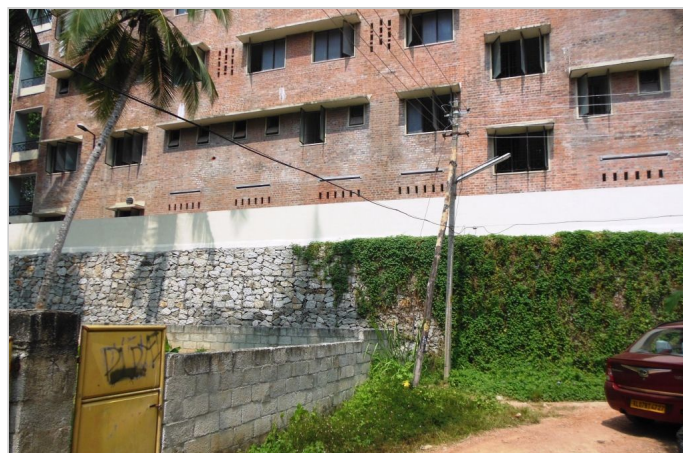
Photo 6: Structure after 2 years

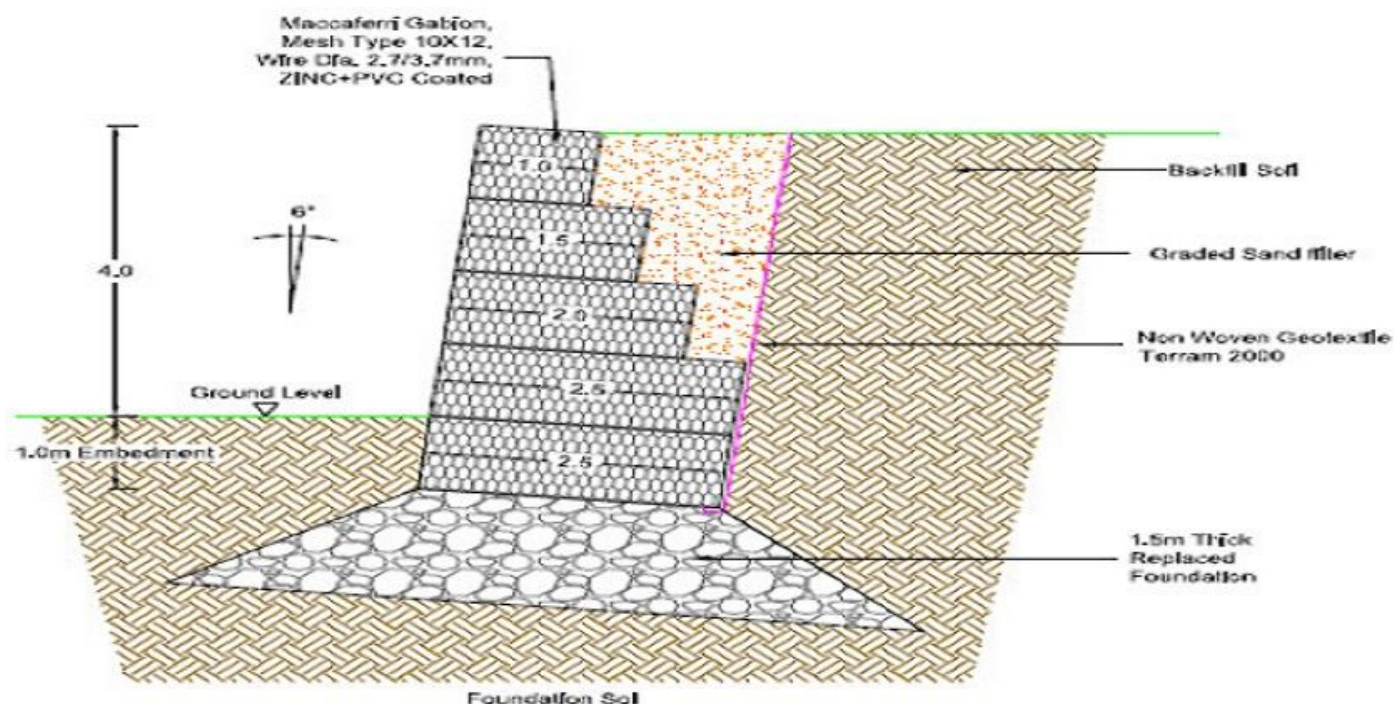
Cross sectional drawing

A Gabion wall of 2 m to 5m height including foundation and batter of 6 degree was constructed.

SOIL	Cohesion (kN/m ²)	Friction Angle (Deg)	Unit Weight (kN/m ³)
Foundation Soil	0	24	18
Backfill Soil	0	24	18
Graded Sand Filter	0	34	18
Replaced Foundation	0	34	18
