DISMANTLING WORKS OF UNSTABLE ROCK BOULDER LOCATED AT GAYA, BIHAR BRAHMAYONI HILLS, SHAHMIR TAKIYA, GAYA, BIHAR, INDIA

Surface Strengthening and Support

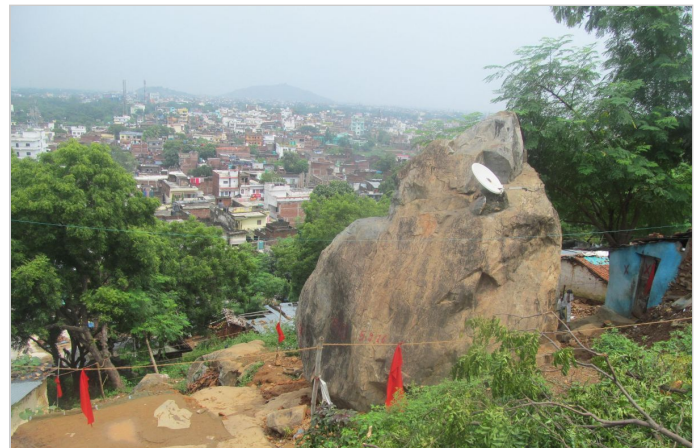
Figure 1- Initial site condition

Bramhani Pahar is located in the eastern part of Gaya, Bihar. In the gentler slope portion of the hill towards the bottom a dense habitat is prevailing. On the hill slope a lots of unstable boulders have been present in precarious condition. During the first week of September 2016, during heavy rainfall a huge boulder (approx. Size-16mx10m) slipped and has moved towards the locality. The boulder has been resting in a precarious position and was expected to move and cause damage to houses on downslope side.

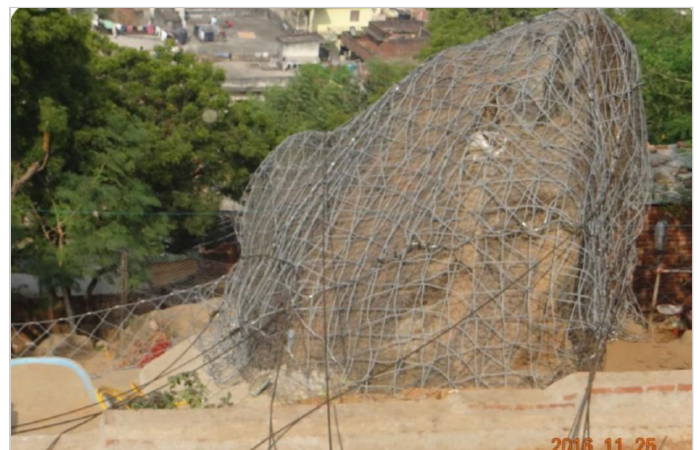
Figure 2- Boulder covered with the meshes and mesh fence on side

Immediate protection measure for the massive boulder which was in the verge of sliding has been done by wrapping the boulder with High Energy Absorption (HEA) Panel and mechanically woven hexagonal Double Twisted (DT) Mesh and secured with cable belting using wire ropes (16mm dia) and anchors(32mm dia, Fe-500) of 2m length.

A temporary fence (barrier) with HEA Panel, DT Mesh and support ropes has been additionally installed near the massive boulder during the control blasting to protect the houses nearby from any detachments during blasting.

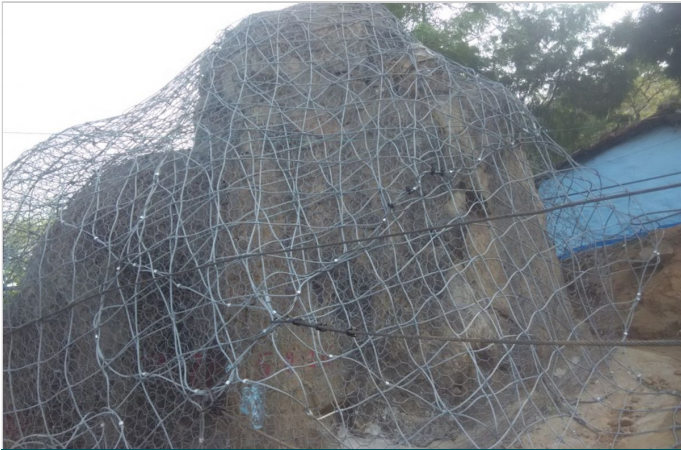
Figure 3- Boulder covered with the meshes and wire ropes anchored with nails

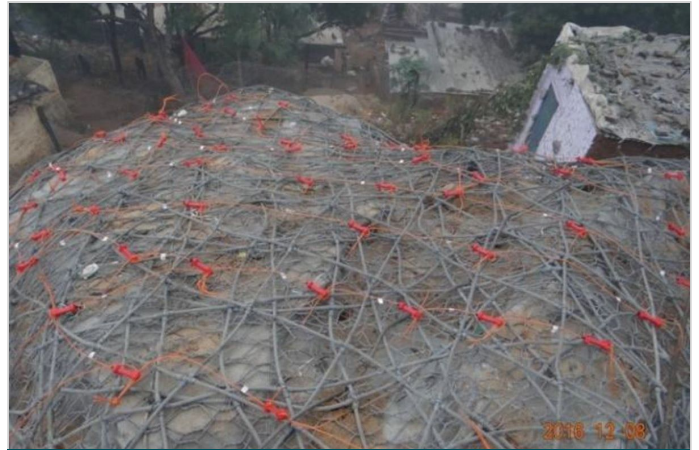
Figure 4- Catridge explosives and nonel units fixed above the boulder

25mm catridge explosives and Nonel units(shock tube detonators) for initiation of in-hole and surface explosions are fixed over the mesh for the purpose of blasting of rock as part of the controlled blasting operations along with necessary precautionary measures. The bigger and smaller fragments have been contained by HEA Panel and DT Mesh respectively. After the controlled blasting, the muck/ fragments contained by HEA Panel and DT Mesh have been removed and cleaned off.

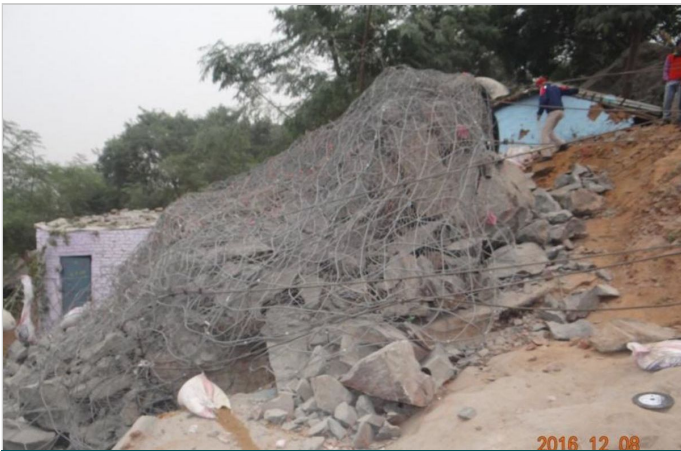
Figure 5- Boulder after blasting with mesh containing demolished fragments

The blasting has been successfully completed without damage to structures (even for the structures as close as 2m away from blasting zone) and no accidents by employing control blasting and installation of high strength mesh systems.

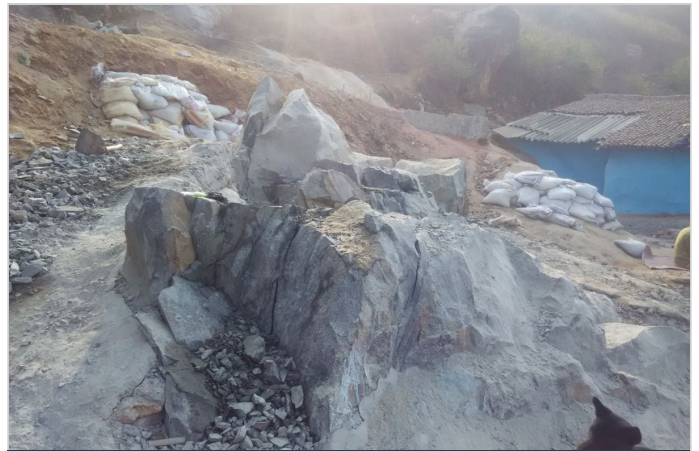
Figure 6- After removal of rock fragments
