## EROSION CONTROL MEASURES FOR HINDALCO'S MINE AT MURI, JHARKHAND

### MURI, JHARKHAND, INDIA

#### Slope Protection

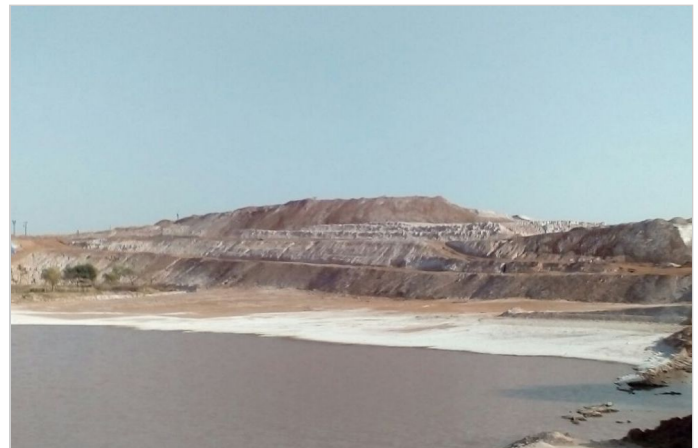
Photo 1: Initial site condition

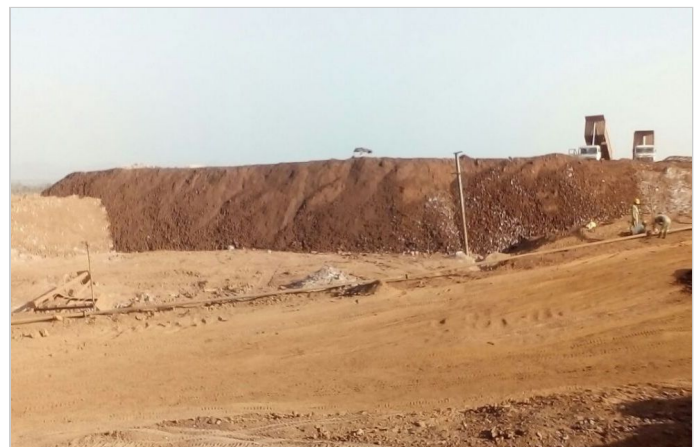
Photo 2: Application of MacGanics completed

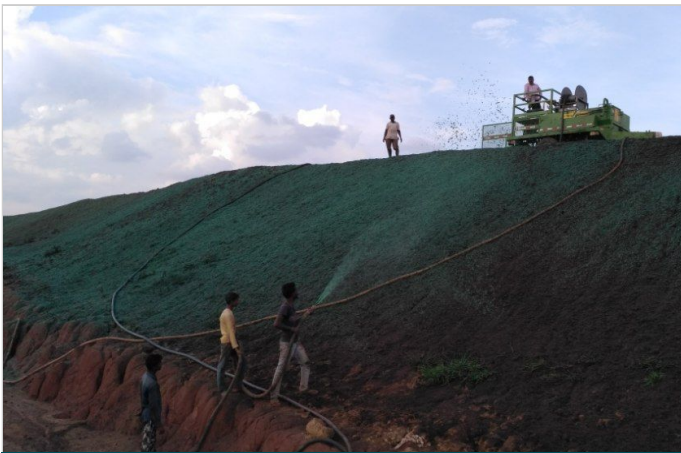
Photo 3: Application of MacFlex

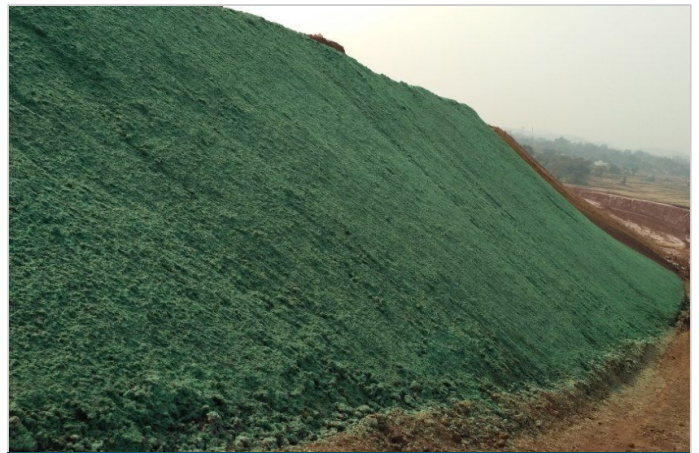
Photo 4: Application of MacFlex completed

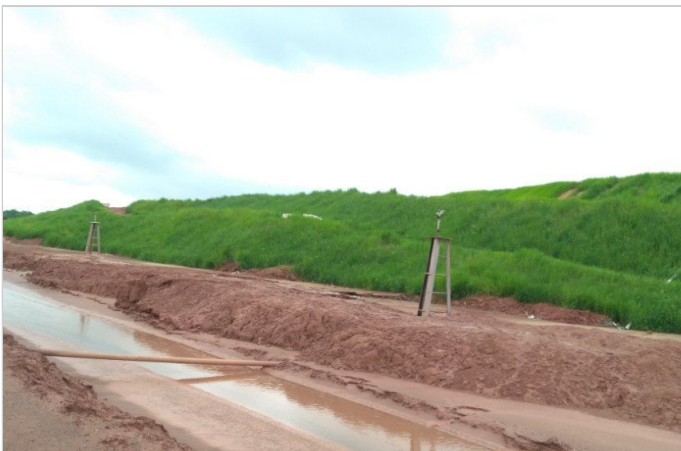
Photo 5: Vegetated overburden slopes

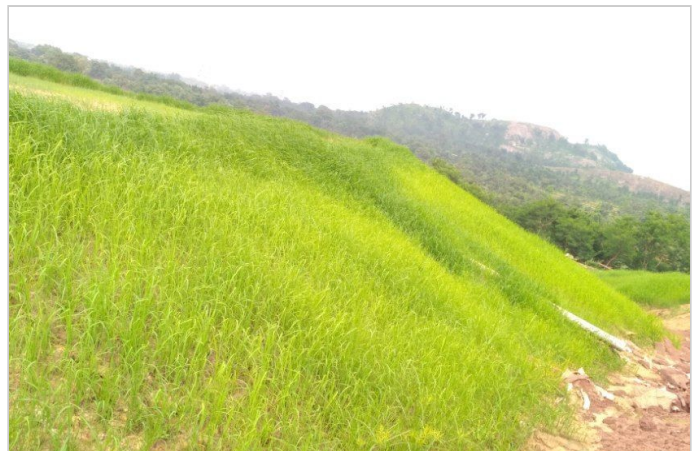
Photo 6: Vegetated overburden slopes
