CULVERT PROTECTION WITH GABION AT KURAL-SHANPUR-SOKHADA RAGHU ROAD

KURAL-SHANPUR-SOKHADA-RAGHU, GUJARAT, INDIA

Weirs, Culverts and Transverse Structures

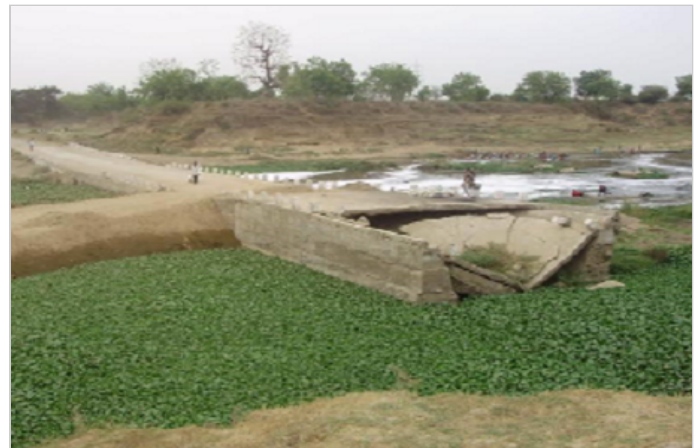
Photo 1: Site Before Construction- RCC Structure failure

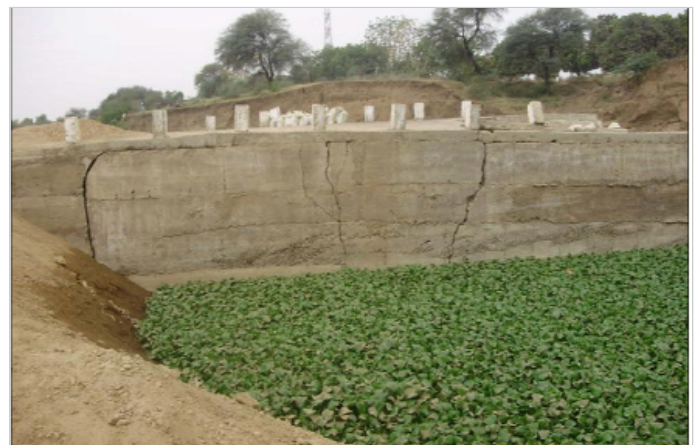
Photo 2: Site Before Construction- RCC Structure failure

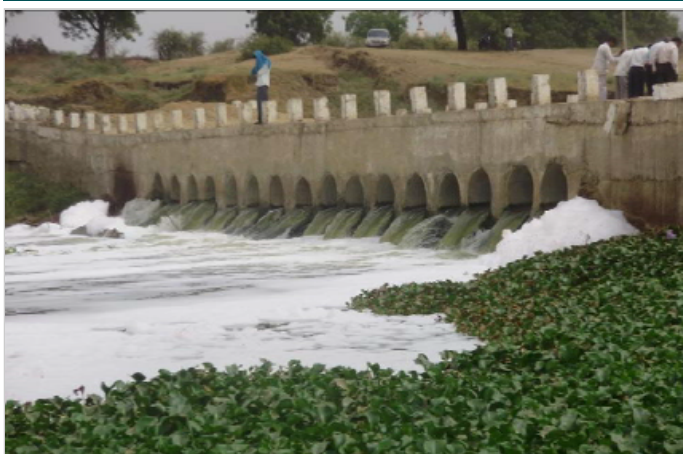
Photo 3: Existing Pipe Culvert

Dhadhar river flows in Gujarat State. It originates from the Pavagadh Hills of Gujarat State and flows through Vadodara and Bharuch districts. Kural-Shanpur-Sokhada-Raghu road is an approach between two villages in Gujarat. There is an existing pipe culvert over river Dhadhar on the approach road. The road located beyond the pipe culvert was constructed over fills which was retained with RCC structure. Due to frequent floods, the RCC structure was damaged and the approach road beyond the pipe culvert was washed away, affecting the road link between two villages. The villagers had to suffer throughout the year by using long route for travel. Road and Buildings Department requested Maccaferri for a suitable solution.

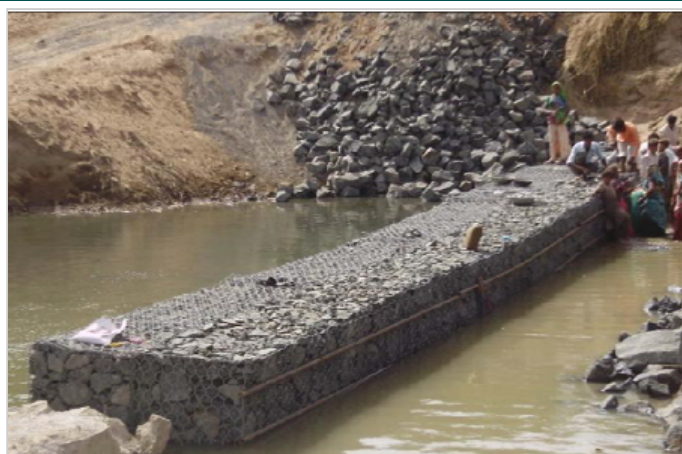
Photo 4: Gabion layers placed in position

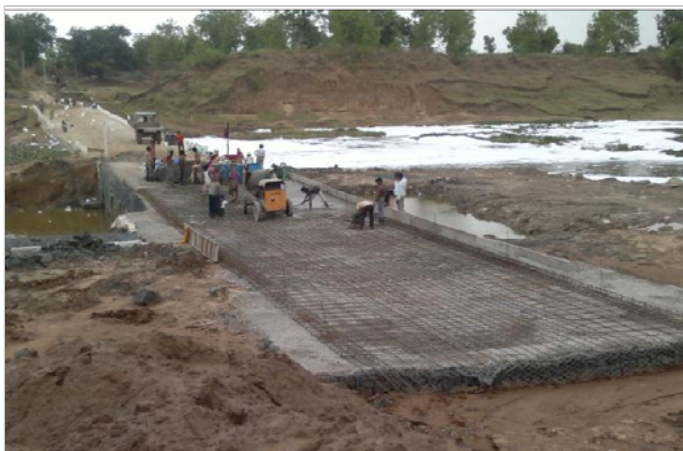
Photo 5: Construction of approach road

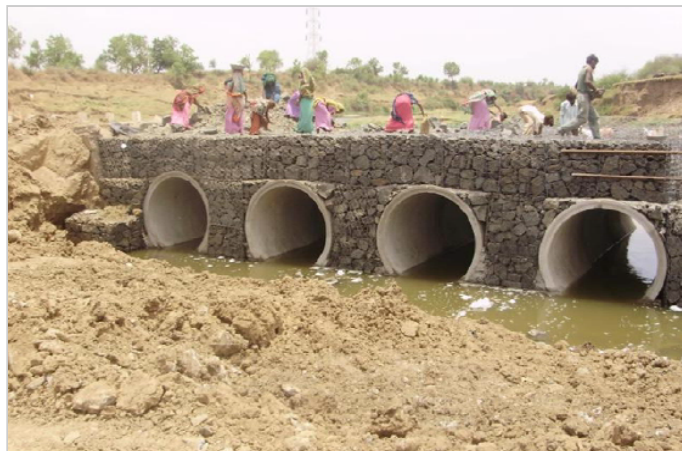
Photo 6: Construction of gabion wall

The embankment being located in high flood zone, an inherently permeable and free draining structure would have been technically suitable. Maccaferri suggested flexible gabion retaining walls. Considering the heavy flood conditions and extensive discharge through culvert, few more pipes of higher dia were provided in addition to the existing ones. Flexible structures of approximately 6m height were designed and constructed.
