TERRAMESH WALL SYSTEM IN NANDGAON NANDGAON, MAHARASHTRA, INDIA

Reinforced Soil Walls and Slope Reinforcement

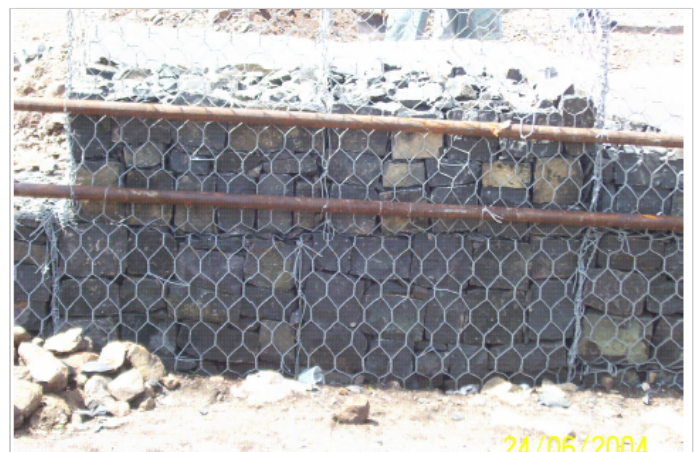
Photo 1: During construction

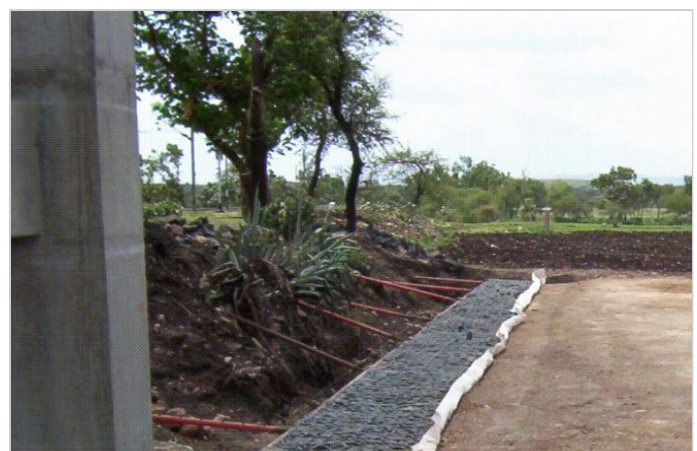
Photo 2: During construction

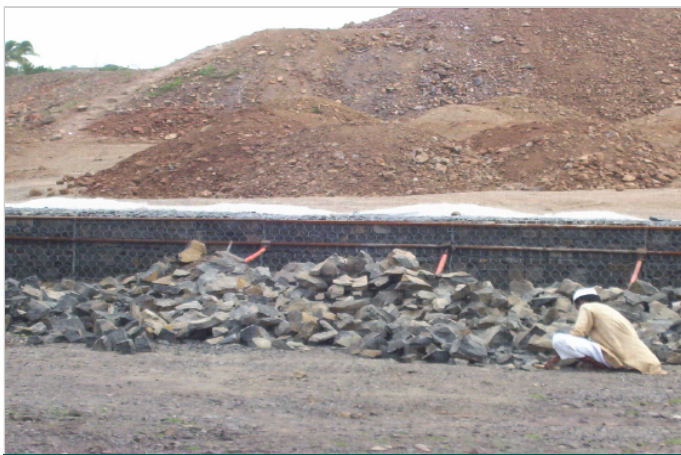
Photo 3: During construction

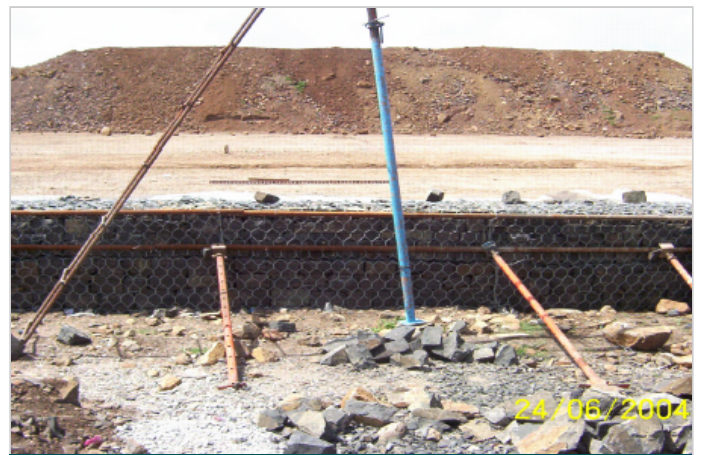
Photo 4: During Construction

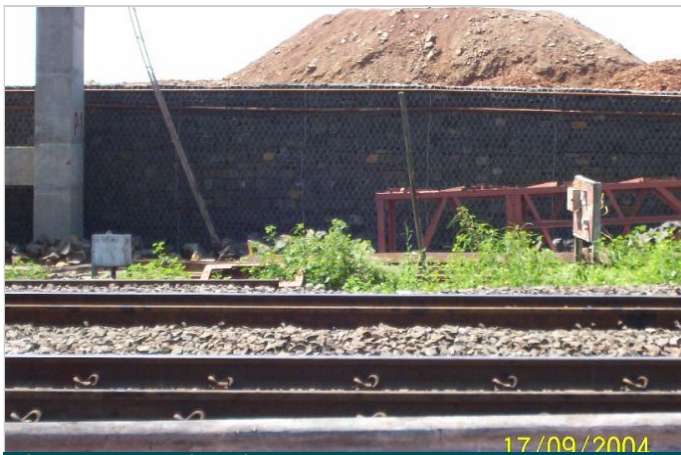
Photo 5: Completed structure

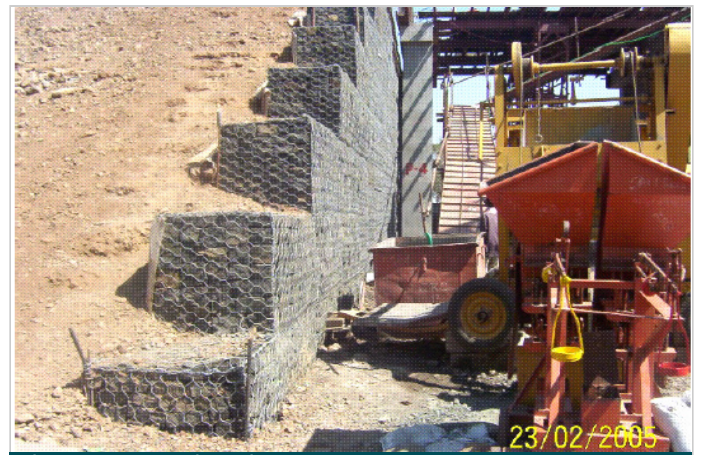
Photo 6: Completed structure

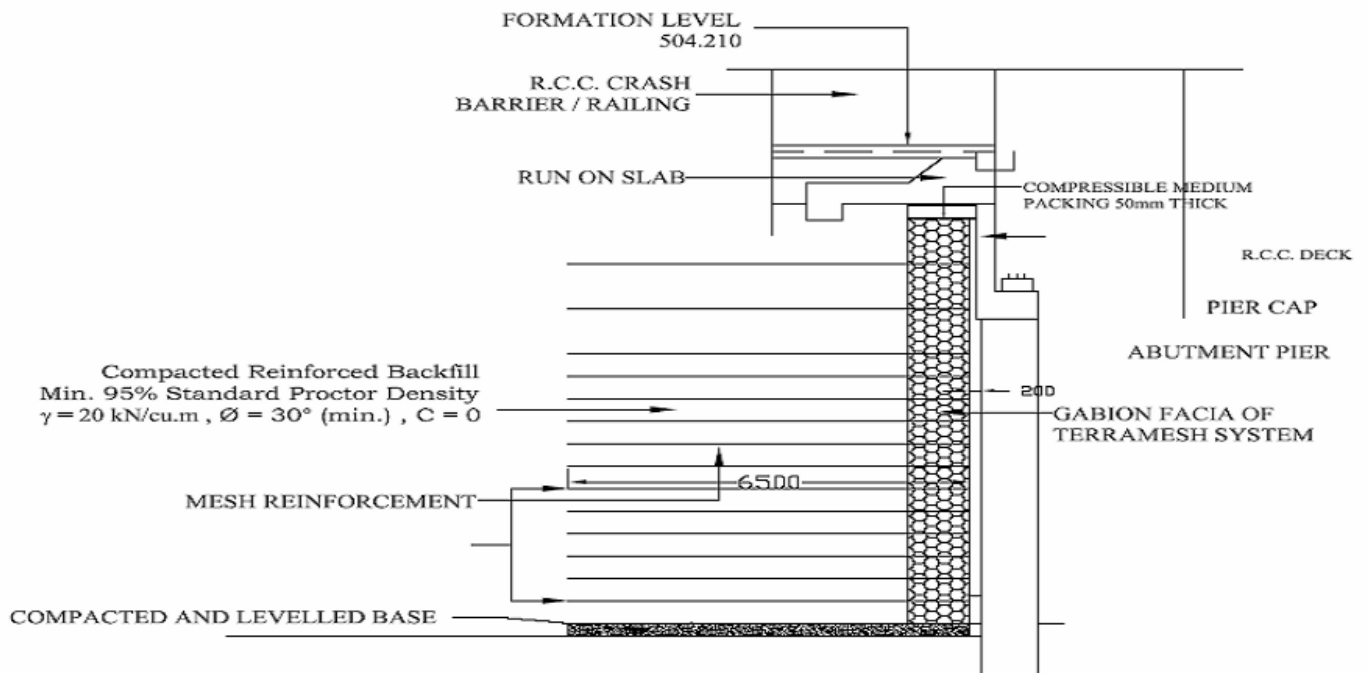
Typical section at the junction of the closing wall and abutment pier
