## EROSION CONTROL MEASURES ALONG NH 39, MANIPUR, INDIA

### CH: 350+000KM TO CH: 395.680KM, IMPHAL - MOREH SECTION, INDIA

#### Slope Protection

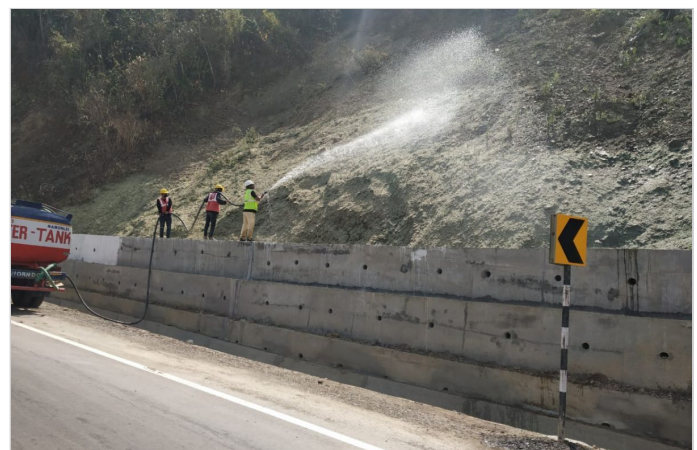
Figure-1 Pre-watering works (hill side)

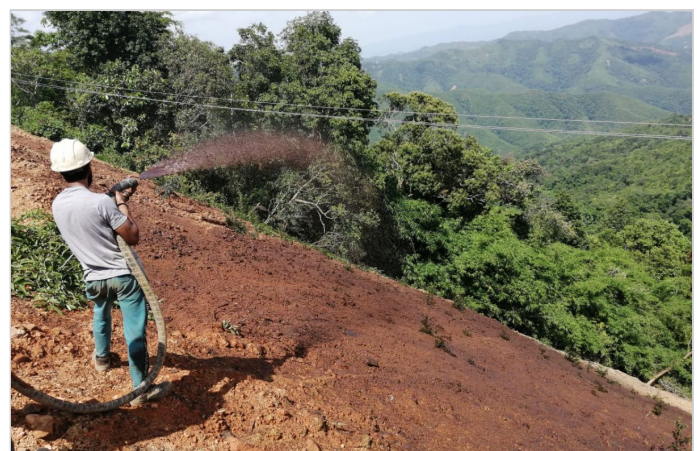
Figure-2 Application of MacGanics (valley side)

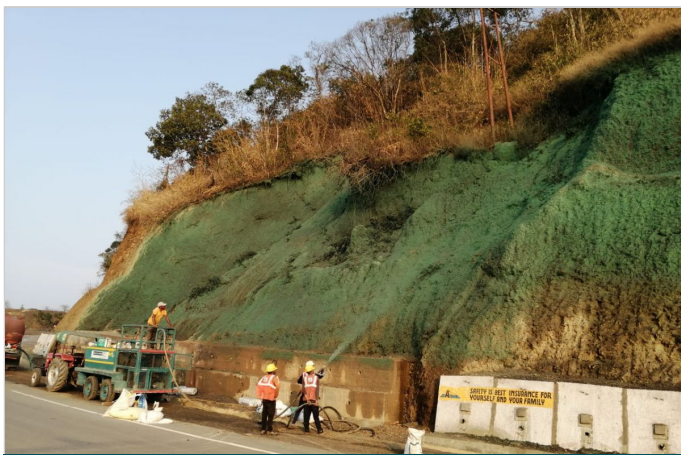
Figure-3 Application of MacFlex(hill side)

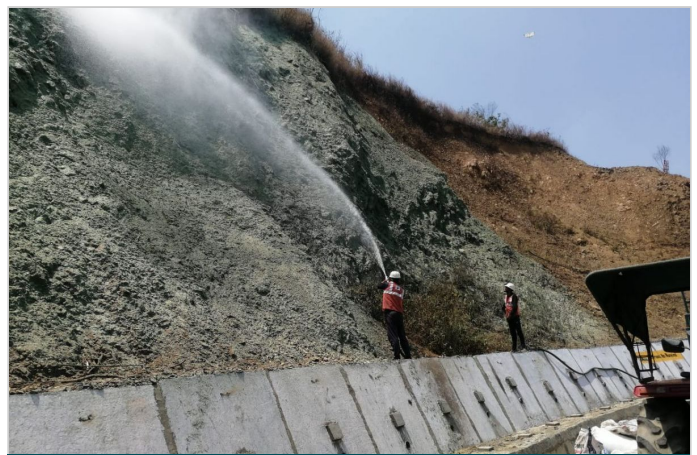
Figure-4 Watering after mulch application (hill side)

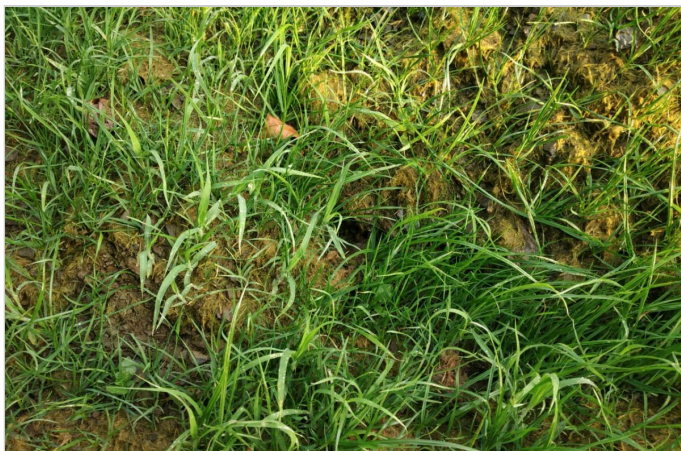
Figure-5 Germination observed after some days of application

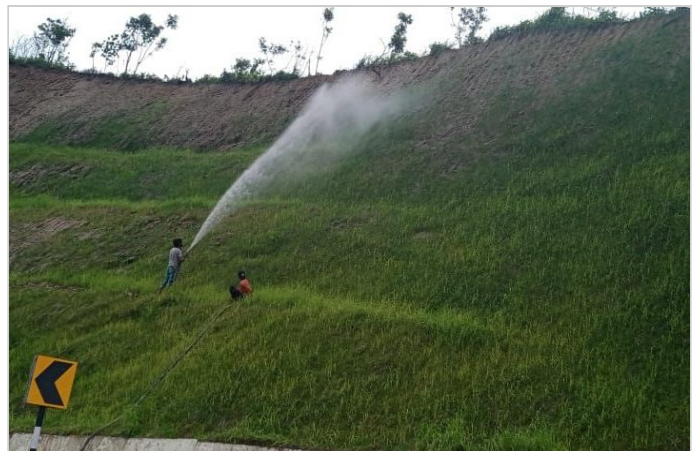
Figure-6 Watering done over vegetated slope(hill side)
