## EROSION CONTROL MEASURES ALONG C-Z ROAD, NAGALAND, INDIA

**CHAKABAMA-ZUNHEBOTO (C-Z) ROAD -CH: 00+000KM TO CH: 25+760KM, NAGALAND, INDIA**

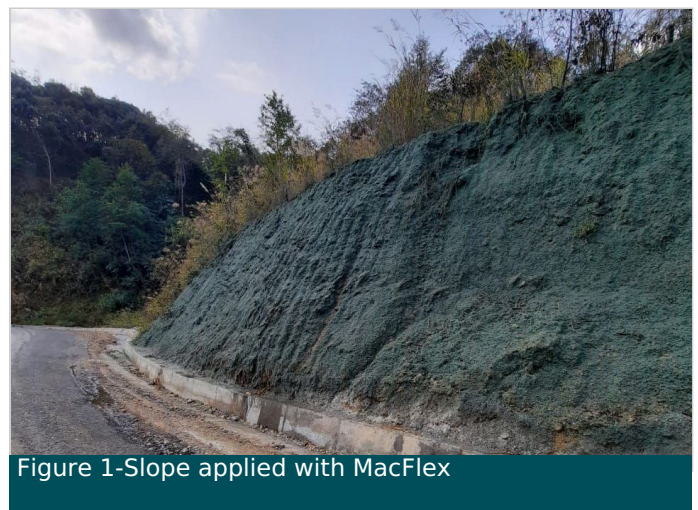
Figure 1-Slope applied with MacFlex

To protect the slope, hydraulically applied erosion control measures comprising of MacFlex HP FGM (HECP), and other agronomic amendments are applied on identified application area. Agronomic soil tests have been conducted to determine the soil nutrients inherent condition so as to recommend the suitable amendments as per requirement to improve the soil and to ensure appropriate plant species selection.

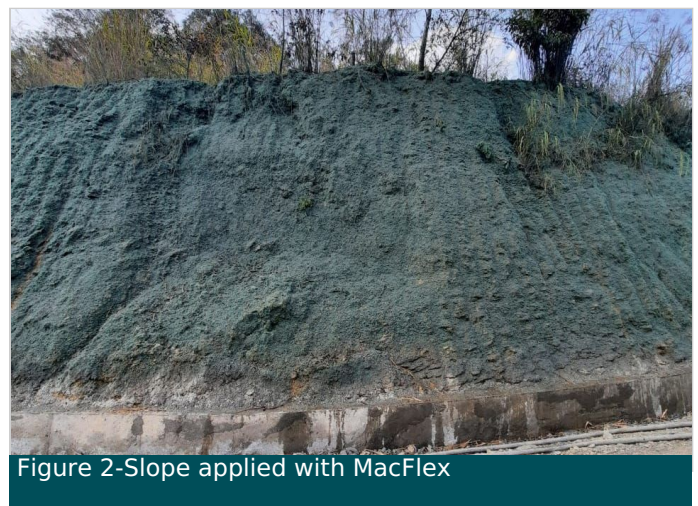
Figure 2-Slope applied with MacFlex

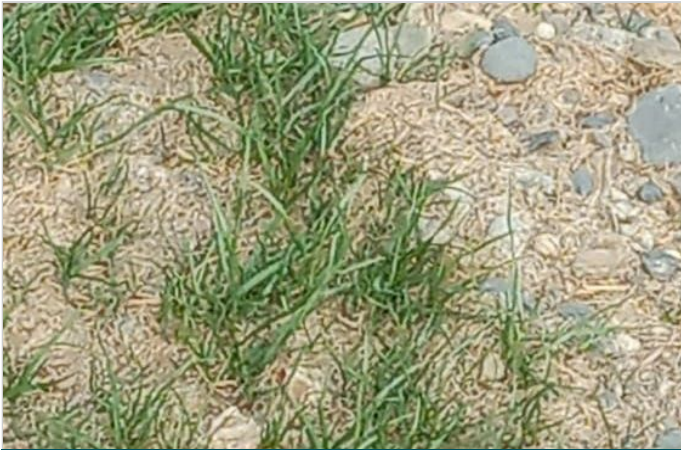
Figure 3-Germination observed after some days

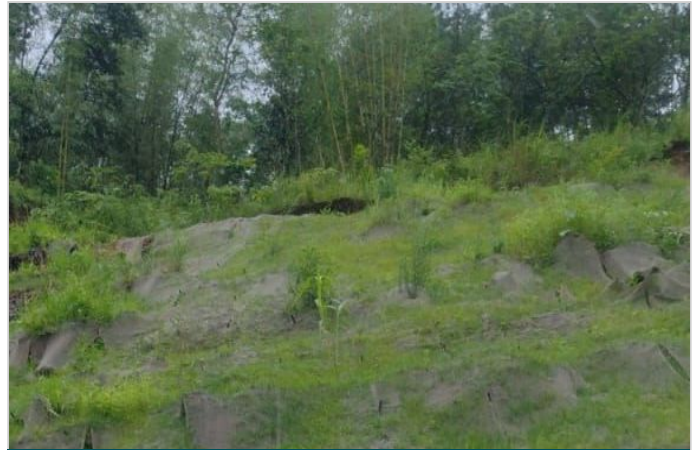
Figure 4- Slopes after vegetation establishment
