## ROCKFALL MITIGATION WORKS- DHAULIGANGA HEP STATION, UTTARAKHAND TAPOVAN, DHARCHULA, UTTARAKHAND, INDIA

### Dynamic Barriers

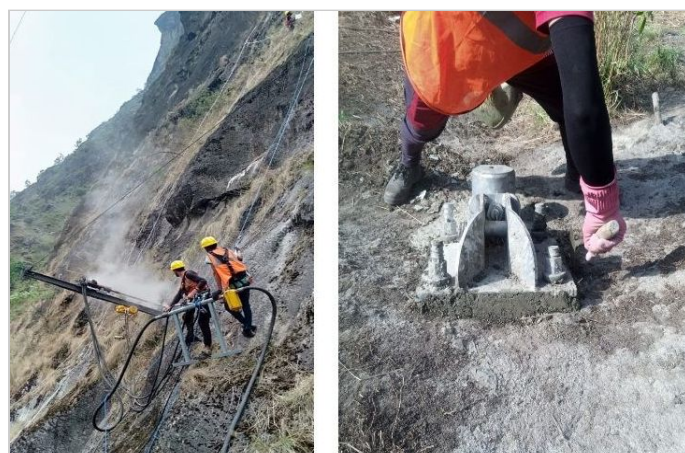
Figure-1 Activities related to installation of barrier posts

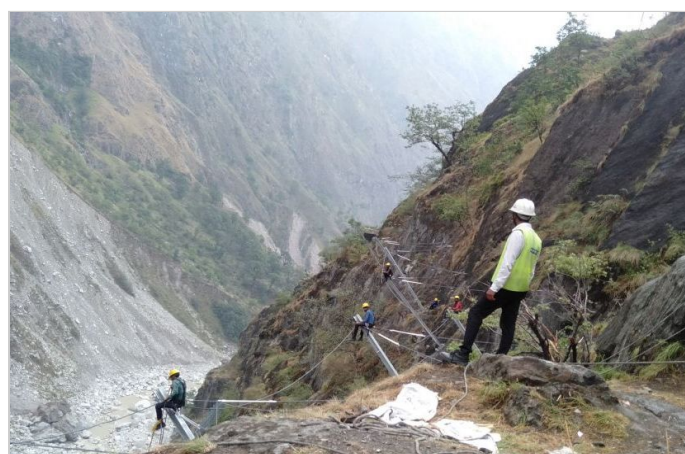
Figure-2 Rockfall barrier post erection completed

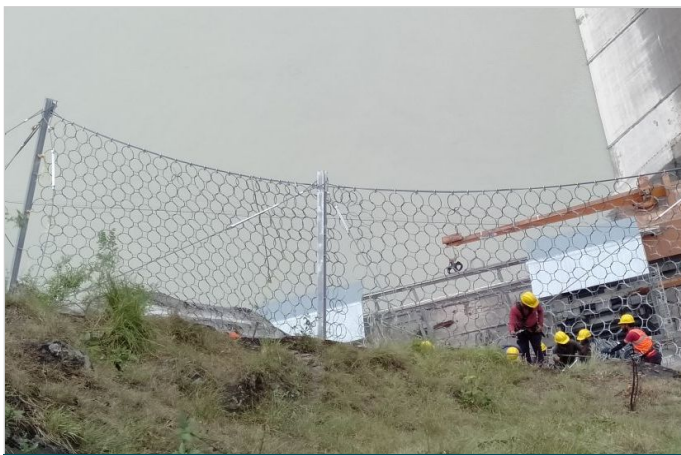
Figure-3 Installation of primary interception mesh (MacRing)

The dynamic rockfall barriers installed are EAD certified and comprise of primary interception mesh of MacRing (Ring Net) and secondary interception mesh of DT Mesh.

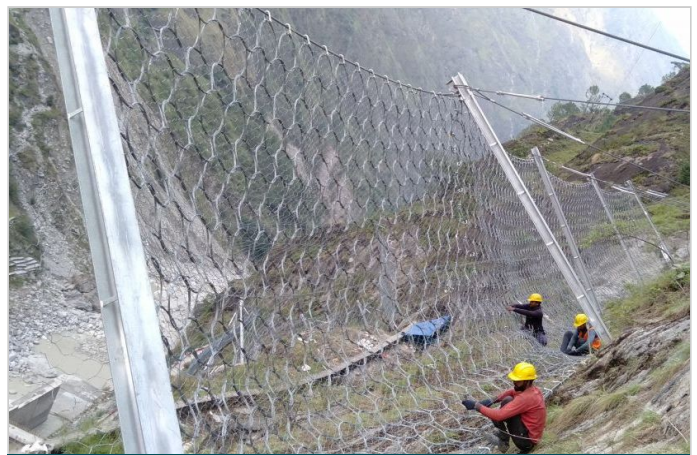
Figure-4 Installation of Secondary mesh (DT mesh) on upslope side of MacRing

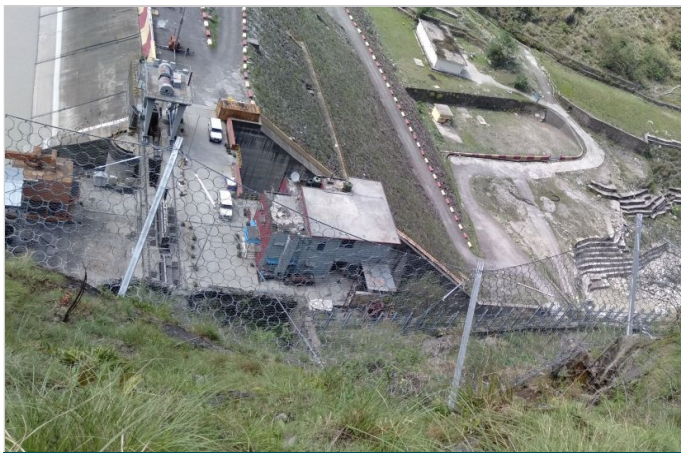
Figure-5 Top view of installed Rockfall barrier

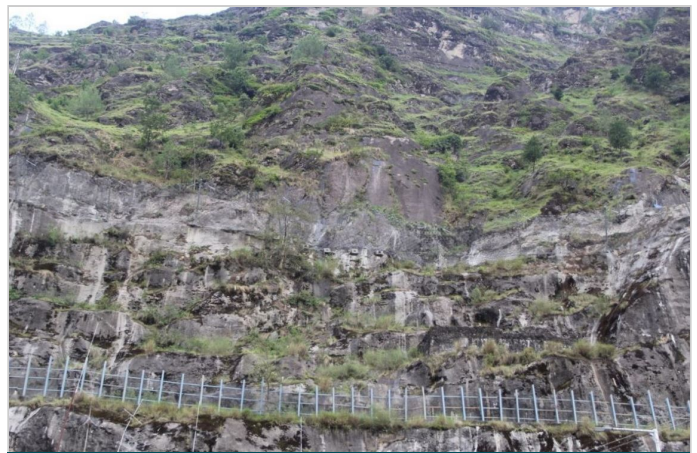
Figure-6 Front view of installed Rockfall barrier
