ROCKFALL MITIGATION WORKS AT ST-1 OF TEESTA STAGE-III HEP, SIKKIM CHUNGTHANG VILLAGE, SIKKIM, INDIA

Dynamic Barriers

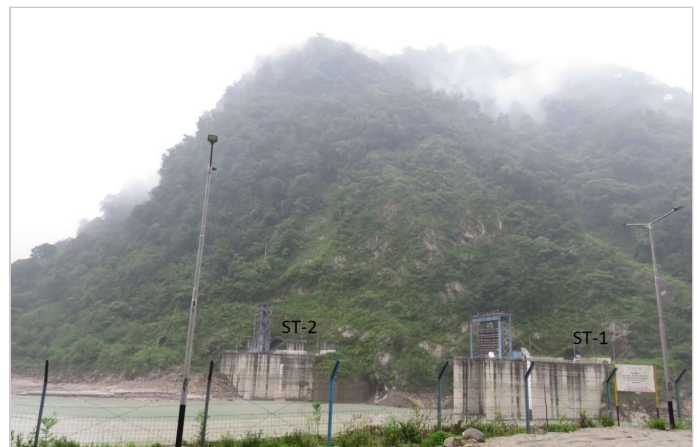
Figure-1 Initial site condition

Rockfall is a major problem at the dam site, especially in the vicinity of spillway tunnels and chute spillways. The surface morphology shows that the moderately fractured weathered rock with vegetation over the slope. The exposed slope is formed with weathered rock strata that were subjected to rainfall during the monsoon seasons. The rainfall infiltration when accompanied by the erosion factors and the steepness, trigger the rock detachment. During past rockfall events, the dam infrastructure were damaged by the shooting stones. Hence, suitable rockfall protection measures are needed to address the problem.

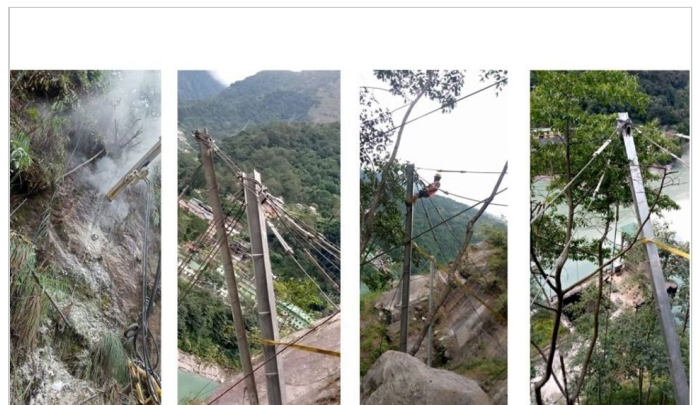
Figure-2 Barrier posts and various cable installation in progress

The dynamic rockfall barriers installed are EAD certified and comprise of a primary interception mesh of MacRing (Ring Net) and a secondary interception mesh of DT Mesh. Skirting arrangement has been adopted wherever applicable. These rockfall barriers have braking system which maintains performance throughout the entire design life of the structure and are easy to visually inspect by maintenance engineers as it progressively deforms once the barriers are impacted.

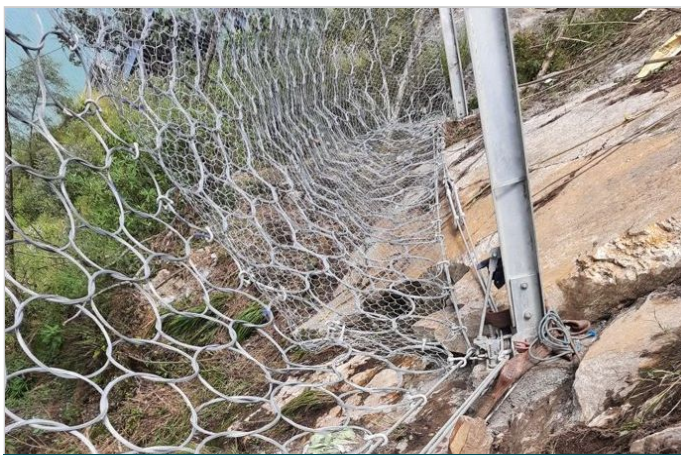
Figure-3 Installation of interception meshes (primary and secondary) in progress

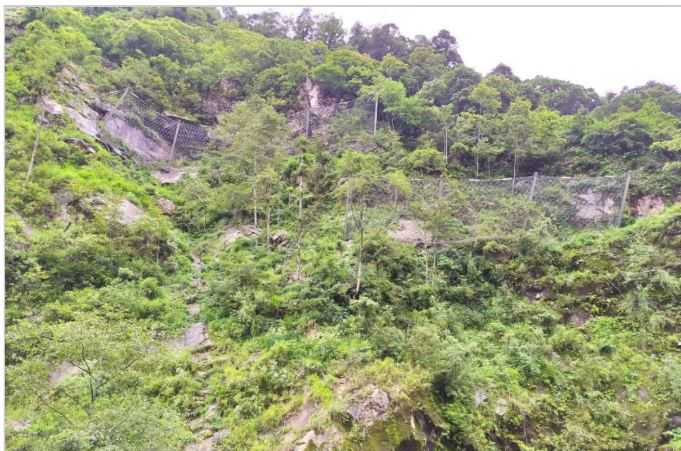
Figure-5 Installed rockfall barriers above ST-1 portal

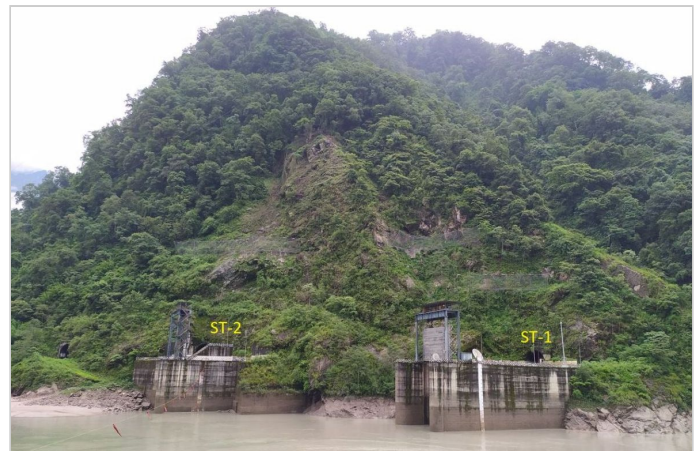
Figure-6 Overall site view after the installation of rockfall barriers
