## EROSION CONTROL TRIAL ALONG OOTY STATE HIGHWAY, TAMILNADU NILGIRI DISTRICT, TAMILNADU, INDIA

### Slope Protection

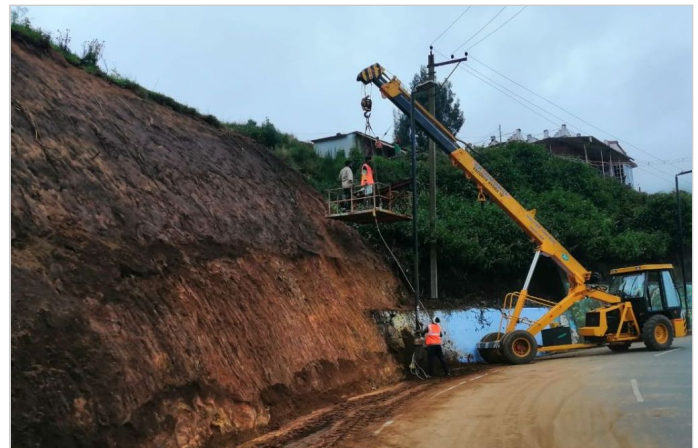
Figure 1-Site preparation

After the site preparation, the soil slope has been trimmed to max. 70 degree. To prevent erosion on slope, suitable erosion control measures have been proposed and the trials are done to demonstrate the effectiveness of the proposed measures.

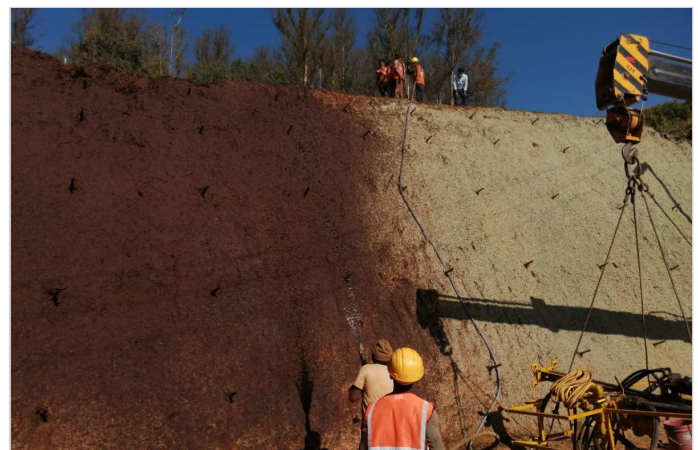
Figure 2-Application of MacGanics over nailed slope

To carry out the trial in identified slope area of 300 sq.m, Maccaferri suggested surface nails (Self drilling Anchors (SDA) of 32mm dia.), 3D erosion control mat ( a steel reinforced synthetic geomat ie, MacMat R) and hydraulically applied erosion control measures (MacFlex HP FGM and MacGanics BSM (top soil alternative)) and agronomic amendments, along with seeds. The top anchoring of MacMat R is done with top nails at crest. Agronomic soil tests have been conducted to determine the soil nutrients condition to measure soil's ability to supply essential elements to seeds, to recommend the suitable solution, assess required amendments to improve the soil and to ensure appropriate plant species selection.

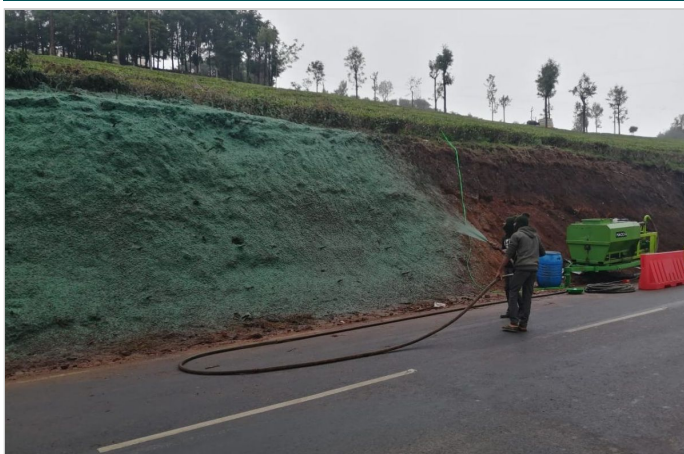
Figure 3-Application of MacFlex

The seed species are selected based on the soil type present at site, pH, climate, type of planting, availability of local seeds and discussions with a horticulturist. The quantities of various components are finalized before mixing in a hydroseeder along with seeds and water in a two step process. The mixed slurry has been sprayed over the slope surface and maintenance has been done by spraying water on the slope to avoid drying of the material.

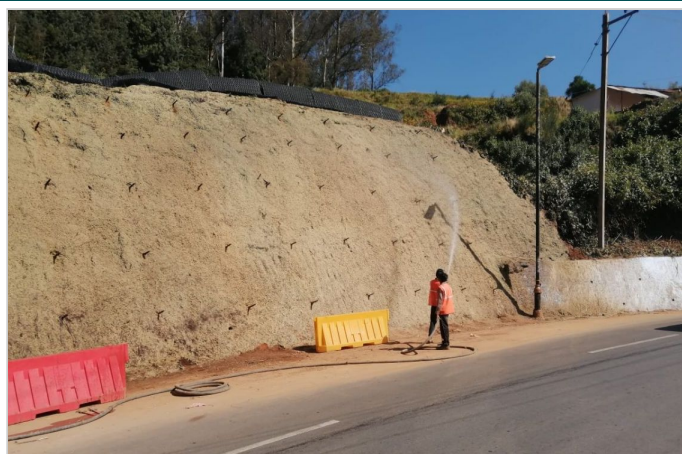
Figure 4-Watering after mulch application

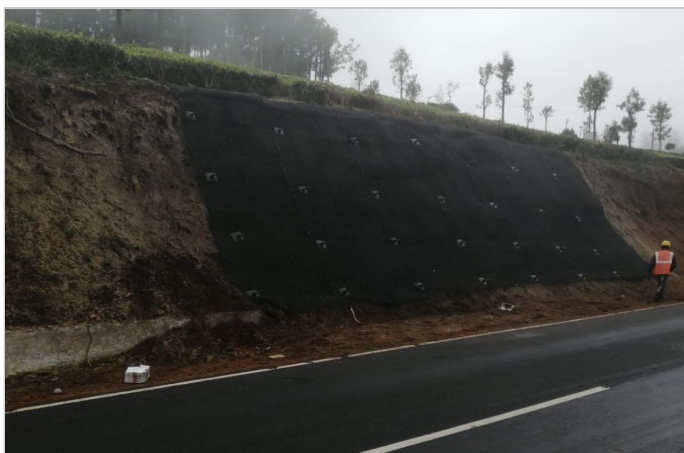
Figure 5-Laying of MacMat R over hydroseeded slope

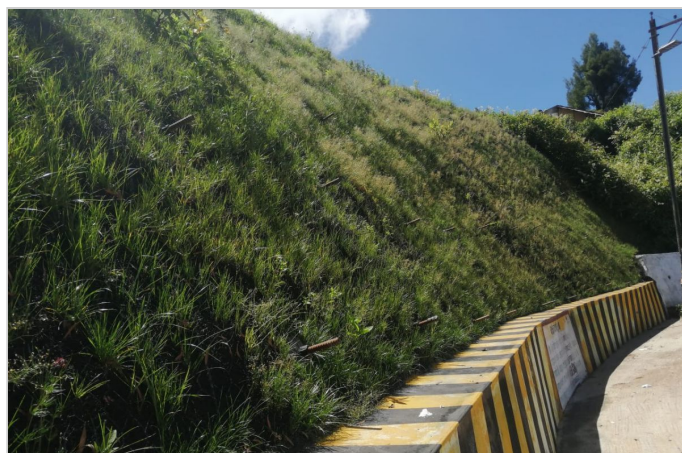
Figure 6-Vegetation establishment on slope

Soon after the application of erosion control measures at site, the solution started showing the performance with respect to erosion control of the embankment slope (i.e, vegetation coverage). Trial has been successful with germination starting within few weeks and grasses were visible on the treated slope. Proper maintenance of the treated areas was mandatory to ensure the effectiveness of the system.
