## ROCKFALL MITIGATION WORKS- MAT - TEESTA STAGE-III HEP, SIKKIM SINGHIK VILLAGE, MANGAN, SIKKIM, INDIA

### Dynamic Barriers

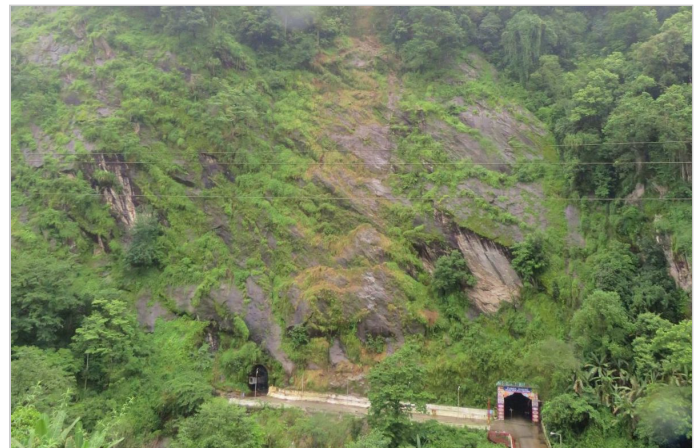
Figure-1 Initial site condition

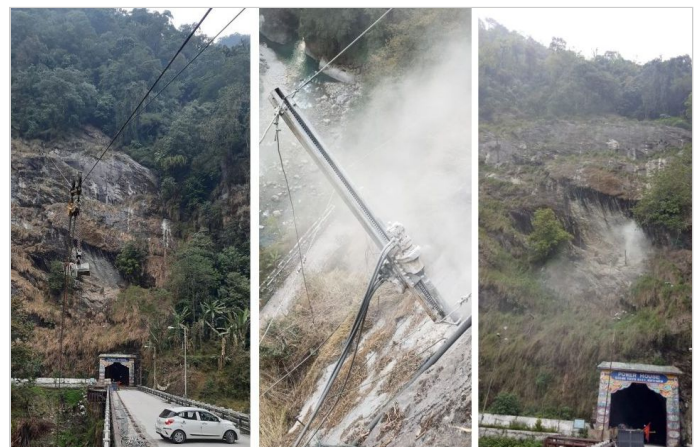
Figure-2 Shifting and drilling activities

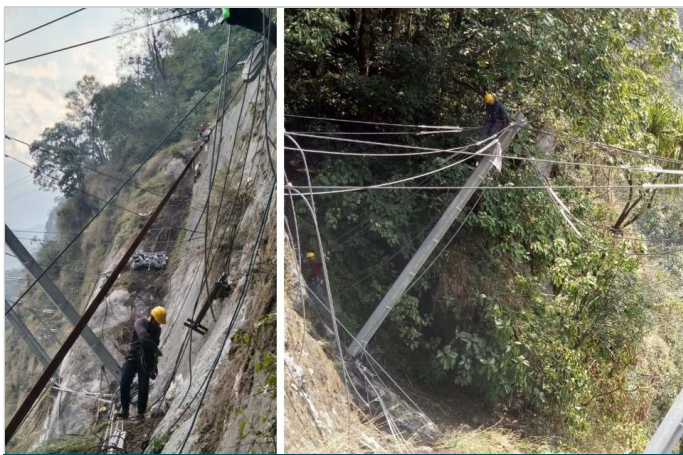
Figure-3 Installation of posts

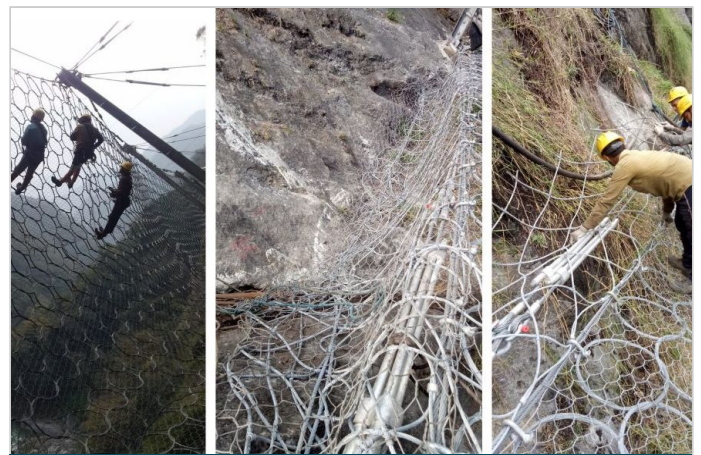
Figure-4 Installation of interception meshes and skirting arrangement

The dynamic rockfall barriers installed are EAD certified and comprise of a primary interception mesh of MacRing (Ring Net) and a secondary interception mesh of DT Mesh. Skirting arrangement has been adopted wherever applicable. These rockfall barriers have a braking system, which maintains performance throughout the entire design life of the structure and are easy to visually inspect by maintenance engineers as it progressively deforms once the barriers are impacted.

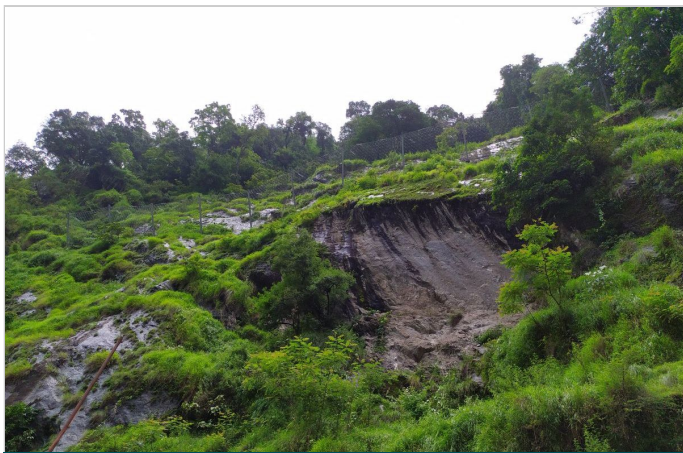
Figure-5 Installed Rockfall barrier

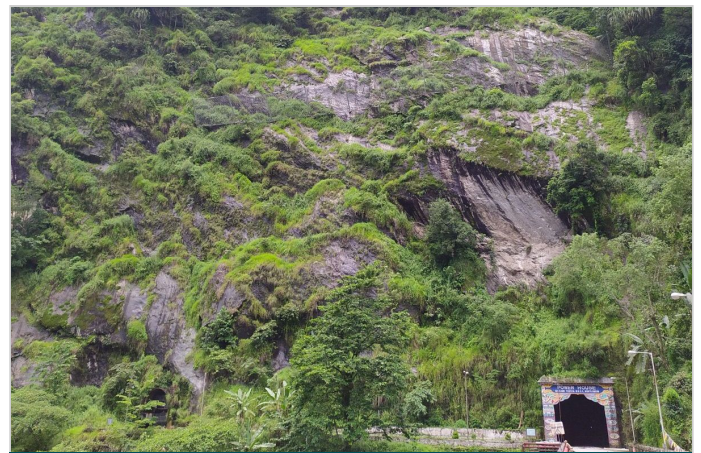
Figure-6 Overall view of slope after the installations of Rockfall barrier
