ROCKFALL MITIGATION WORKS- CS DAM TOP-TEESTA STAGE-III HEP, SIKKIM CHUGTHANG VILLAGE, SIKKIM, INDIA

Dynamic Barriers

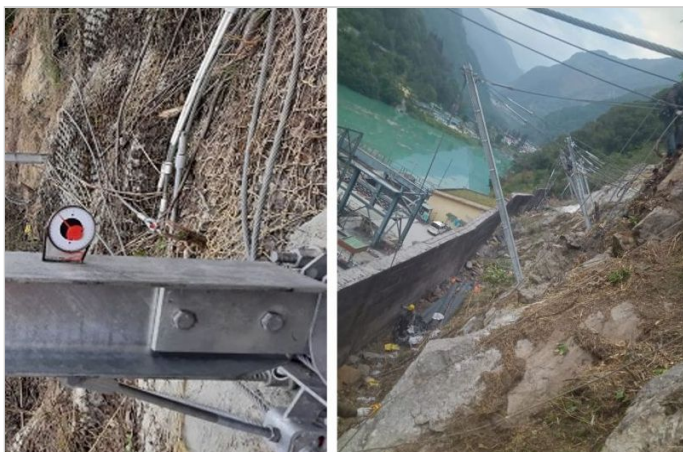
Figure-3 Installation of posts of rockfall barrier

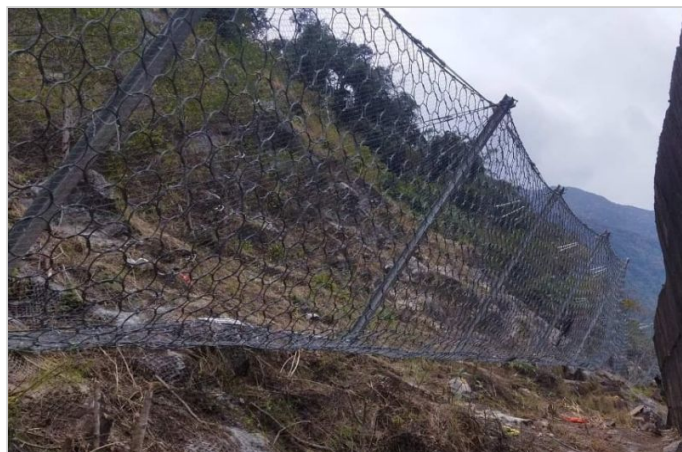
Figure-4 Installation of interception meshes

The dynamic rockfall barriers installed are EAD certified and comprise of a primary interception mesh of MacRing (Ring Net) and a secondary interception mesh of DT Mesh. These rockfall barriers have a braking system, which maintains performance throughout the entire design life of the structure and are easy to visually inspect by maintenance engineers as it progressively deforms once the barriers are impacted.

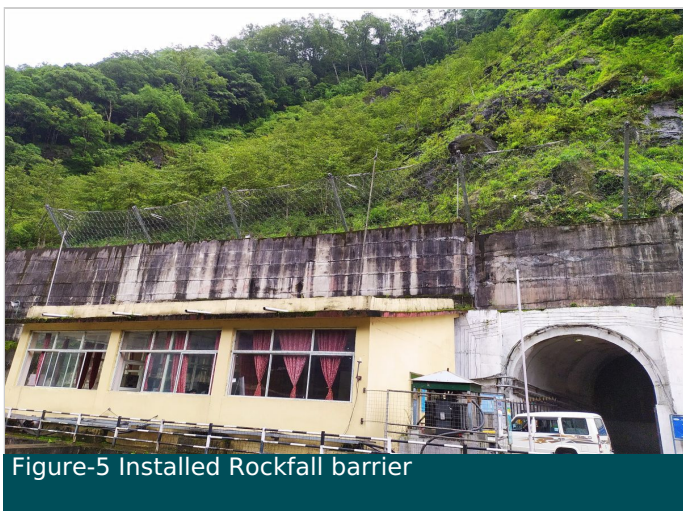
Figure-5 Installed Rockfall barrier

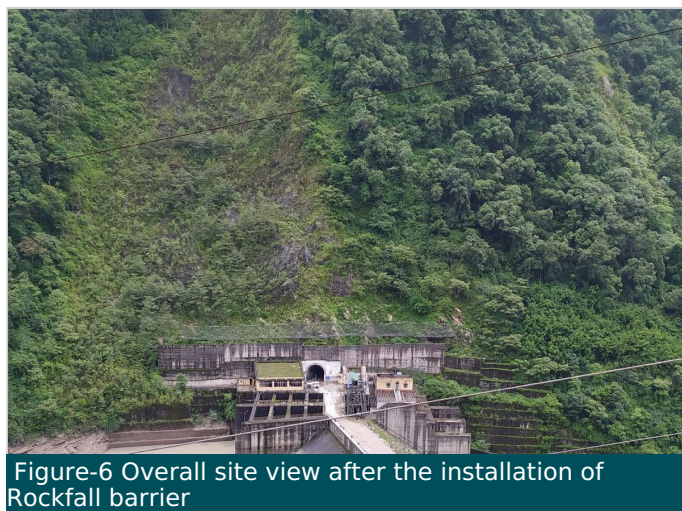
Figure-6 Overall site view after the installation of Rockfall barrier
