EROSION PROTECTION WORKS ALONG BANKS OF BRAHMAPUTRA RIVER ROHMORIA, ASSAM, INDIA

ENVIRONMENTAL / HYDRAULICS / EROSION PROTECTION

Product: Gabion, Geotextile Bags

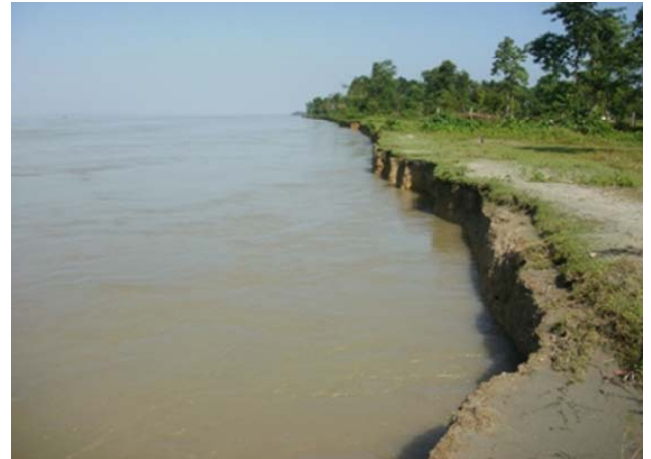
Photo 1 Scouring of the banks of Brahmaputra River

Brahmaputra River is one of the major and aggressive rivers in Asia. It flows in countries of China, India and Bangladesh. In India it enters North East state of Arunachal Pradesh and then widens as high as 10km in the state of Assam. Over the past 20 years, the river has destroyed many paddy fields, homes, schools and plantations in the village of Rohmoria.

Brahmaputra channel belt is highly dynamic due to the incessant structural changes in the basin part and the basin margin areas as well as the sediment load dumping patterns. Rohmoria, in the upper reaches of the Brahmaputra River in Assam, is an area most severely affected by river erosion. This area is located about 20 to 30 km away from Dibrugarh town in the upstream direction of the south bank of Brahmaputra River. The area has witnessed erosion for the last sixty years and more than 25 villages have been wiped out by erosion.

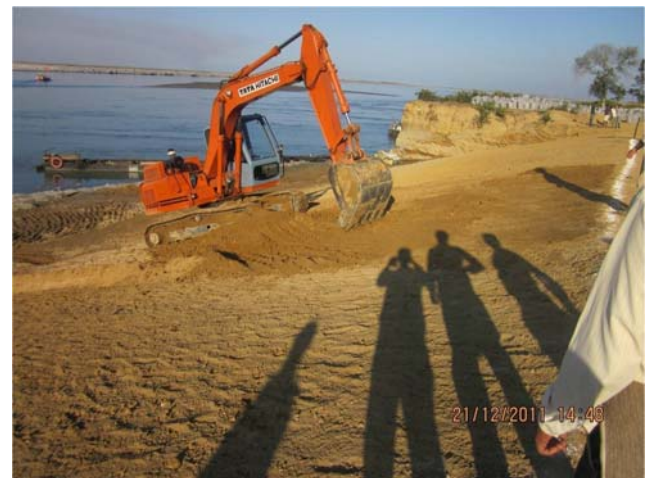
Photo 2 Dressing of slope

The height of slope was approximately 5.5m. The bank and bed protection were carried with MacBags placed on geotextile filter layer. Peripheral strips of Steel Gabion and PP rope gabions filled with layers of geotextile bags were placed at regular intervals to impart further stability to the scour protection measure.

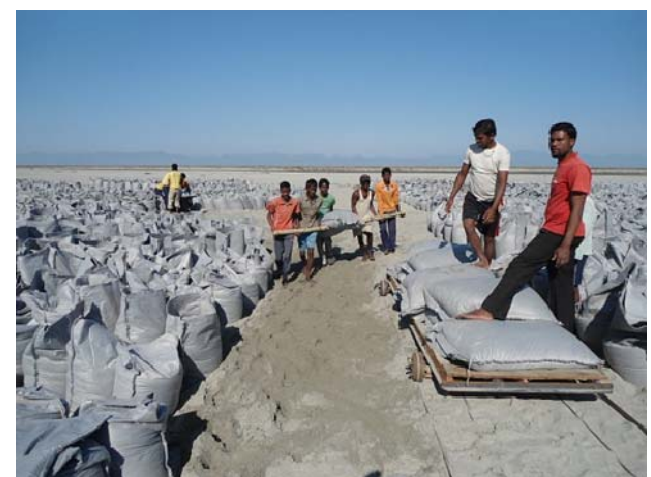
Photo 3 Filling & transportation of MacBags™

Maccaferri MacBag™ is a geotextile bag filled with sand and commonly adopted for hydraulic protection works. These geotextile bags are produced from either woven or non-woven polypropylene geotextile or non-woven polyester geotextile.

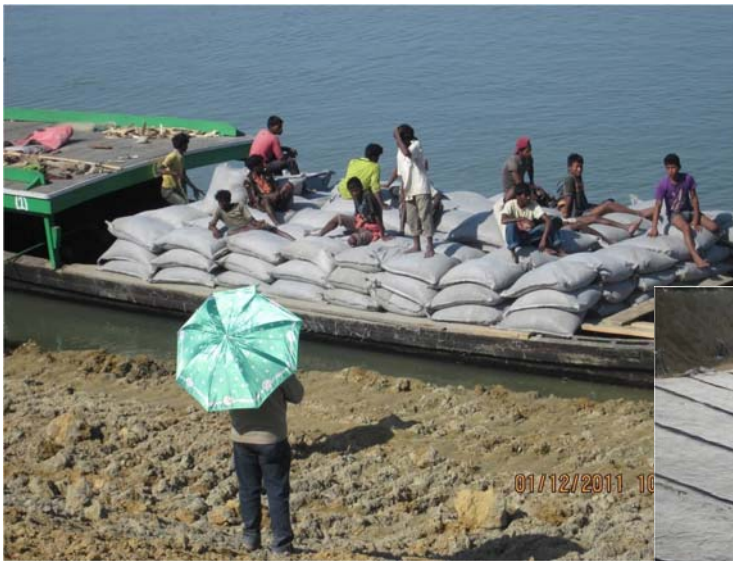
Photo 4 Unloading of MacBags™ on the river bank

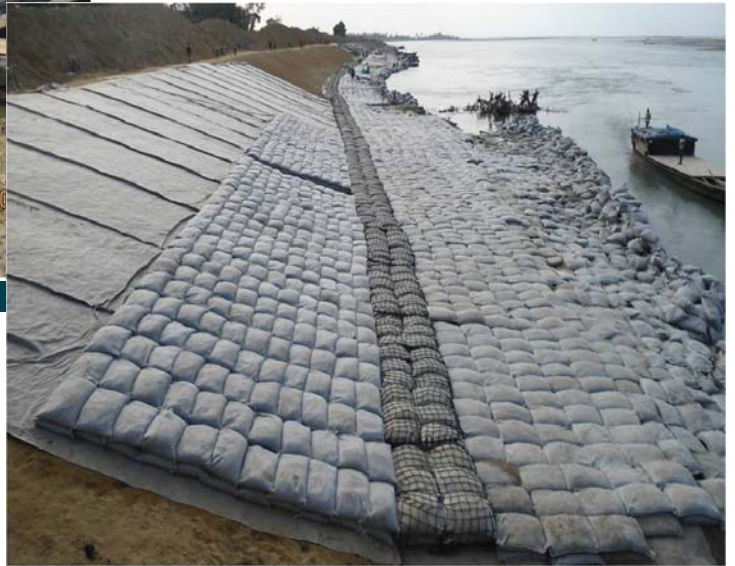
Photo 5 Placement of MacBags™ on the river bank

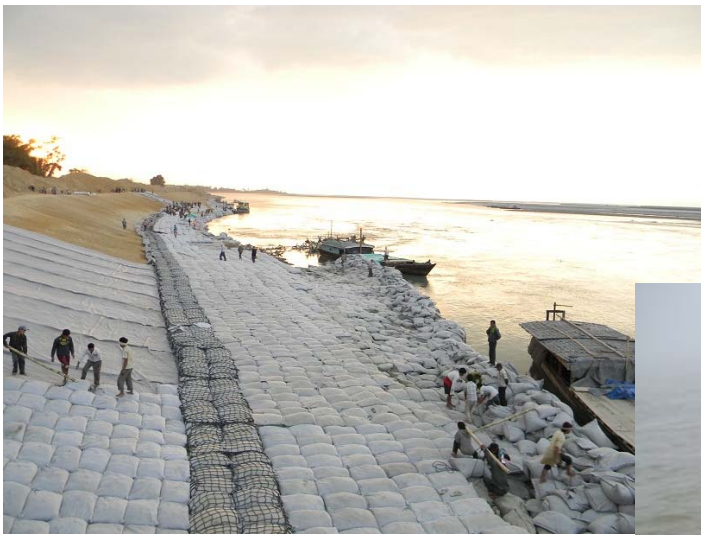
Photo 6 Placement of MacBags™ on the river bank

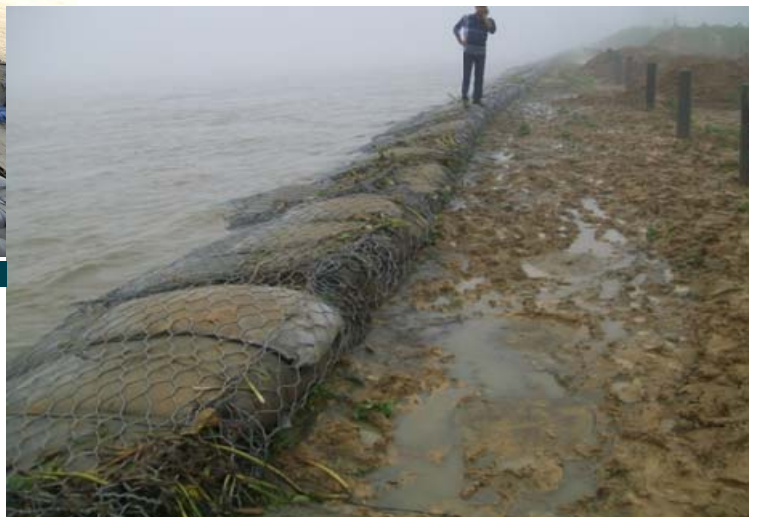
Photo 7 Condition of MacBags™ & River Bank during Flood

In June 2012, the flood situation in Assam deteriorated more than 1,000 villages and water level in other villages was about five feet high. The anti-erosion work constructed in April 2012 was totally submerged under water and in some part flood water passed over the protection work. The erosion protection measures constructed with MacBags™ survived the flood and protected the banks. After flood, considerable amount of silt deposits was noted which is an indication of success of anti-erosion works along the river banks.

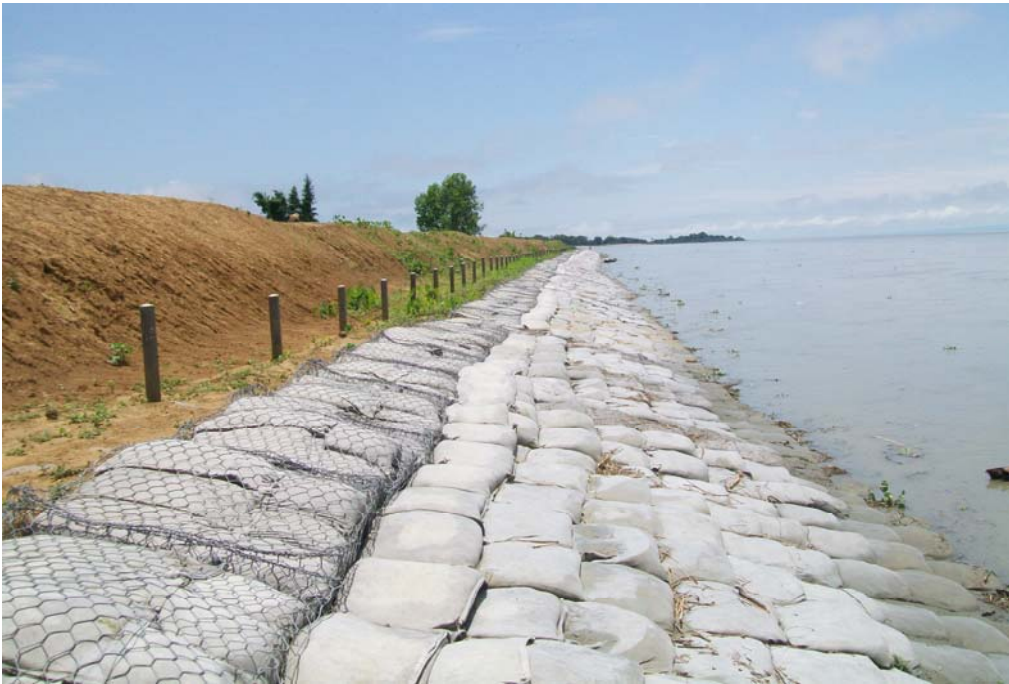
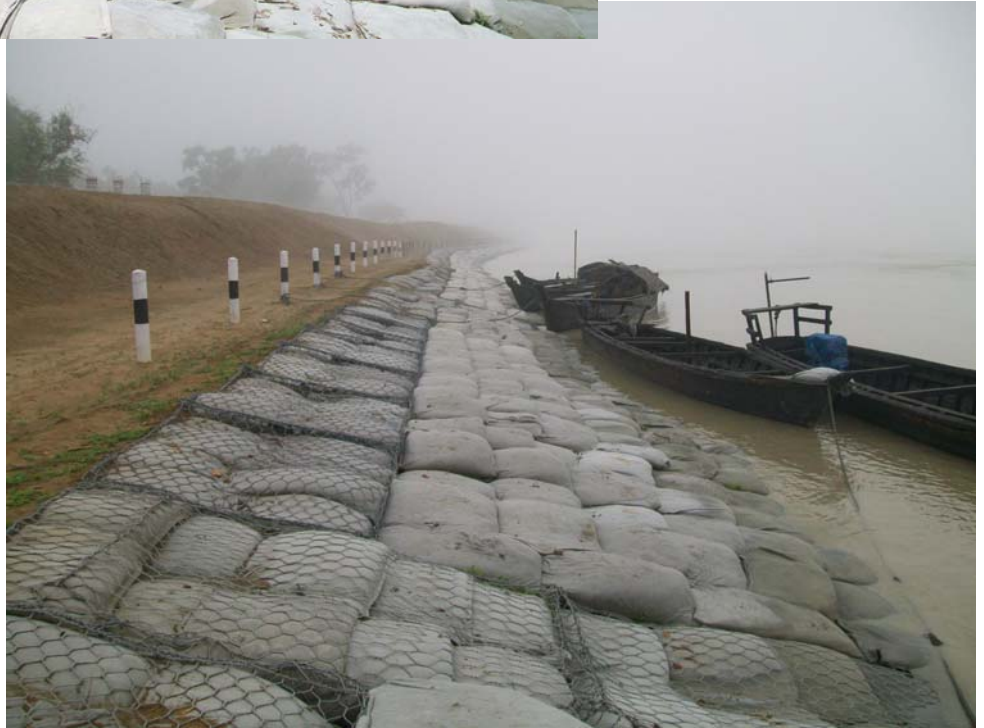
Photo 8 & 9 : Condition of MacBags™ & River Bank after flood

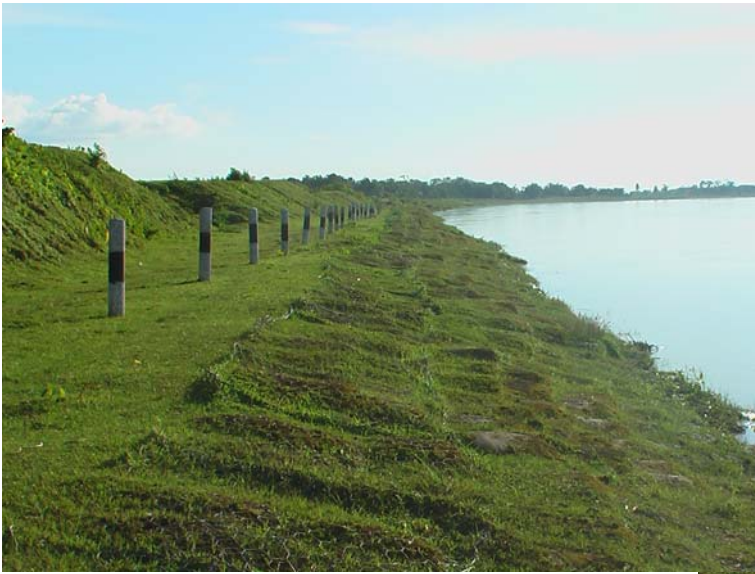
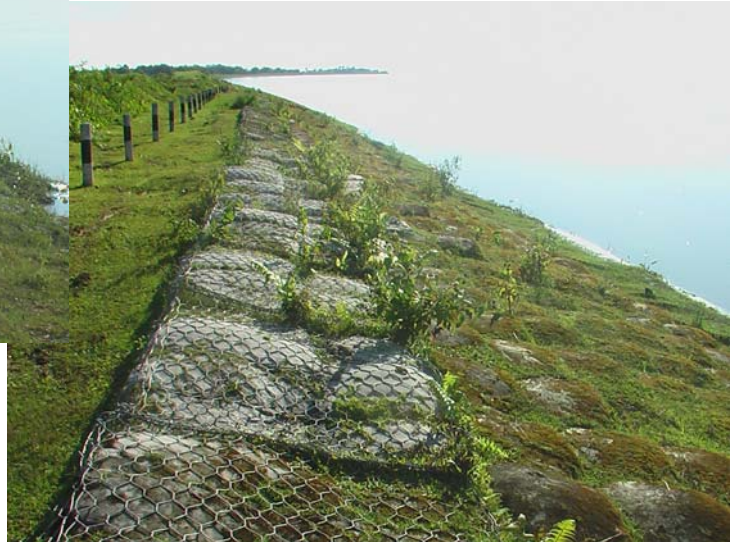
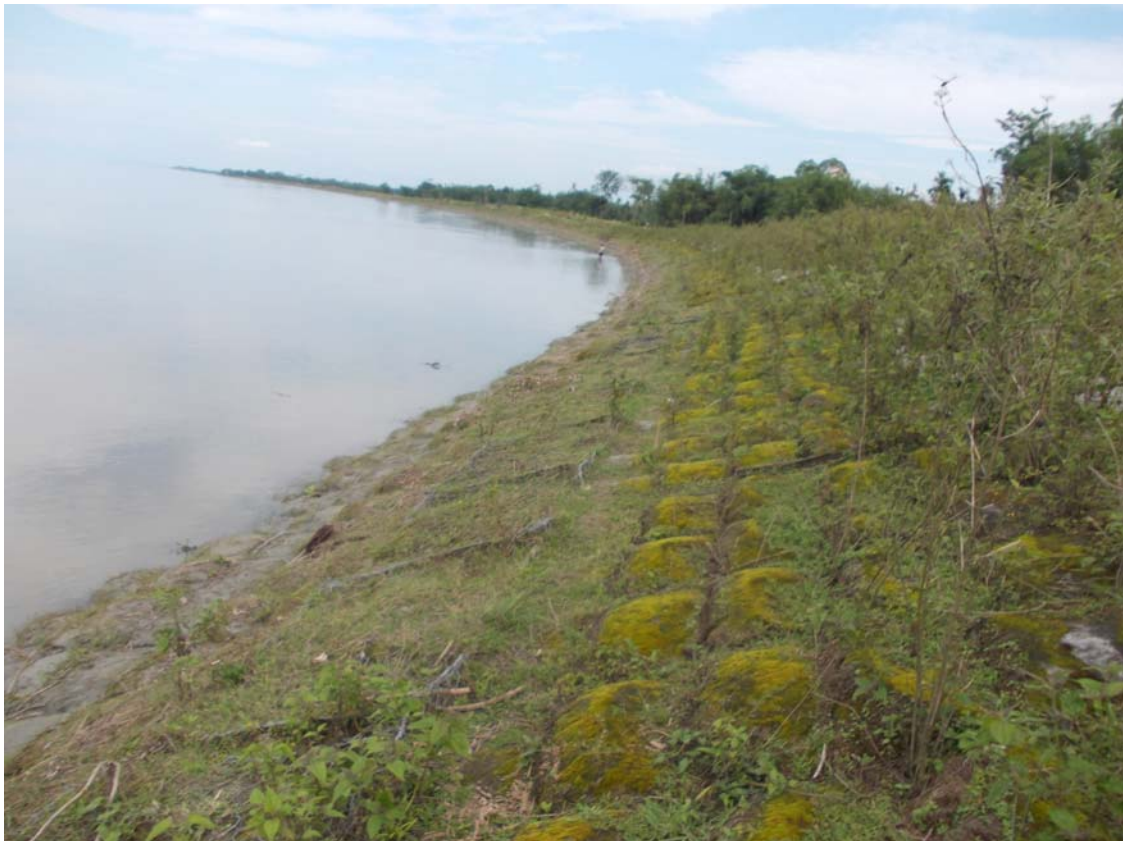
Photo 10, 11 & 12 : Condition of MacBags™ after 2 years
