## SLOPE REPAIR WORKS AT PEDAS LINGGI, NEGERI SEMBILAN, MALAYSIA

### SEREMBAN, NEGERI SEMBILAN, MALAYSIA

#### Slope Protection

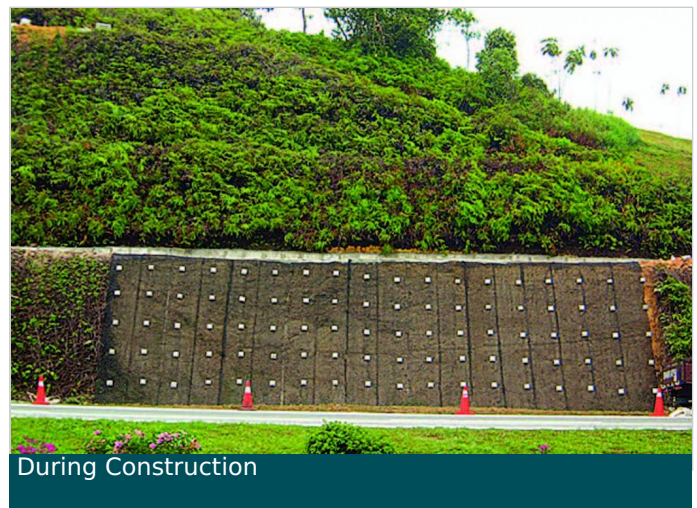
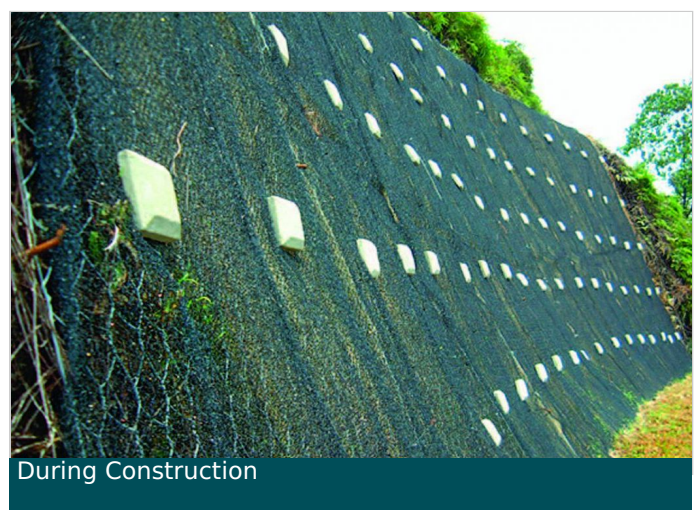
A surface erosion problem occurred at the first and second berm slope beside this expressway. If not treated properly, this problem may develop into a larger slope failure.

Instead of adopting a conventional method of using rubble pitch stone wall, Opus International has contacted Maccaferri for a 'softer' and environmentally friendly solution. After several meetings and discussions, Enkamat 7018 three dimensional (polyamide) mat combined together with double twist wire mesh netting was proposed and subsequently adopted.

The mat and mesh are pinned down to the slope surface with 1.0m length Y25mm  $\phi$  galvanised steel bar coupled with a concrete head. The surface was hydroseeded prior to the placement of the mat and mesh for a green surface to blend with the surroundings.

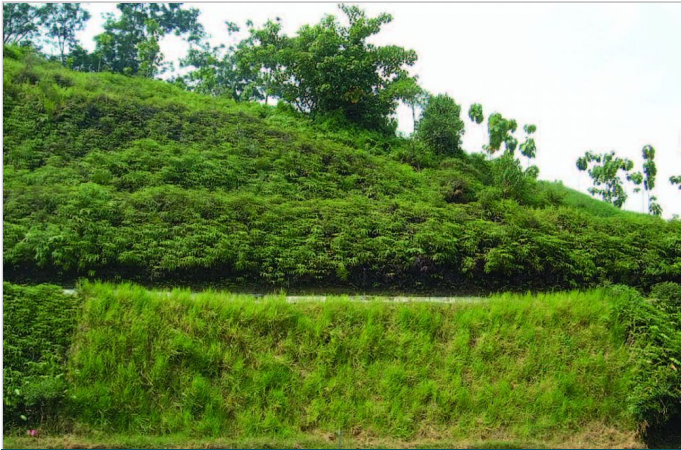
after construction
