HOLCIM BULACAN CEMENT PLANT NORZAGARAY, BULACAN, REGION III, PHILIPPINES

Simple Drapery

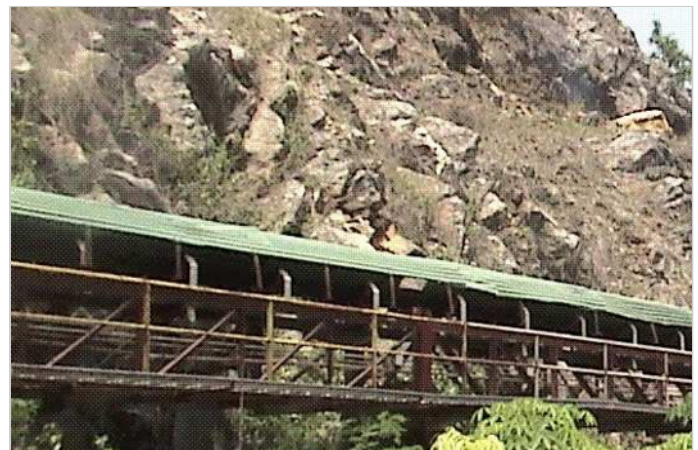
Before Installation

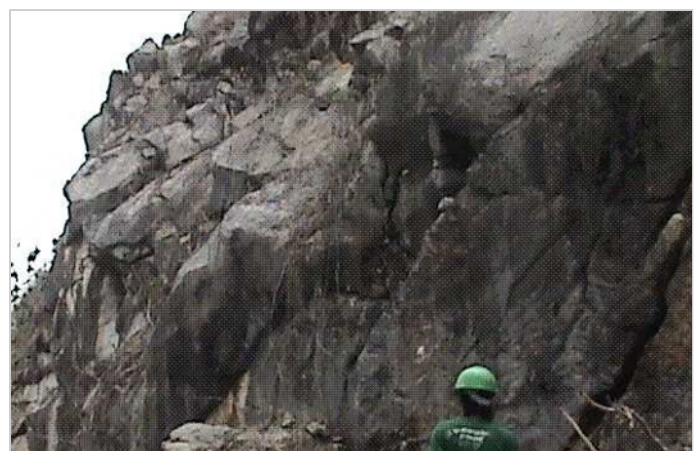
During Construction

The solution proposed by Maccaferri, in coordination with the contractor, was to use a polymeric-coated double-twist rockfall net acting as a simple drapery system to prevent rocks from damaging the conveyor. A simple drapery system features panels of mesh netting anchored securely on top of the slope as well as onto the face of the rock slope where it aimed to restrict movement of detached rocks and to guide the detached rocks downslope without unnecessary damage to the nearby structure. Holcim approved the design because of its cost effectiveness and ease of installation within the limited time frame.

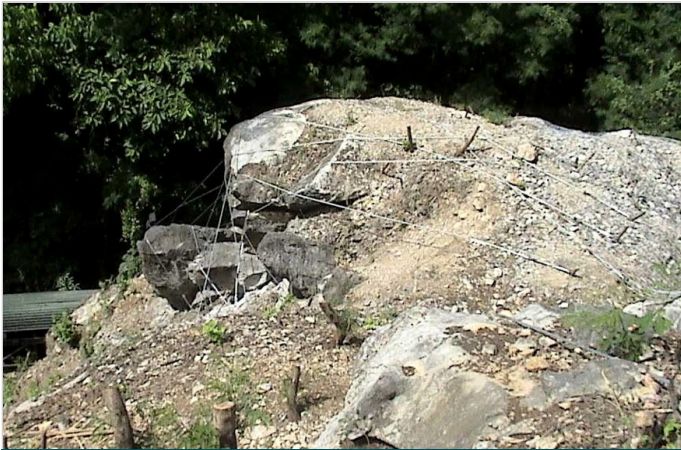
Near Completion

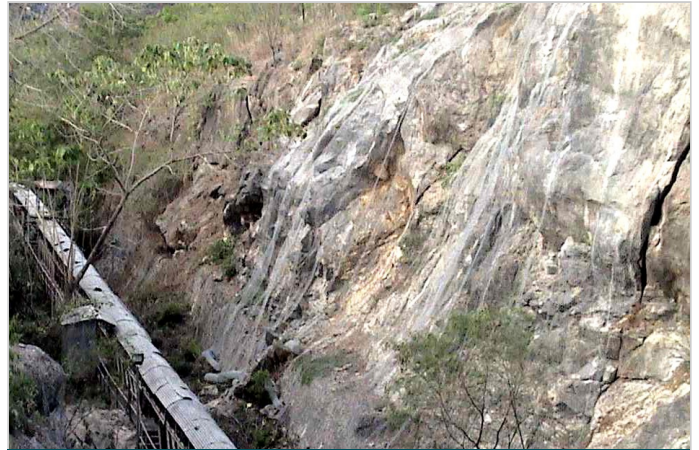
Near Completion

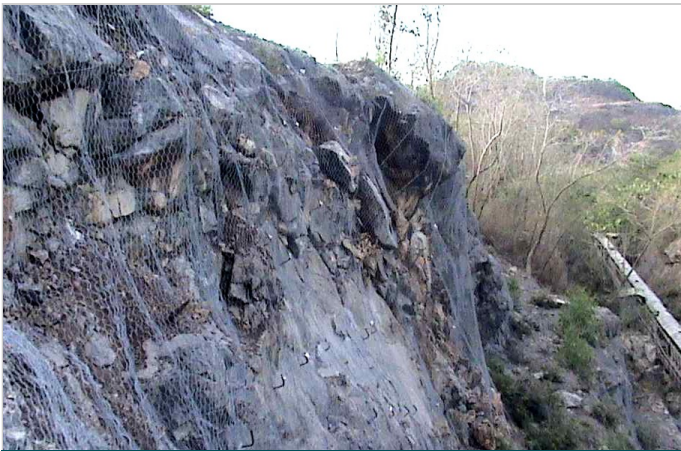
Project Completed

The contractor was able to construct the simple drapery system for a 150 meters long section of rock slope within 15 working days.

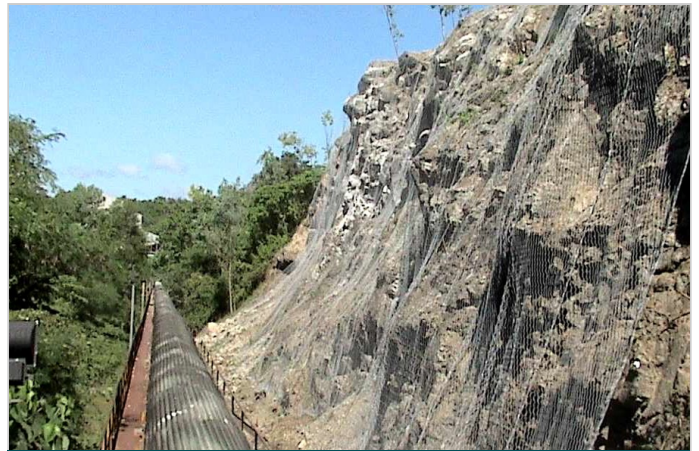
Project Completed
