# ROCKFALL MITIGATION WORKS- RAILWAY LINE-NEAR CH 14 - ANPARA, UP ANPARA, UTTAR PRADESH, INDIA

## Dynamic Barriers

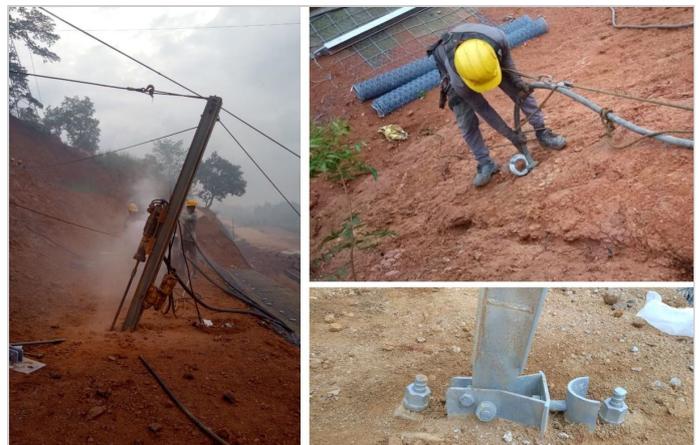
Figure-2 Activities related to installation of barrier posts

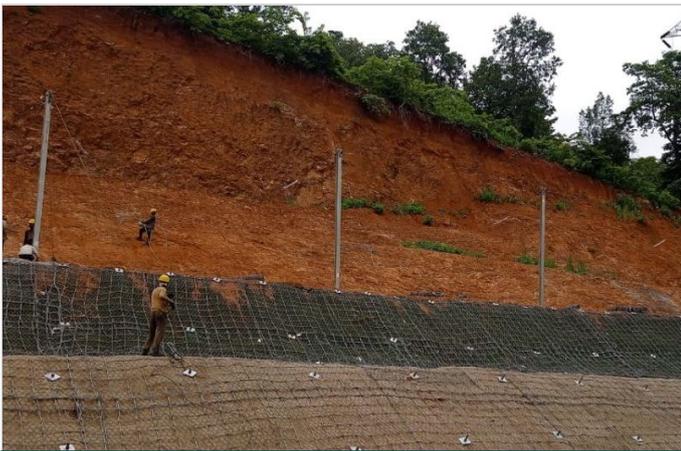
Figure-3 Connecting upslope or lateral anchors with help of bracing cables

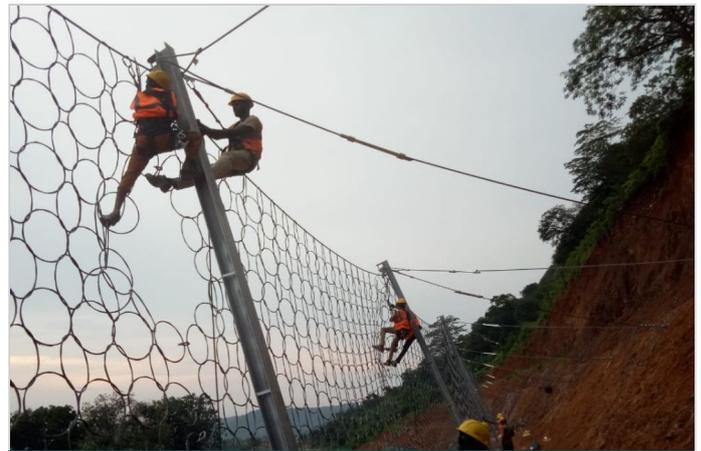
Figure-4 Installation of Primary Interception mesh (MacRing)

The dynamic rockfall barriers installed are ETA/EAD certified and comprise of primary interception mesh of MacRing (Ring Net) and secondary interception mesh of DT Mesh. These rockfall barriers have a compression braking system, which maintains performance throughout the entire design life of the structure and is easy to visually inspect by maintenance engineers as it progressively deforms once the barrier is impacted.

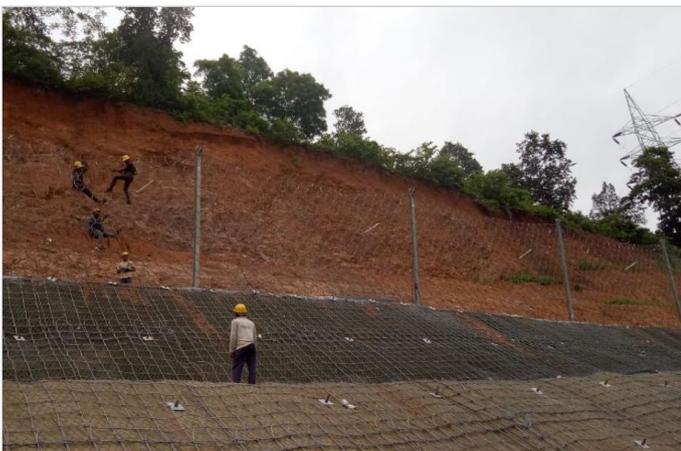
Figure-5 Installation of primary and secondary mesh (MacRing + DT mesh)

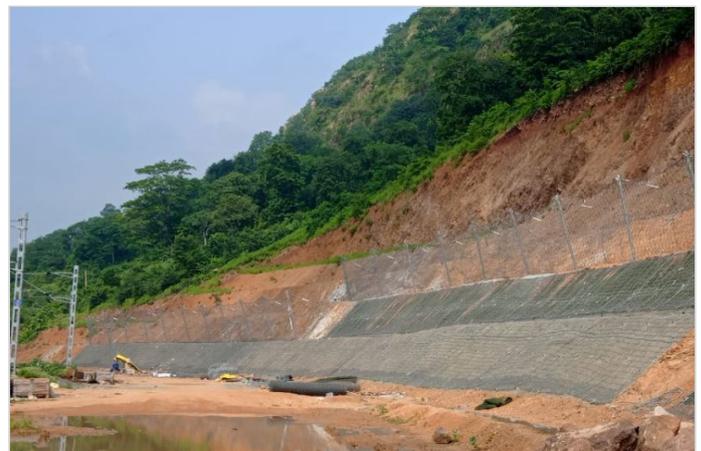
Figure-6 Overall site after the installations of Rockfall barriers
