# SLOPE PROTECTION MEASURES- RAILWAY LINE- NEAR CH 13 - ANPARA, UP ANPARA, UTTAR PRADESH, INDIA

## Surface Strengthening and Support

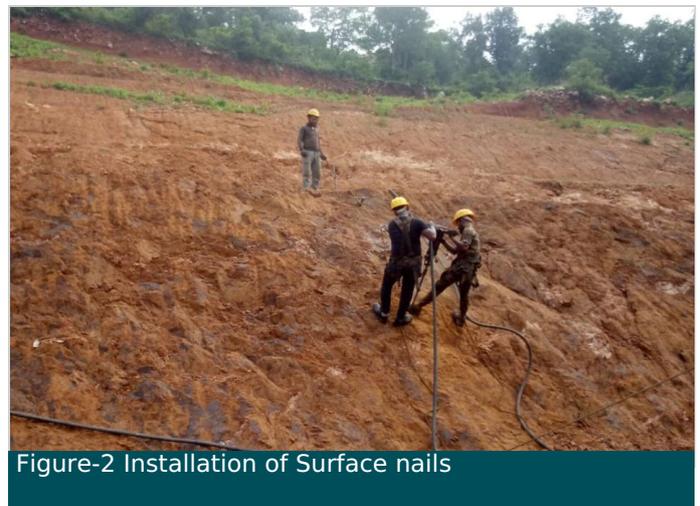
Figure-2 Installation of Surface nails

The MacMat R1 polymeric reinforced and/or BioMac CC are used for providing immediate, high-performance erosion control and root reinforcement for re-establishing vegetation on vulnerable/exposed slopes. Self-Drilling Anchors (SDA) were installed on the slope with nail lengths of approx. 4m for surface and top nails. The meshes used in the slope protection system are conforming to existing Indian and international codal guidelines.

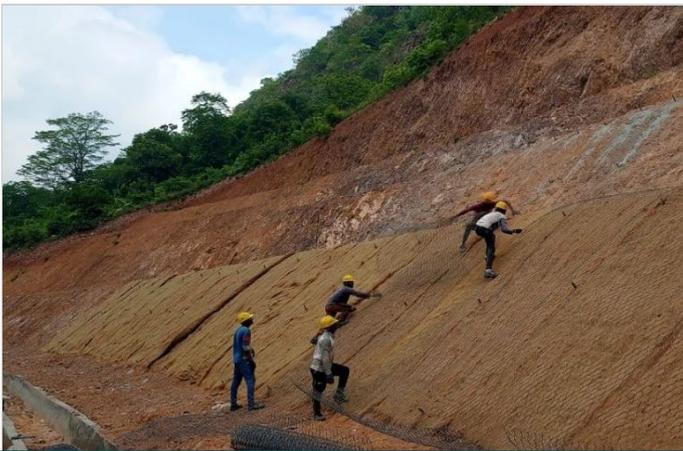
Figure-3 Providing DT mesh over the erosion control mats

Maccaferri has offered different solutions based on the slope geometry which is to be protected against surficial instability and erosion. Installation of HEA SQ Panel over DT mesh along with wire ropes installed in a vertical fashion is done along with erosion control mats such as BioMac CC and MacMat R1 polymeric for erosion protection. Bioengineering measures are proposed for vegetation.

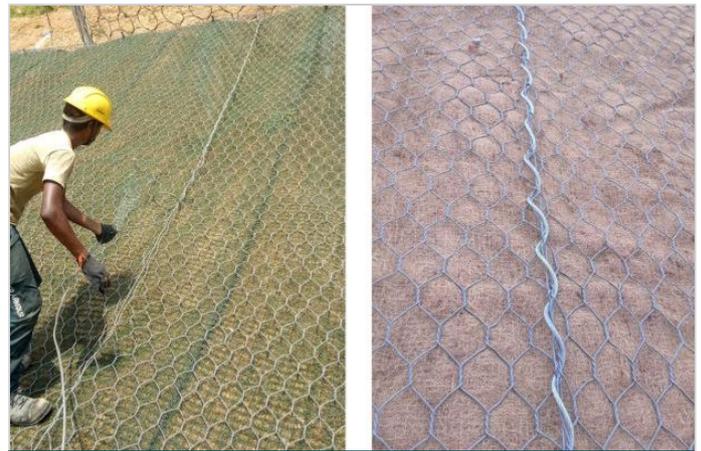
Figure-4 Installation of wire rope vertically on the edges of DT mesh

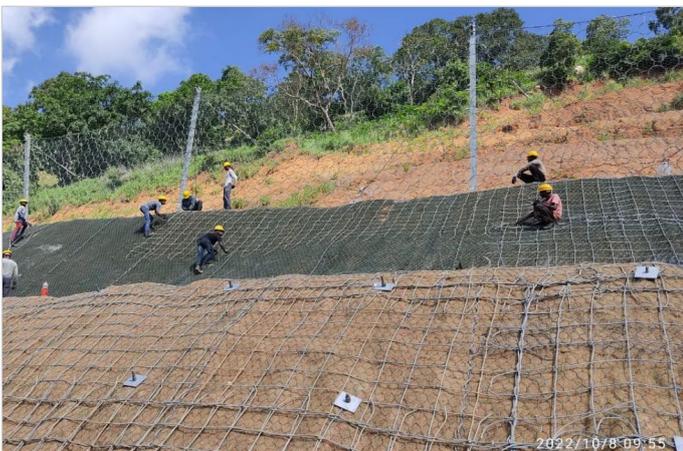
Figure-5 Mesh installation over nailed slope face

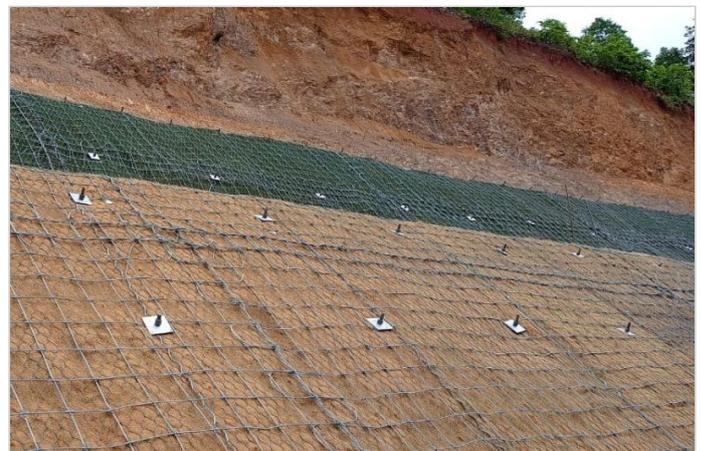
Figure-6 Overall site after the installation of slope protection system

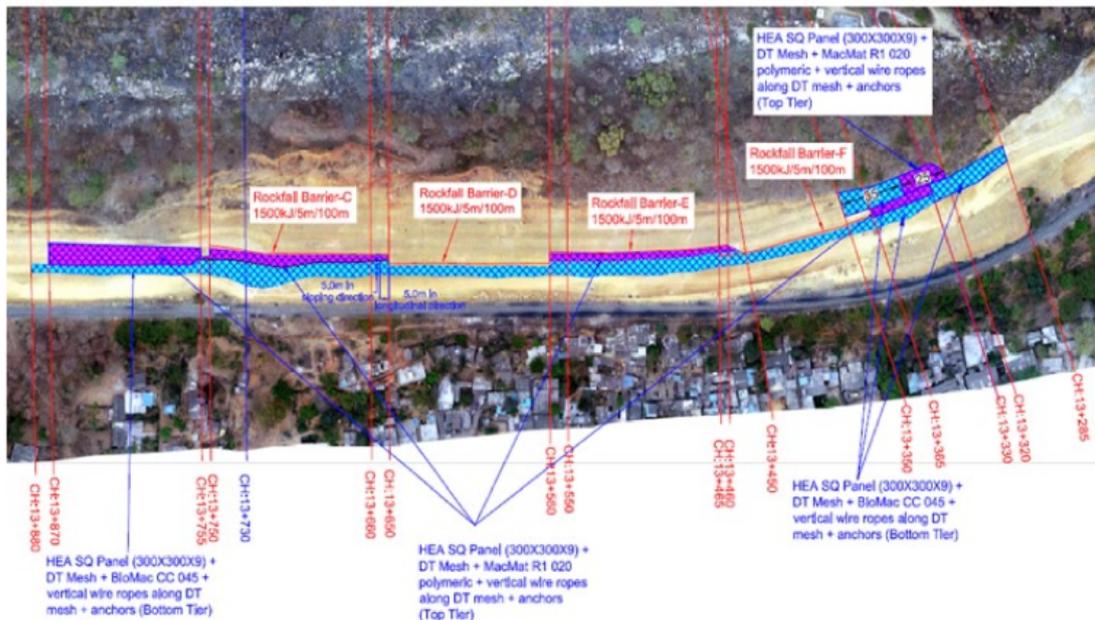
## PART PLAN

Plan showing scheme
