SH73 BELOW STARVATION POINT BETWEEN OTIRA GORGE & ARTHUR'S PASS, WEST COAST, NEW ZEALAND

Debris Flow Barriers

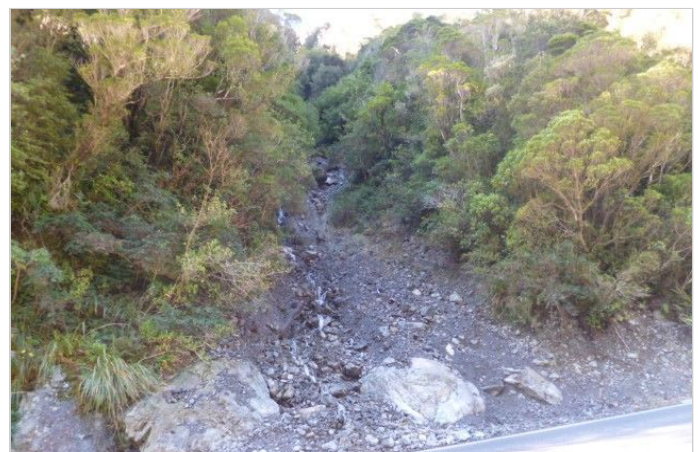
Before installation of debris flow barrier

The site "Below Starvation Point" is located in the Otira Gorge on SH73, approximately 8 km north from Arthur's Pass township. The site is essentially a debris channel estimated to experience large volume debris flows (50 - 100m³) during periods of high rainfall intensity. The debris flow contains rock sizes between 0.4 - 1.0m diameter.

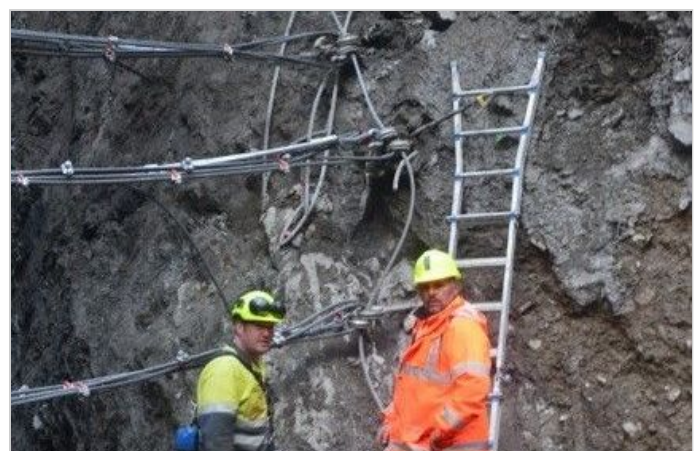
Longitudinal cable installation

The debris flow fence considered both dynamic and static components of the imposed pressure by the debris flow; these component loads are then distributed to the ring net panel which in turn transmits the load to the longitudinal cables. The cables will activate the energy dissipators and finally transmits the load to the lateral anchors. Double spiral rope anchors type ICAF 44/22 were installed up to 10.0m lengths into the ground.

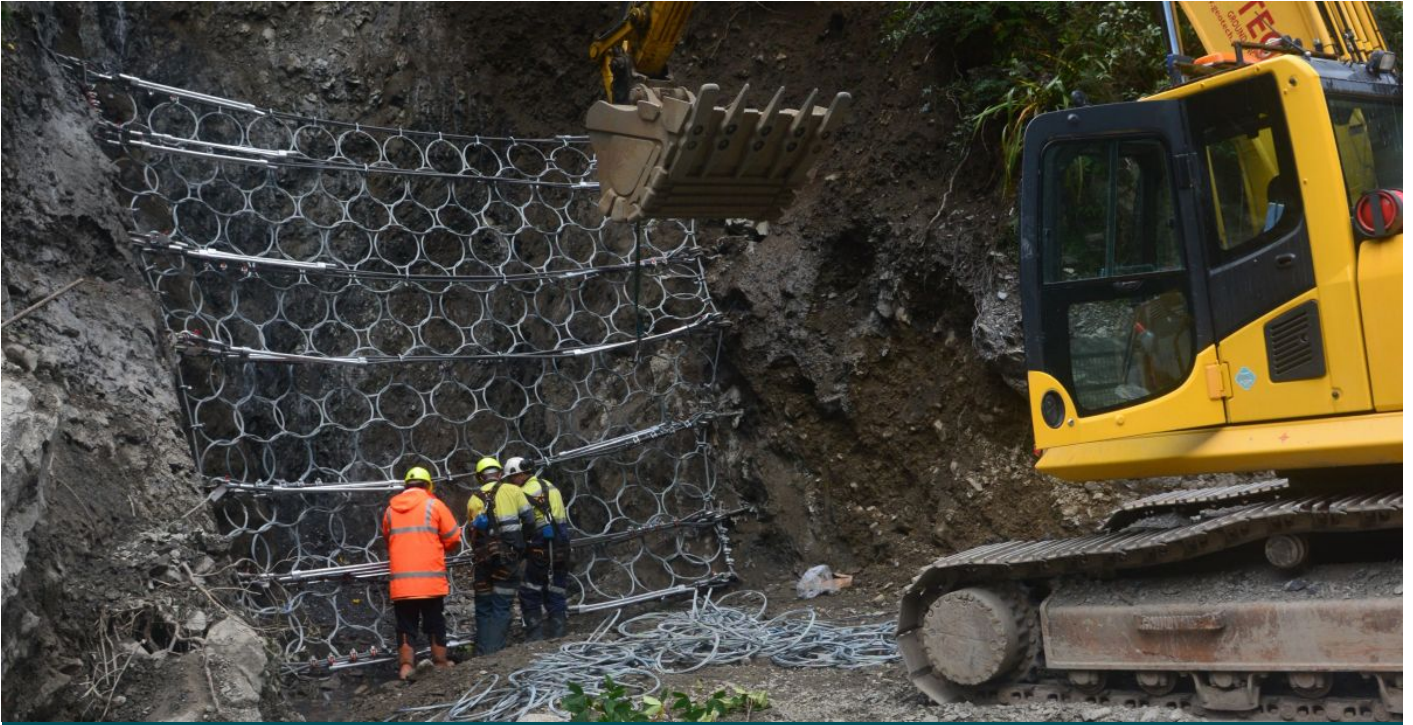
Debris flow fence nearing completion

The client had accepted a proposal to install a debris flow fence (without posts) with the capacity of capturing 300m³ debris volume accumulated from consecutive debris flow events.

The debris flow barrier components used were tailored to offer maximum strength and durability whilst remaining easy to handle and practical to install. The primary interception mesh adopted (high strength ring nets); and the energy dissipators adopted for this project are the same components used for the 5,000kJ dynamic barriers.
