50 YEAR OLD GABION STRUCTURE, RIVER HUMBER
BROUGH, UK

HYDRAULIC WORKS

Product: Gabion wall and mattress apron

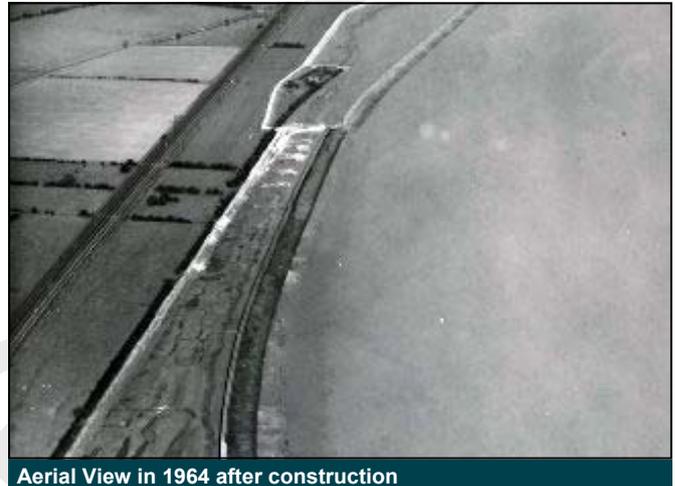
Aerial View in 1964 after construction

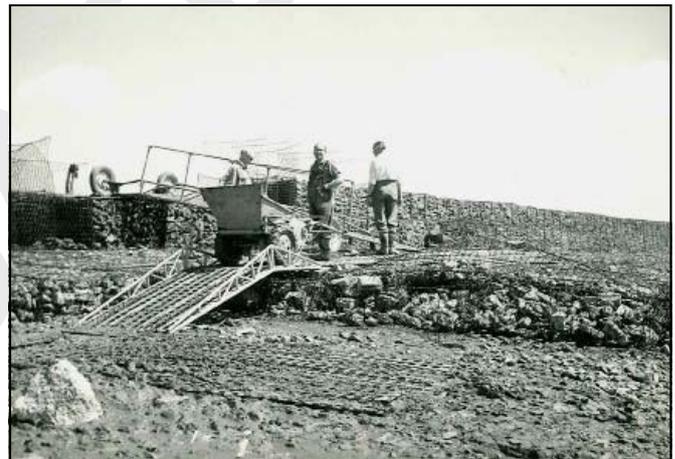
During construction in 1964

The wall was started by dumping 200 ton loads of lump chalk from a hopper barge at high water and it was completed by running tipping lorries on to it at low water.

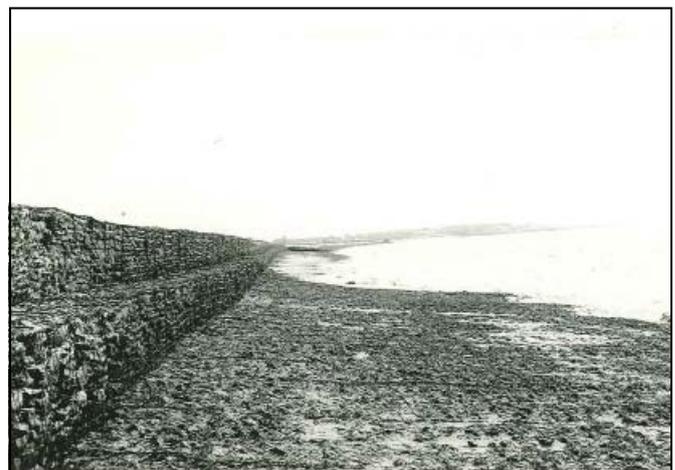
After construction in 1964

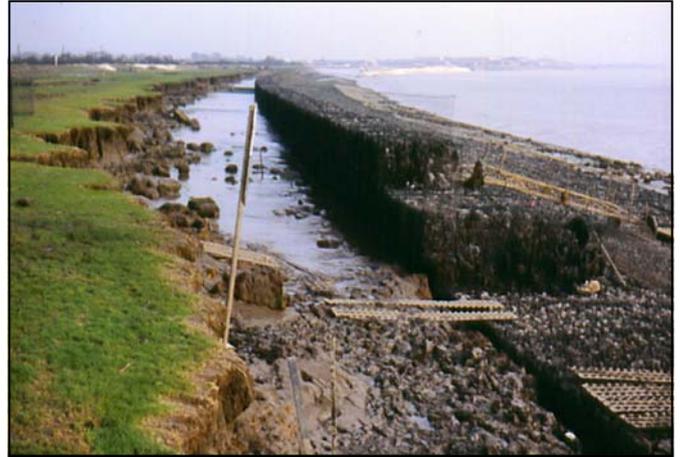
During construction—showing nature of erosion

For many years there had been severe erosion to the north bank of the River Humber at Brough, which is some ten miles to the west of Hull.

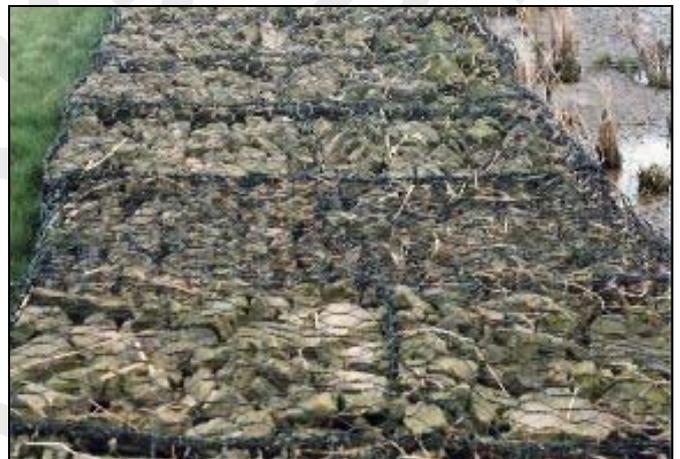
Some time after construction in 1986

The wall was built with its crest below the high water level to allow over topping at high tide and silt to build up behind the wall. (See middle right photo)

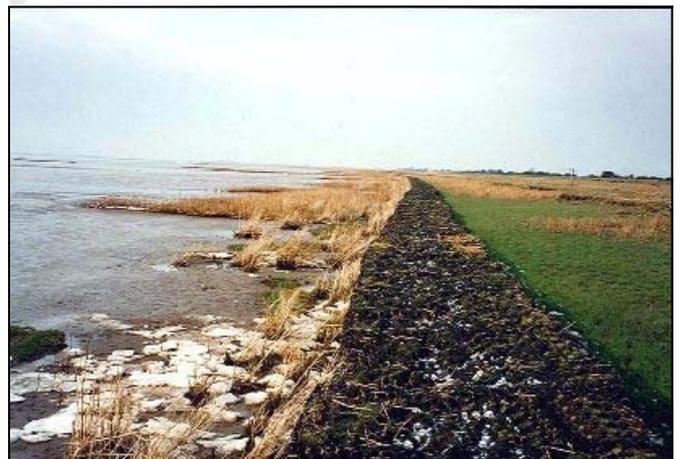
Some time after construction in 1993

The area behind the wall is now completely built up and the area has become a natural haven for wildlife (see bottom right photo).

By 1993 silt had built up over the gabion apron, almost to the crest and erosion has been completely halted.
