HIGHWAY 41 CALL BOX LANDSLIDE

BETWEEN ATASCADERO & MORRO BAY, CALIFORNIA

ROCKFALL

Product: [Double Twist Wire Mesh Cable Nets](#)

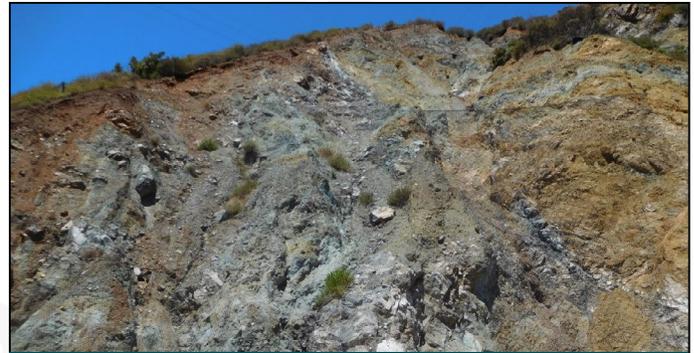
The previous attenuator system was installed to prevent rocks from falling in the road. When the landslide occurred, a large amount of the roadcut collapsed into the road. (July 2016)

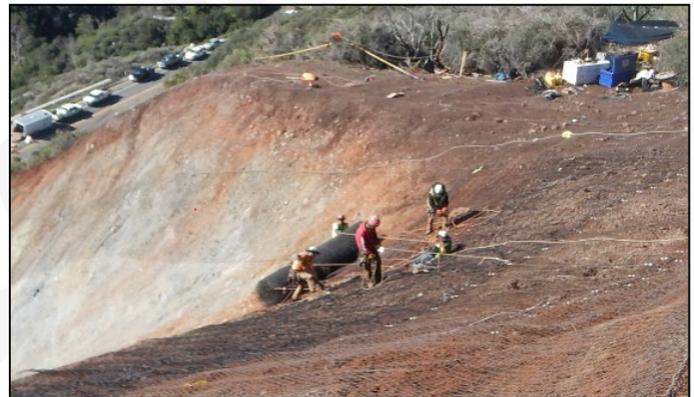
Crews begin unrolling the easy install Maccaferri system

Installation of the system took about six days, after the removal of loose material and re-contour roadcut. Coupled with the readily available material, the ease of installation of the Maccaferri system, allowed Access Limited Construction to stay ahead during this emergency response.

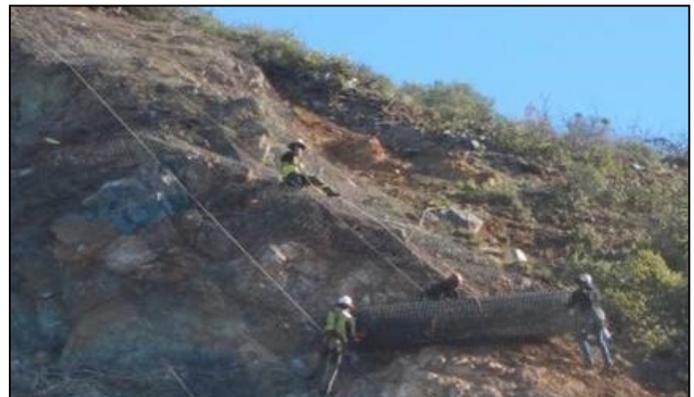
Crews ensuring the system is properly in place

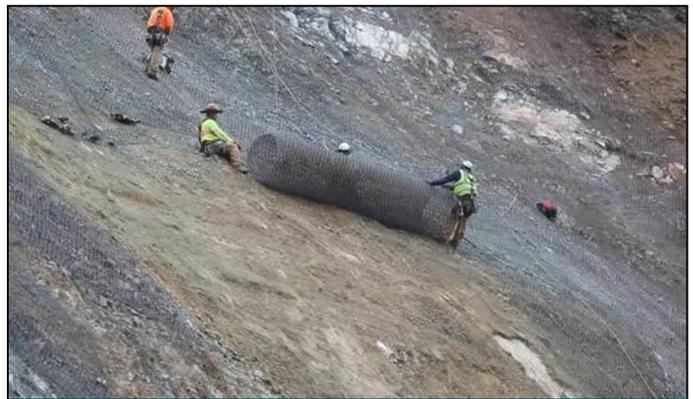
Crews deploying the Maccaferri Double Twist Wire Mesh

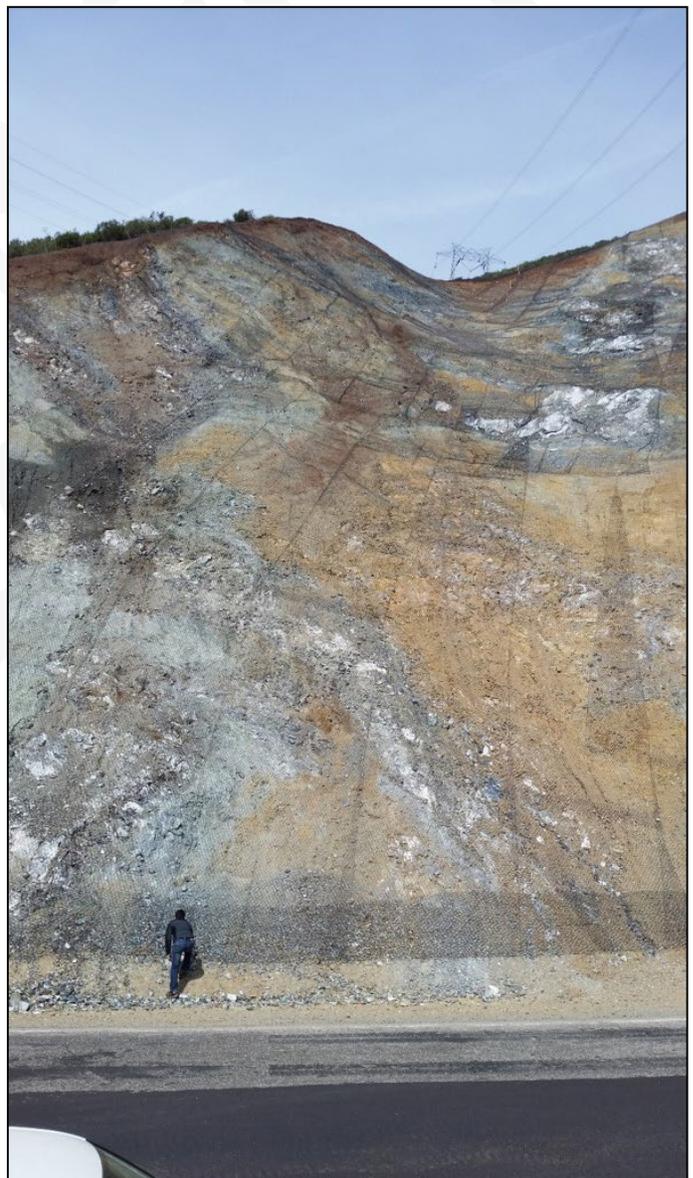
Double Twist Wire Mesh solution in place

Availability of material was key. Access Limited Construction placed the order on January 16, 2017 and the entire order was delivered, on-time, by February 1, 2017. Caltrans elected to use black PVC to blend. In some instances, dark brown PVC mesh was substituted, which blends almost seamlessly with the black. This substitution allowed the proper quantities of materials to ship on-time in order to accommodate the project's expedited schedule. The mixtures of PVC Coating allowed the system to blend with roadcut colors, while the heavier mesh conforms to roadcut contours and keeps loose materials contained.
