Wall Township Gabion Wall Protection
MONMOUTH COUNTY, NJ

COASTAL EROSION

Product: Gabions and Geotextile

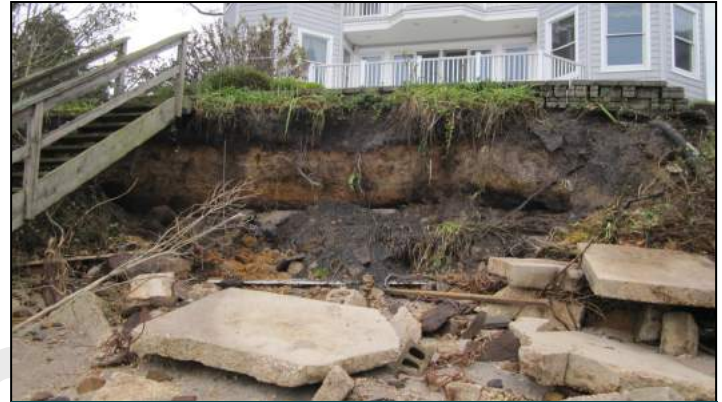
Damage and destruction done by Sandy to the existing concrete retaining wall along the rear of the homeowners property. With the failure of that retaining wall a portion of the backyard was lost and exposed to further erosion with any future storm events.

Damage caused by Sandy in October 2012

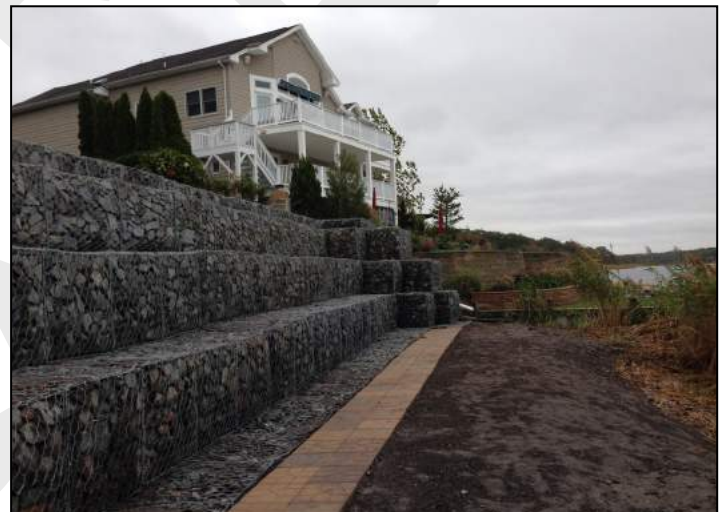
Post installation- completed wall

Gabions were installed from the beach elevation up to the yard elevation. The wall is 13' high with 3' buried at the bottom to act as a scour protection so that the wall can't be undermined by tides, future storm events etc.... so the wall has an exposed height of 10'. So the solution solved the problem of protecting the homeowners property as well as reestablishing the yard and giving the homeowner a flat backyard area again

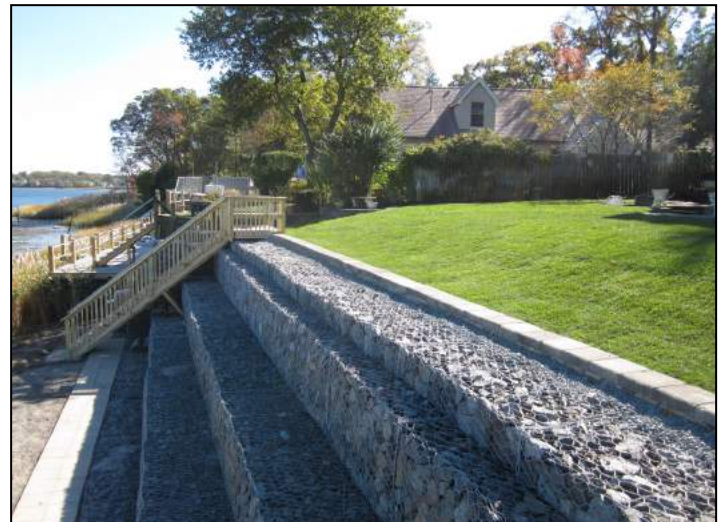
View of completed project approximately 1 year after installation.

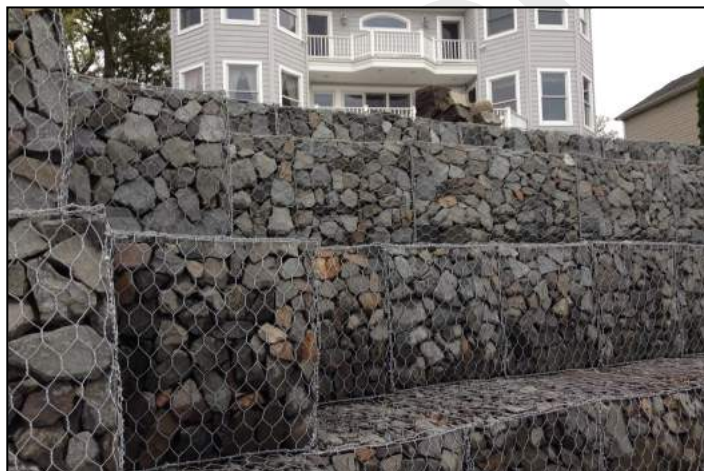
View of return wall

Due to the limited room to work due to the landscape, construction began on one corner of the wall, the gabion was built to a height of two courses (6' high), and approximately 24' long with the return wall. After backfilling this section, this created a platform by which the excavator could be used and work could continue on the rest of the wall.
