50 YEAR OLD GABION STRUCTURE, RIVER HUMBER BROUGH, EAST RIDING OF YORKSHIRE, UNITED KINGDOM

Weirs, Culverts and Transverse Structures

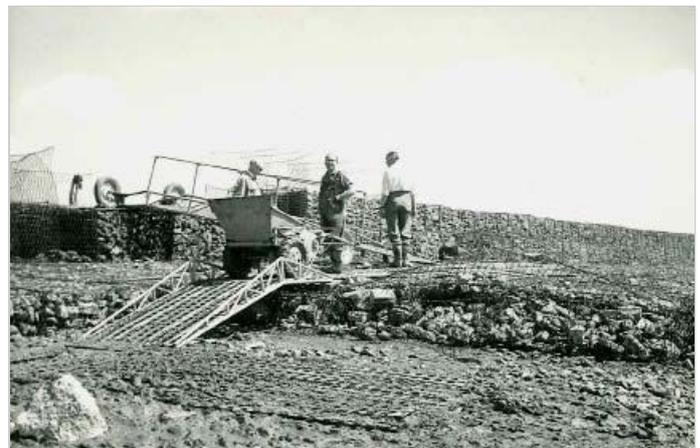
During construction in 1964

The wall was started by dumping 200 ton loads of lump chalk from a hopper barge at high water and it was completed by running tipping lorries on to it at low water.

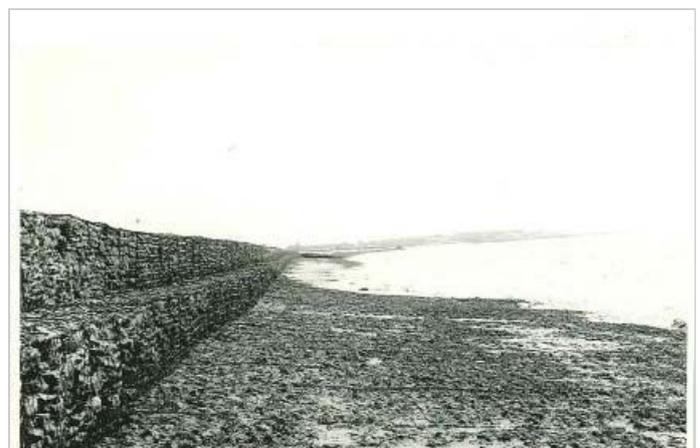
After construction in 1964

The flexible nature of the gabion platform enabled it to follow exactly the profile of the foreshore, and if erosion continues the platform will be able to take up the new profile. The main purpose of the gabion wall is to provide sufficient weight to anchor the gabion platform.

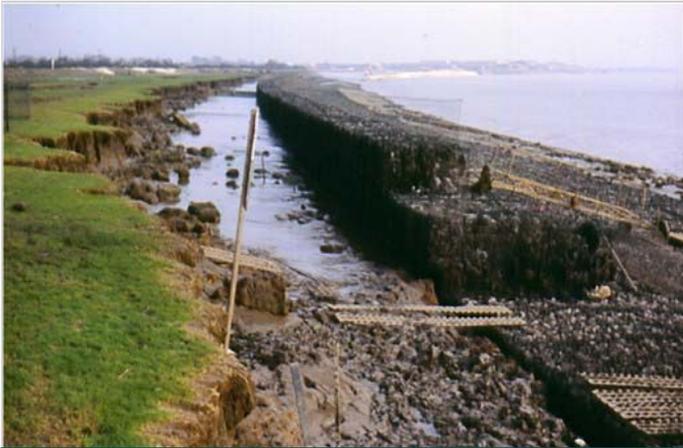
During construction—showing nature of erosion

For many years there had been severe erosion to the north bank of the River Humber at Brough, which is some ten miles to the west of Hull. Much of the land at Brough is below the level of ordinary spring tides in the Humber, and the agricultural land, together with the main railway line to Hull, an aircraft factory, and a timber yard are protected by an earthen flood embankment. Erosion continued and the Hull and East Yorkshire River Board considered a number of schemes. It eventually agreed that the remedial works should comprise about 1000 yd. of half tide wall, and a similar length of gabion revetment.

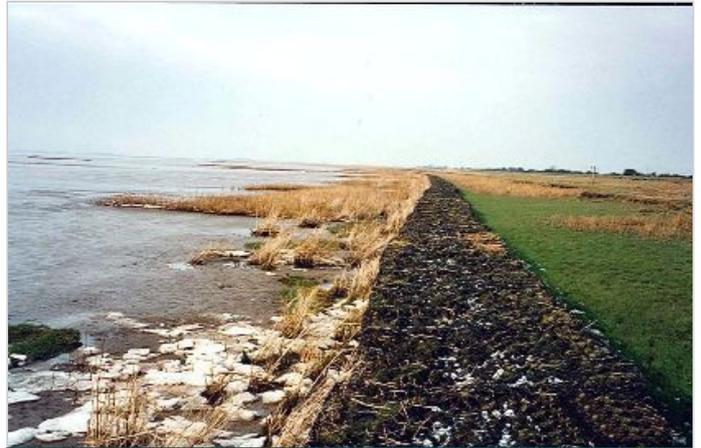
Some time after construction in 1993

The wall was built with its crest below the high water level to allow over topping at high tide and silt to build up behind the wall. The area behind the wall is now completely built up and the area has become a natural haven for wildlife. By 1993 silt had built up over the gabion apron, almost to the crest and erosion has been completely halted.
