HARRISON ROAD WASHAWAY

Kwa-zulu Natal

MECHANICALLY STABILISED SLOPES**Product: Green Terramesh™, MacGrid® WG05****Problem**

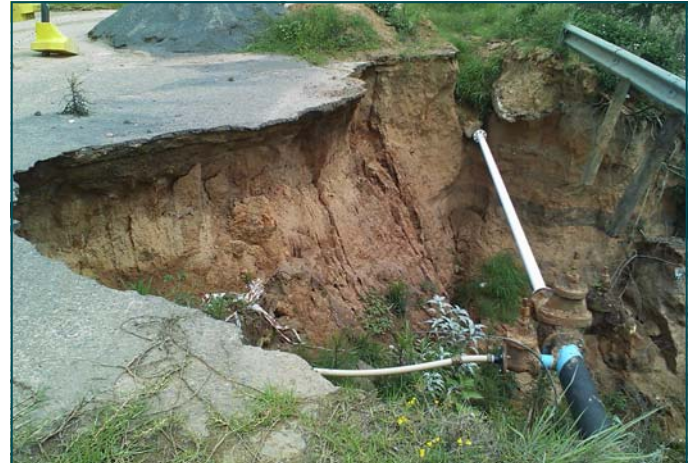
PHOTO 1 - Slip failure showing the pipe failure

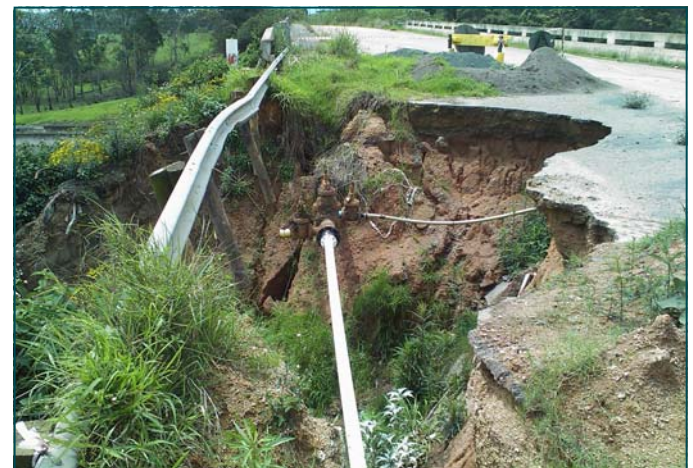
PHOTO 2 - Slip failure showing the impact on the road

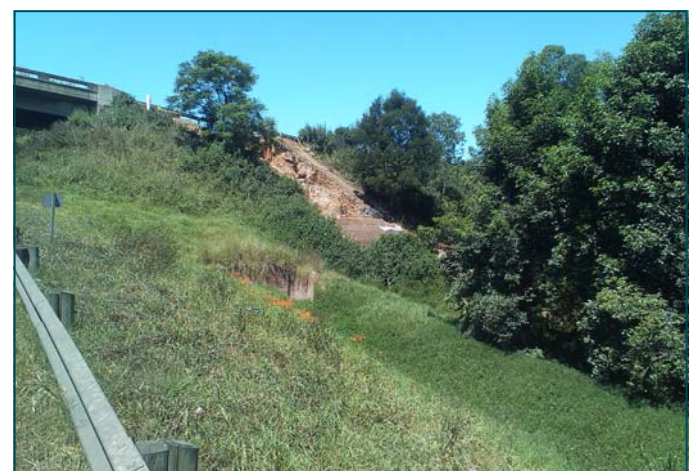
PHOTO 3 - Slip failure as seen from the N3

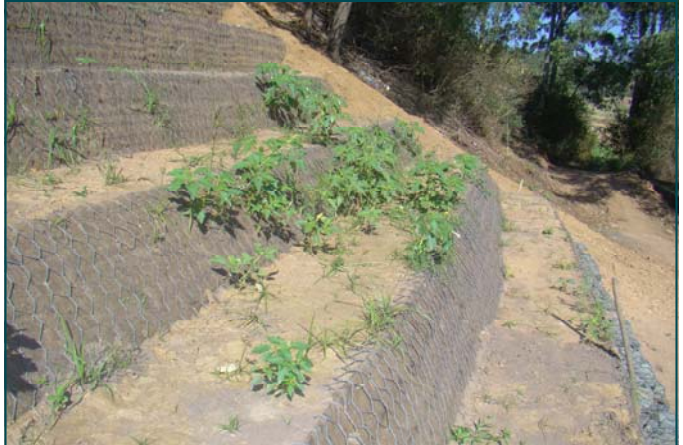
PHOTO 4 - Vegetation establishing naturally

The structural fill comprised a 95% MOD Granular backfill with vegetated topsoil immediately behind the front face of the 70 degree front face. The front face was allowed to vegetate naturally. Additional drains and sumps were created to carry storm water from the road down the 9m high embankment.

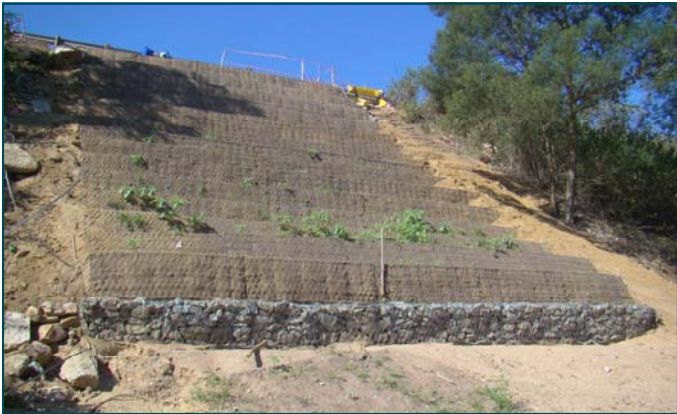
PHOTO 3 - Front View of the completed structure

The embankment design entailed a Terramesh™ toe on which Green Terramesh™ units were placed along the embankment profile. The Green Terramesh™ units were stepped back to provide the required angles of the embankment. In addition to the double twist wire mesh tails, the tails were further extended using MacGrid® WG06.
