# PAVEMENT STRENGTHENING AT NADIA - KAPADWANJ - MODASA ROAD

## NADIA-KAPADGANJ-MODASA, GUJARAT, INDIA

### Asphalt Pavement Reinforcement

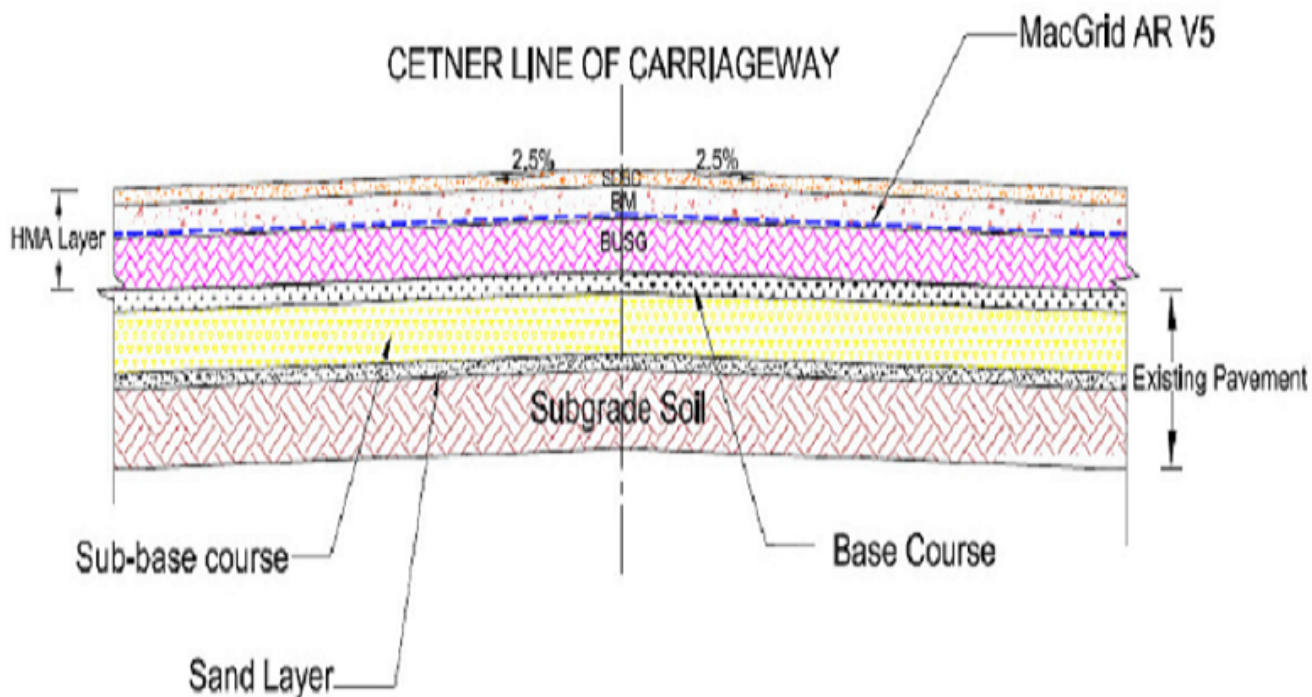
Typical project drawing section

For reinforcing the pavement, geogrid made of fiber glass yarns called MacGrid® AR V5 was suggested to be provided at the interface of the BUSG and BM layer. For ensuring proper adhesion of the MacGrid® to the surface, tack coat is applied over the BUSG layer before laying the MacGrid®.
