BANK PROTECTION WORKS IN RIVER GANGA AT BUDGE BUDGE KOLKATA, WEST BENGAL, INDIA

Longitudinal Protection

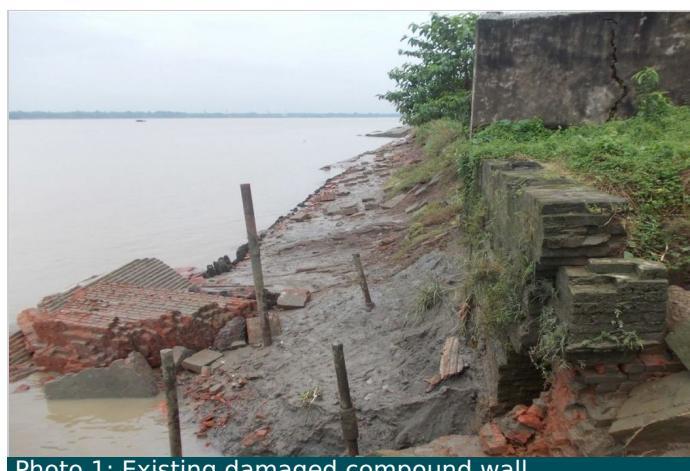
Photo 1: Existing damaged compound wall

The intense turbulence and the hydraulic jump, caused as result of the tidal bore had led to damage of the compound wall of the jute mill.

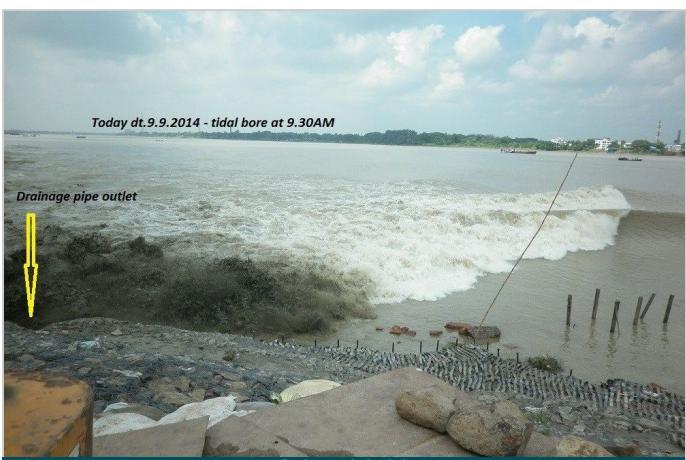
Photo 2: Occurrence of the tidal bore

Tidal Bore is a phenomenon which occurs in the estuary zone near sea where the river mouth opening is funnelled into shallow and narrow river sections. Budge Budge is one such location where it occurs.

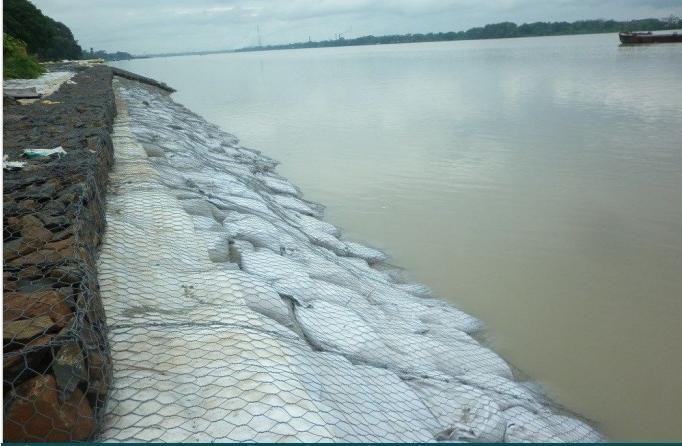
Photo 3: MacBags placed on the slope

Geotextile bag (MacBags) filled with sand are commonly adopted as solution for river hydraulics problems. These bags are preferably produced from woven polyester geotextile material. Here, sack gabions lined with geotextile material containment system were filled with dry sand and placed in position. These were used for preparation of foundation base for the structures.

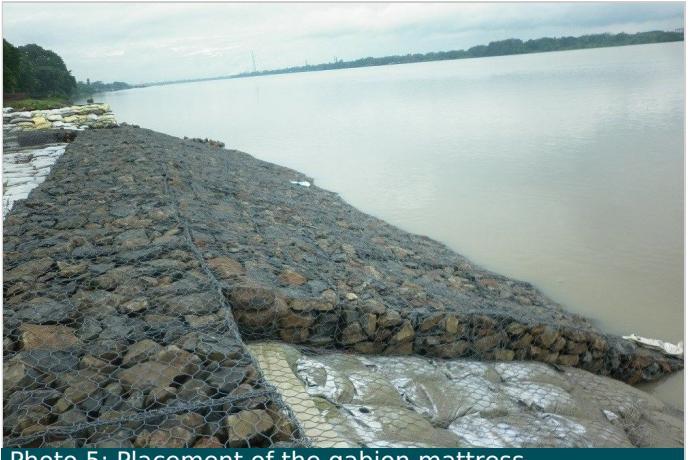
Photo 5: Placement of the gabion mattress

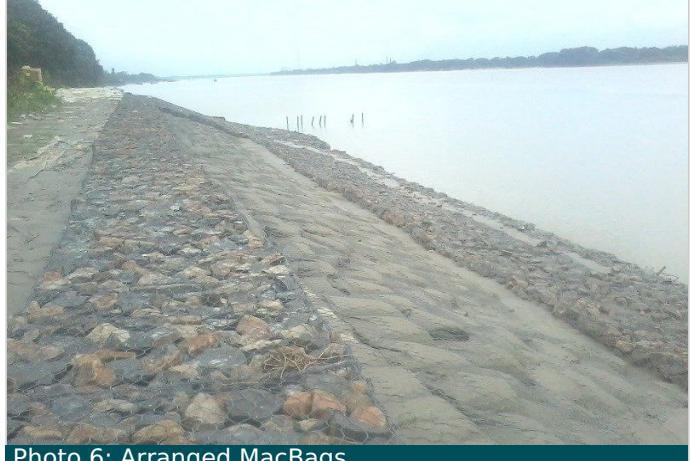
Photo 6: Arranged MacBags

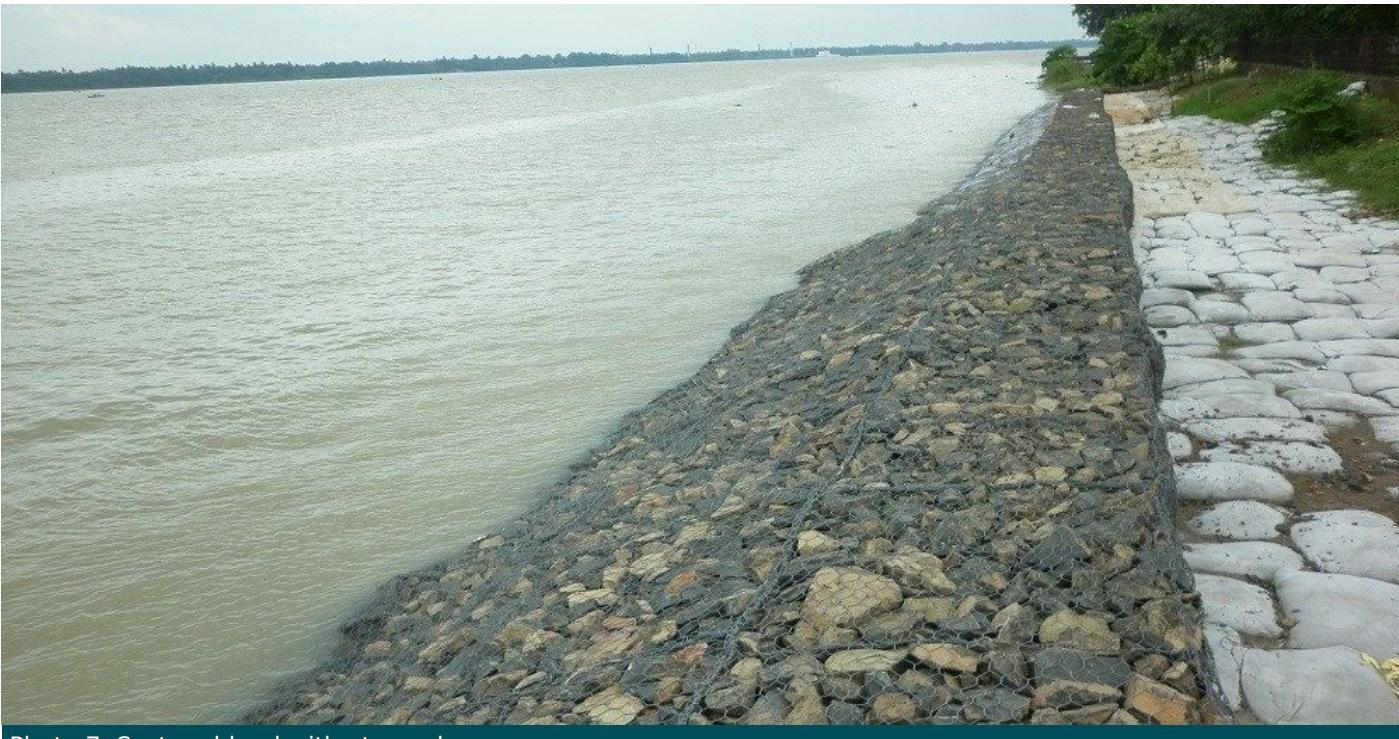
Photo 7: System blend with atmosphere

The anti-erosion works carried out during 2014 got submerged under water during the occurrence of the tidal bore. The erosion measures constructed with MacBags, Sack Gabions, DT Mesh Netting, Gabion Mat-tress survived the tidal bore and protected the banks. After the occurrence of the last tidal bore consider-able amount of silt deposit was noted.
