EROSION CONTROL MEASURES ALONG ARIYALUR BYPASS OF NH, TAMIL NADU

NH 226 EXTN (NEW NH NO 136), ARIYALUR, TAMIL NADU, INDIA

Slope Protection

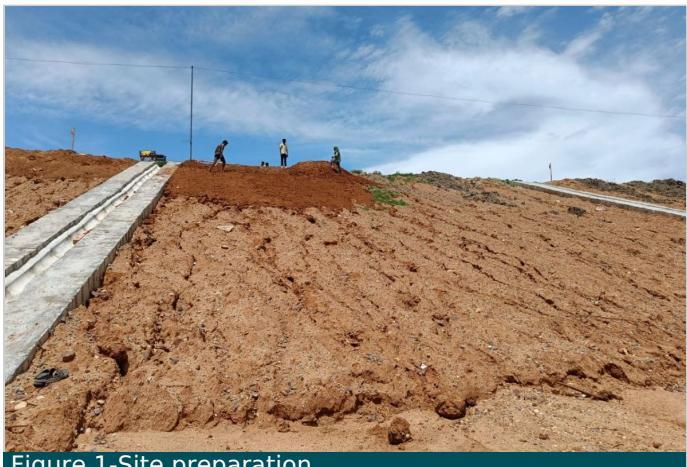
Figure 1-Site preparation

After the site preparation, the soil slope has been covered with a layer of fertile soil and filled all the cuts and gullies present locally. The quantities of various components are finalized before mixing in a hydroseeder along with seeds and water in a two step process. The mixed slurry has been sprayed over the slope surface and maintenance has been done by spraying water on the slope to avoid drying of the material. Soon after the application of erosion control measures at site, the applied systems started showing the performance with respect to erosion control of the embankment slope (ie, vegetation coverage). The successful germination has started within few weeks and grasses have been visible on the treated slope. Proper maintenance of the treated areas was mandatory to ensure the effectiveness of the system.

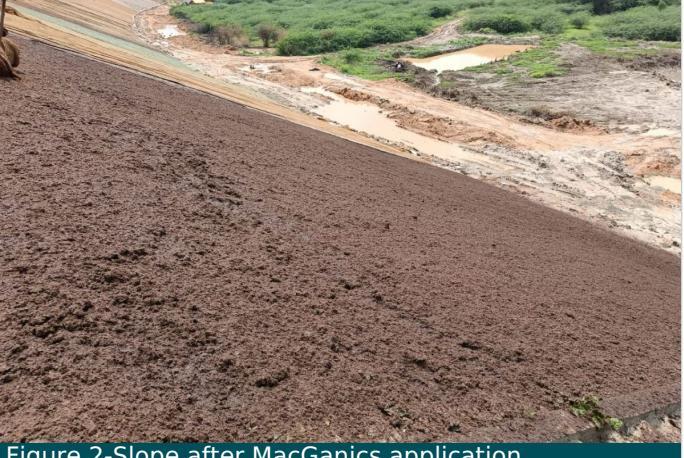
Figure 2-Slope after MacGanics application

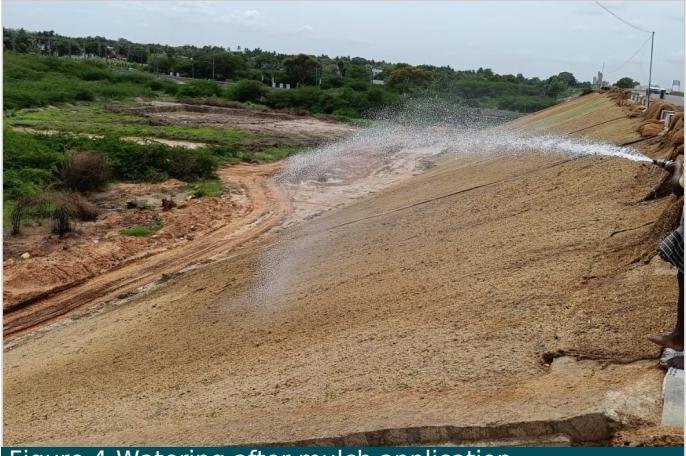
Figure 4-Watering after mulch application

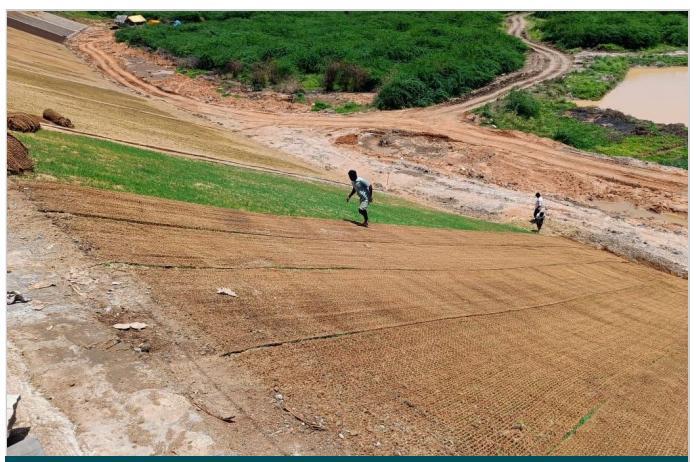
Figure 5- Biomac (with top anchorage) installed slope after hydromulching

To address erosion control, Maccaferri has supplied biodegradable erosion control mat (woven coir mat (BioMac CCW)) and hydraulically applied erosion control measures (MacFlex HP FGM (HECP), MacGanics BSM (top soil alternative) and agronomic amendments, along with seeds). The top anchoring of mat is done with cement concrete blocks at the crest. Suitably designed chute drains are also constructed at stipulated intervals along the slope.
