BADGAT ASBESTOS MINE BADPLAAS, MPUMALANGA, SOUTH AFRICA

Weirs, Culverts and Transverse Structures

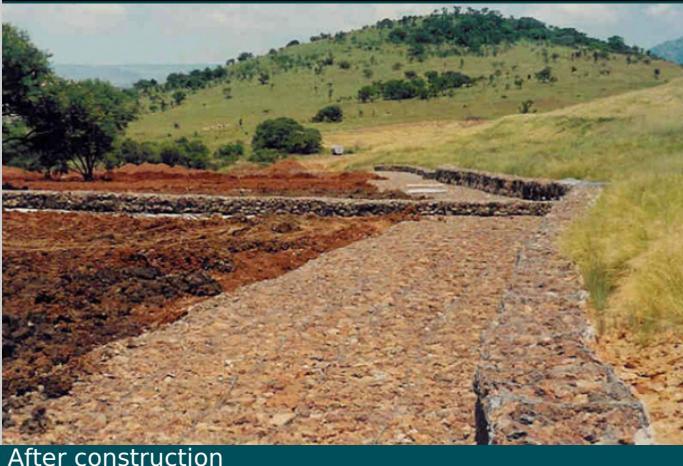
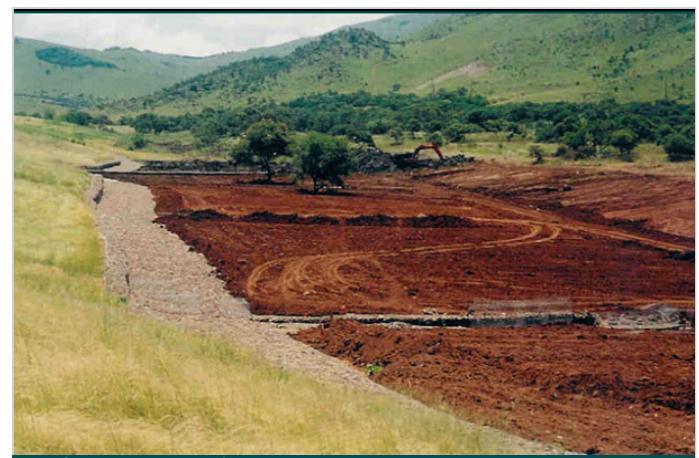
During construction

The rehabilitation work was aimed at increasing the size of the water course to provide protection against high flow velocities. It was decided that the use of gabions structures was the best solution. Maccaferri/African Gabions proposed a low level longitudinal river training wall with transverse groyne structures. This system is designed to shift the main flow channel away from the bank area, which is critical as it is prone to erosion and to prevent further pollution by asbestos fibres by means of a geotextile.
