IoT cutting-edge functionalities applied to a rockfall protection system in Ponza, Italy

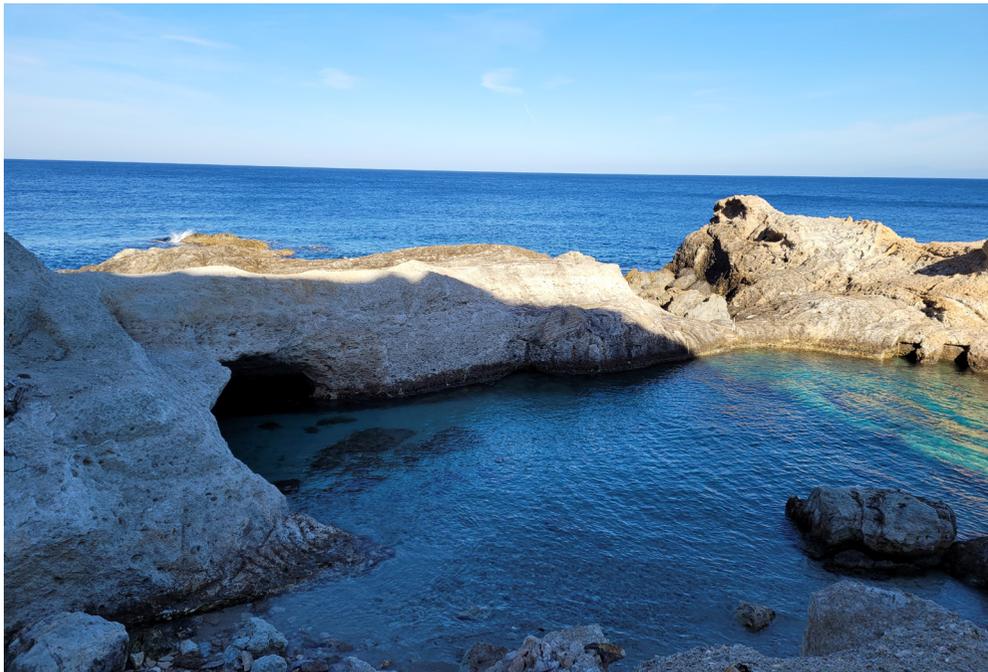
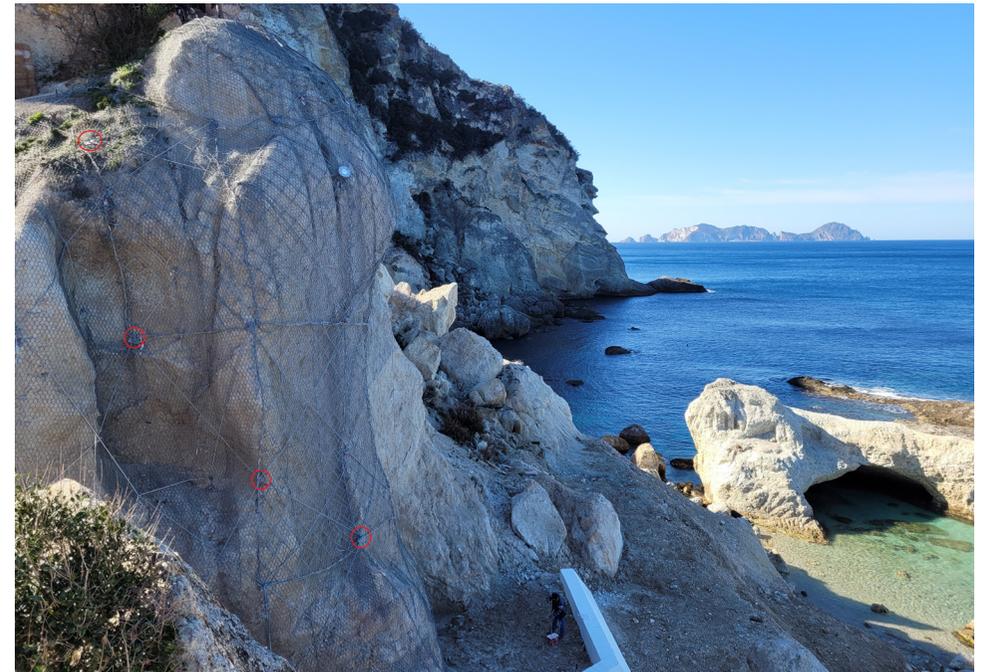
Cala Fonte became inaccessible in 2020 because of a rockfall event: a strong rockfall protection was needed and it was supplied by Maccaferri. A geocomposite with reinforced double twist rockfall drapery mesh as placed over the full height of the cliff; the upper part of the rock face was more liable to instabilities and therefore it was reinforced with HEA PLUS panels (300x300 mm panels made of 10 mm dia. GalMac coated rope) and stabilizing nail anchors. However, even the strongest protection system needs confirmation that everything is functioning to design. Detecting deteriorating conditions early is the best way for achieving risk prevention and traditional monitoring can only be done occasionally, with resource-intensive and time-consuming measures.

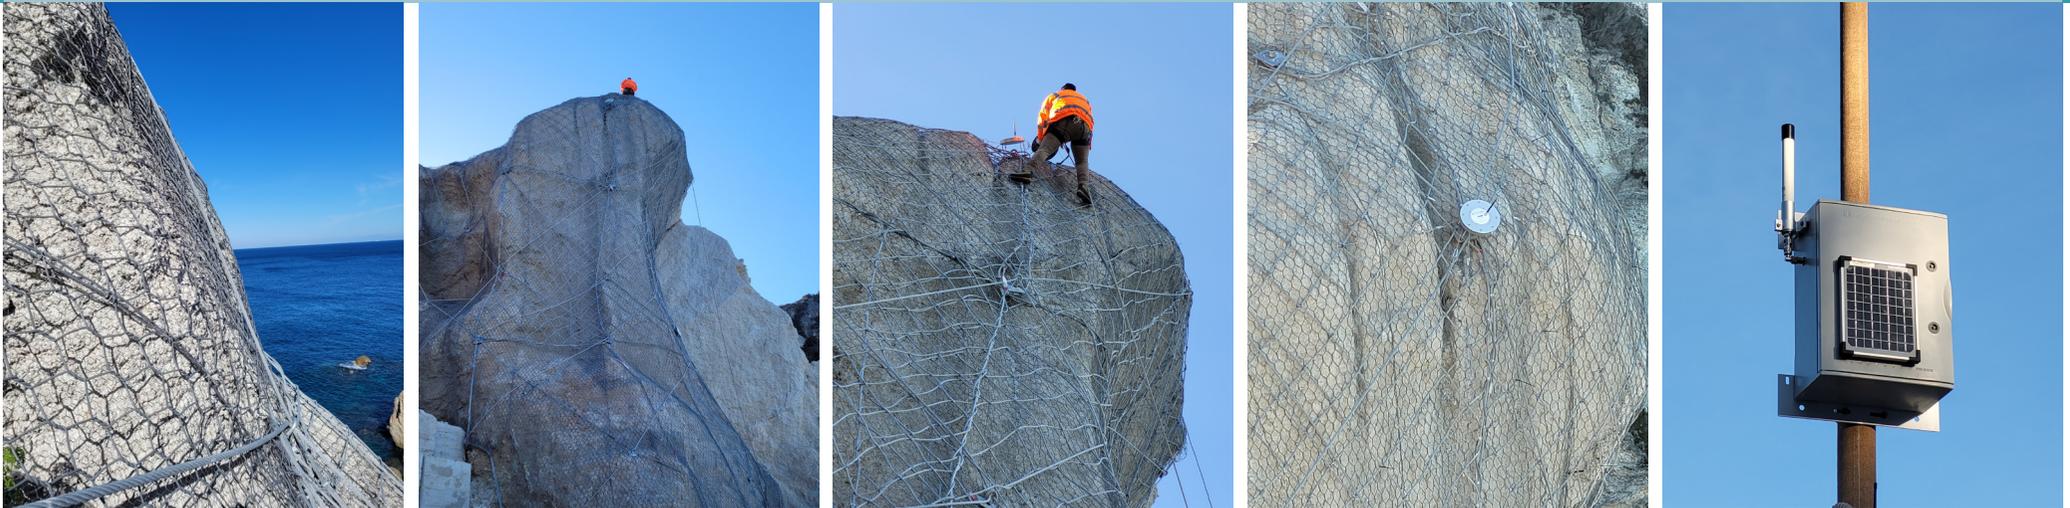
Maccaferri has always pursued innovation and has already taken part of this digital transformation developing a new alert system: HELLOMAC. Thanks to the IoT technology, HELLOMAC ensures real-time and accurate monitoring of rockfall protection systems, even in remote areas with limited or no frequency coverage. In Ponza, in addition to the structural protection system, a rockfall monitoring strategy was integrated into the project. The drapery system was equipped with HELLOMAC and 8 different motion sensors. All the data are transferred using radio waves transmission on specific frequency (868 MHz) to the transceiver device HUBIR. In addition, a linear displacement transducer, also connected to HUBIR, was installed for monitoring of fault-line movements. Thanks to the HELLOMAC app, the protection system's status can be checked daily and if any damage occurs, an alert will be received right away.

Its 8 different motion sensors are connected through 8 long "legs" that allow to cover the entire rock face area and to monitor every eventual movement. Also, thanks to its functioning mode, it was possible to connect HELLOMAC with an additional device, the linear displacement transducer. Last but not least, HELLOMAC is an active early warning system that immediately send warning information: when it comes to rockfall events, time is precious and this device is able to send a real-time warning when something is wrong. HELLOMAC provides an innovative and effective ally to the risk prevention strategy and the protection of the environment and communities.
