CASE HISTORY Rev: 1, Issue Data 27.12.2020

ROMBLON DEO TABLAS CIRCUMFERENTIAL ROAD TABLAS, ROMBLON, REGION IV-B, PHILIPPINES

Debris Flow Barriers

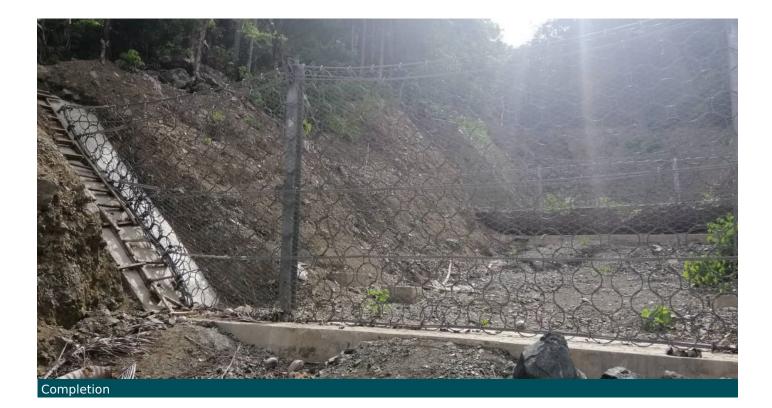
Before Construction

Romblon Deo Tablas Circumferential Road is a coastal road circum-navigating the island of Tablas, Province of Romblon. In the past, the road had suffered from temporary closures after heavy typhoons brought about by debris (logs and woods) that are carried by flood waters from the upland areas. These debris are the product of the clearing and cutting down of trees in the upland areas for cultivation purposes (a traditional but destructive agricultural system).
