**44 YEAR OLD GABION STRUCTURE
DOWDERRY, CORNWALL, UNITED KINGDOM**

Seawalls and Shoreline Structures

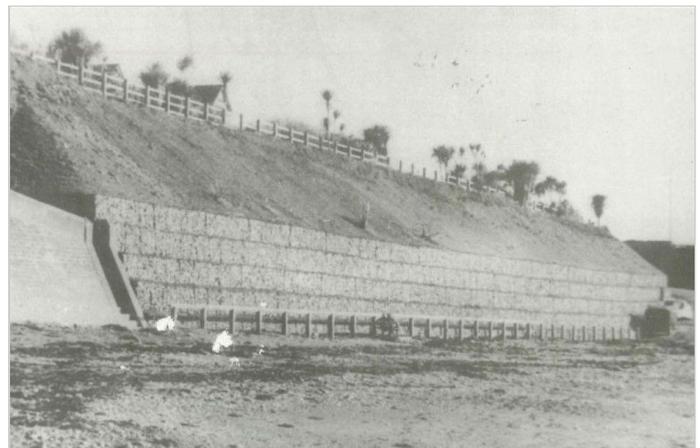
After construction in 1971

As the cliff was above the normal high tide level, it was considered sufficient to construct a stepped retaining wall from mass gravity gabions. The work was completed in 1971, and the threat of erosion was removed. The properties on the cliff were also stabilized and no longer in danger of possible subsidence. After 44 years, the gabion coating and structure seems to show no sign of any significant damage and the gabion structure is perfectly integrated with the coastal environment.

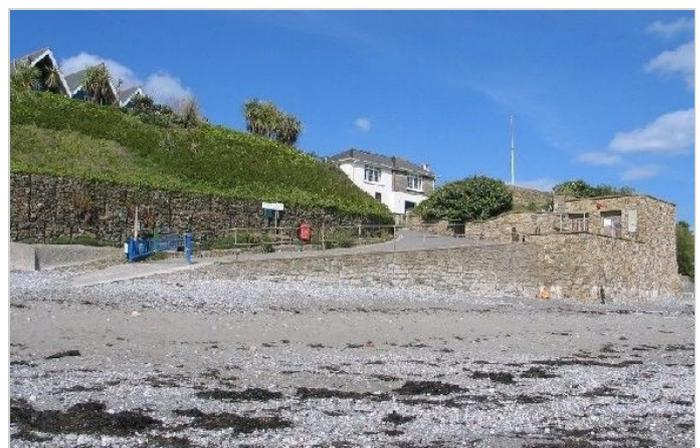
View of the sea defence wall as it now appears

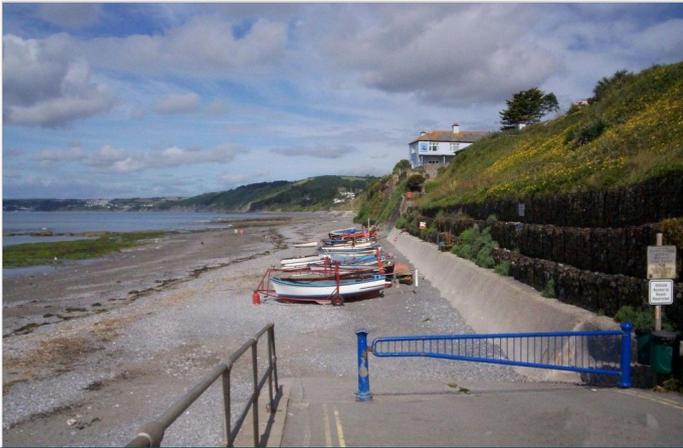
Recent global view of the sea defence wall
