GRAN CANARIA, CANARY ISLANDS, SPAIN

ROCKFALL PROTECTION
Product: *Dynamic Barriers*

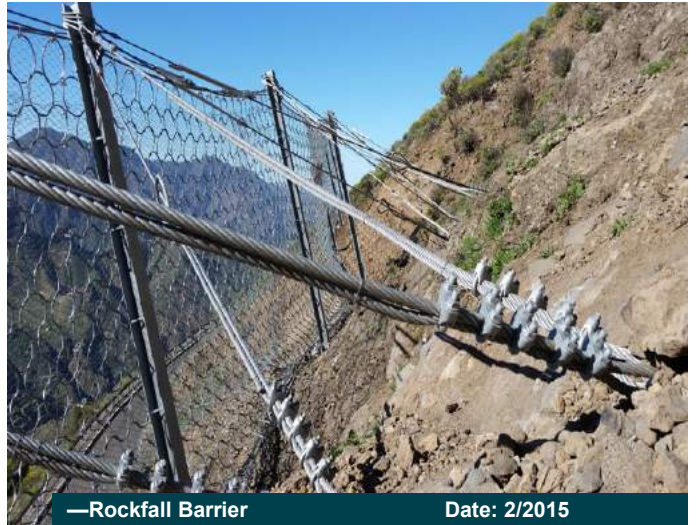
—Rockfall Barrier

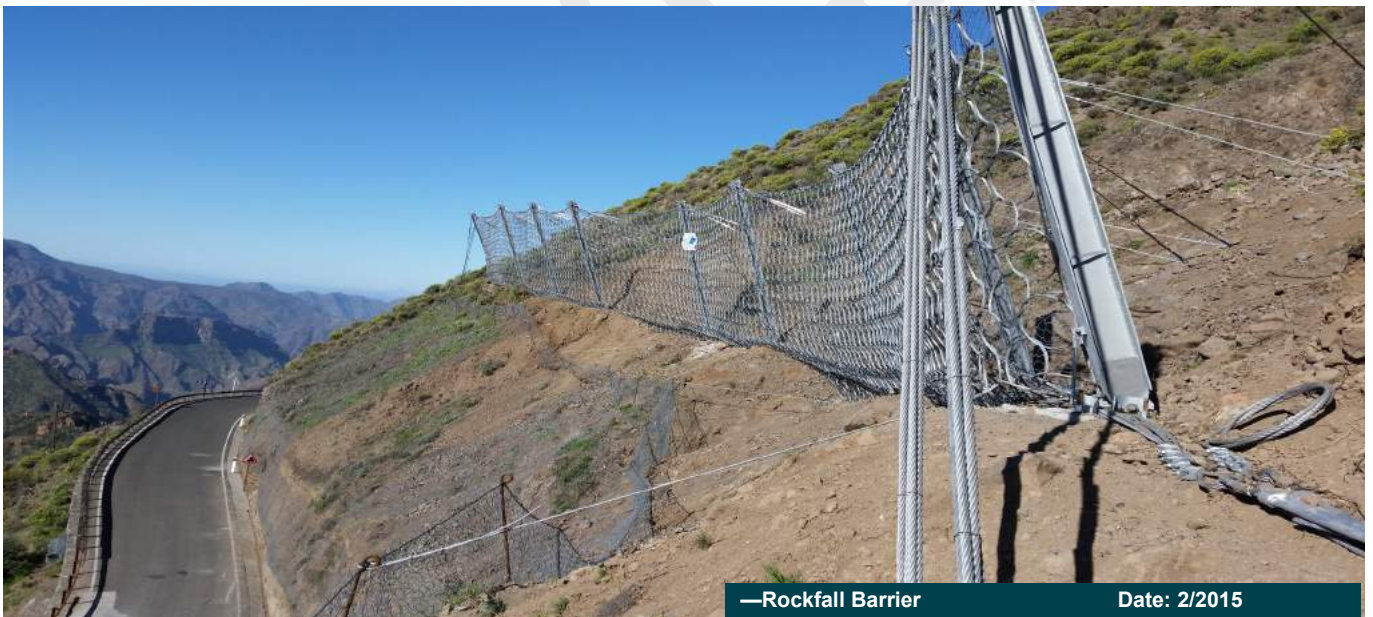
—Rockfall Barrier
