**EROSION CONTROL AT WAY SEKAMPUNG DAM  
PRINGSEWU, LAMPUNG, INDONESIA**

Slope Protection

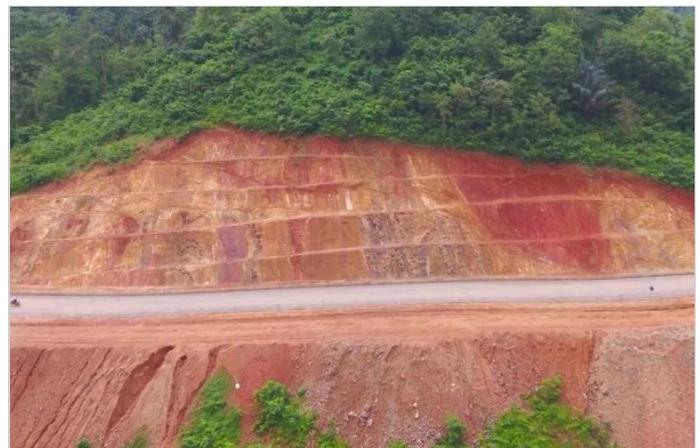
Condition of existing soil

A cut slope at Way Sekampung Dam Project (Pringsewu - Lampung) needed to be protected from erosion potential. The cut slope which was mainly composed of fine-grained soil required protection from erosion created by rain and surface water flow. The selection of the right solution was necessary in order to prevent failure by the presence of water. Erosion Control System by Maccaferri was selected considering its ability to drain water and allow the growth of vegetation.

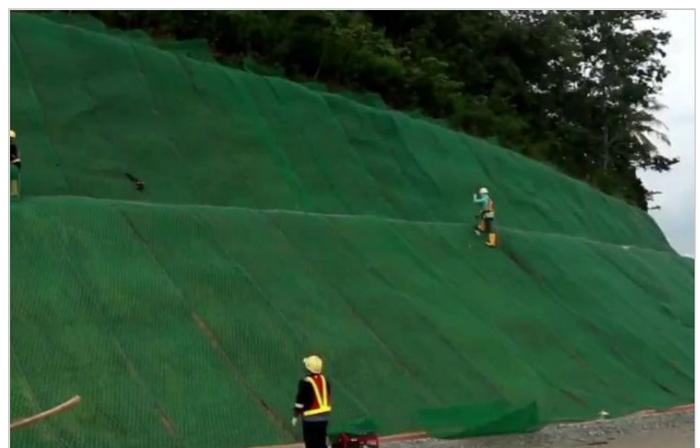
Overview of installed Macmat HS

An Erosion Control System made of a combination between HDPE geomat and double-twisted wire mesh panel with longitudinal high tensile strength steel cables called Macmat HS was installed on the cut slope. An array of mulching contained of seeds was then applied onto the Macmat HS to bring vegetation. The vegetation shall bring the nature back as rehabilitation. For some areas, Soil Nailing was added as additional reinforcement for local stability. Available in rolls, Macmat HS has an easy installation procedure with the support of a T-shape deformed bar to hold the mesh onto the cut slope. Maccaferri Erosion Control System shall grant some advantages such as:  
Easy and Quick Installation ; Allows drainage on the surface of the slope ; Allows vegetation as rehabilitation ; Capable for combination with Soil Nailing ; Suitable for steep slopes.

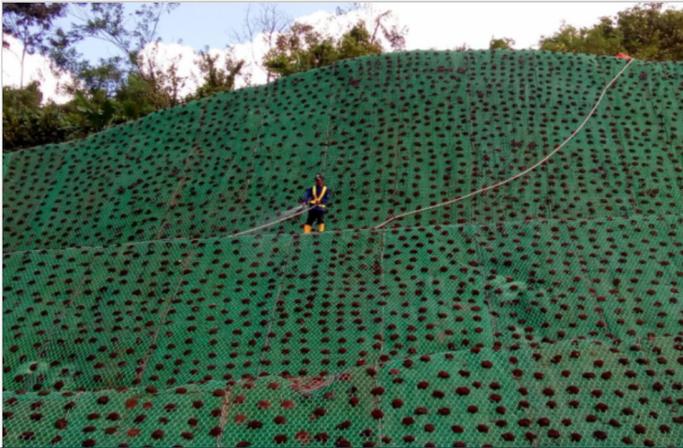
Application of Mulching on Macmat HS

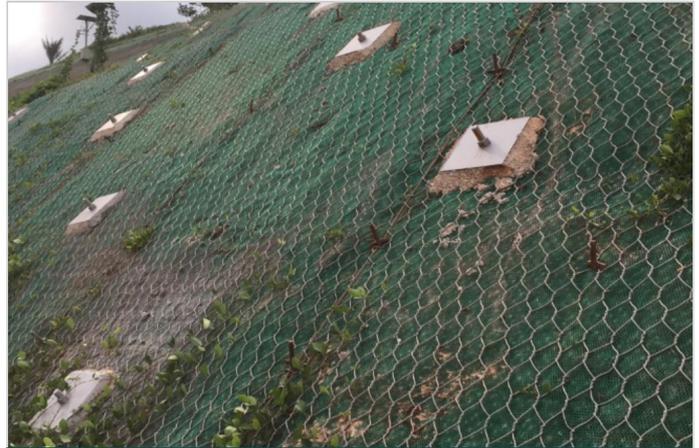
Soil Nailing application on Macmat HS

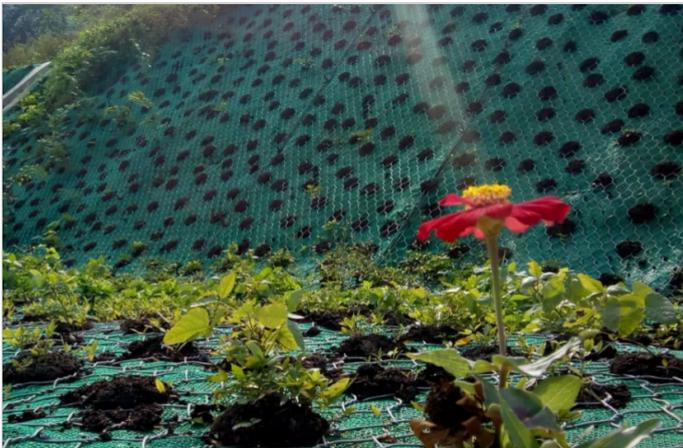
Condition of Installed Macmat HS in August 2018

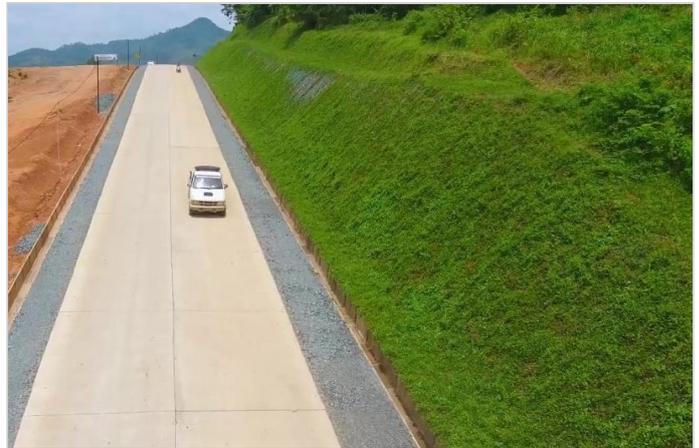
Condition of Installed Macmat HS in February 2019
