LANDSLIDE REHABILITATION SP. TUAN - MERLUNG ROAD MERLUNG, JAMBI, INDONESIA

Reinforced Soil Walls and Slope Reinforcement

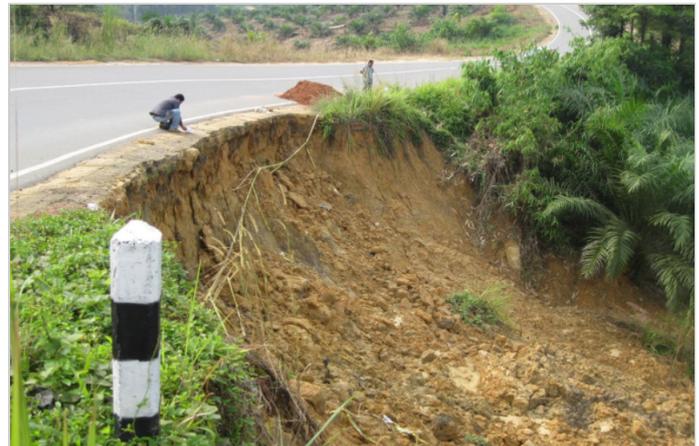
Before Construction

Sp. Tuan - Merlung Road is one of national road i.e Sumatera east cross road at Province of Jambi. The landslide occur on a slope of road. The characteristic of soil mostly Clay. High rainfall in location cause saturation process on soil then increasing pore water pressure and occur instability of slope. This problem need landslide rehabilitation with suitable method.

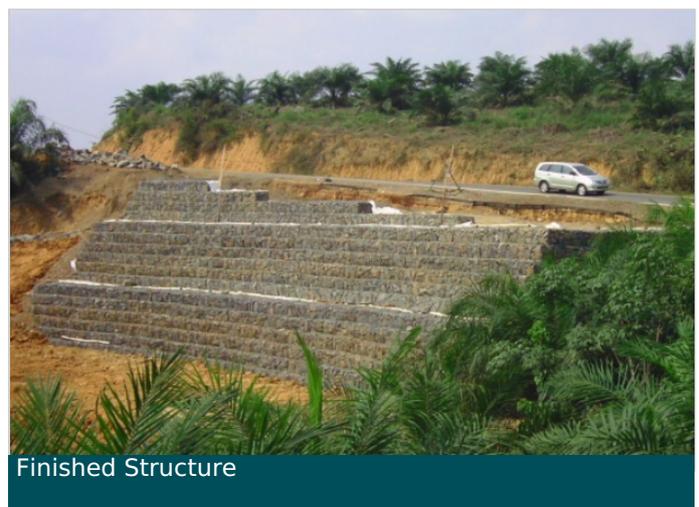
Finished Structure

Maccaferri Terramesh System as a flexible structure can provide solution for the problems. Reinforced embankment structure is able to reconstructed the landslide location and widening the road with the steep slope. Terramesh system with permeable facing in the form of gabion and with the using of Mactex as filter is capable to provide solutions for drainage problems which commonly occur and to prevent the accumulation of saturation without losing soil grain. Characteristic of a flexible structure is capable of delivering more tolerance for differential settlement comparing with rigid structure. The availability of materials, easy installation and the possibility of using local manpower will increase the effectiveness and productivity of the construction work. Terramesh system is a permanent structure and able to achieve a design life of 60 years.
