PARAMESH WALL AT DAARUT TAUHIID MOSQUE, BATAM - KEPULAUAN RIAU BATAM, KEPULAUAN RIAU, INDONESIA

Ground Improvement

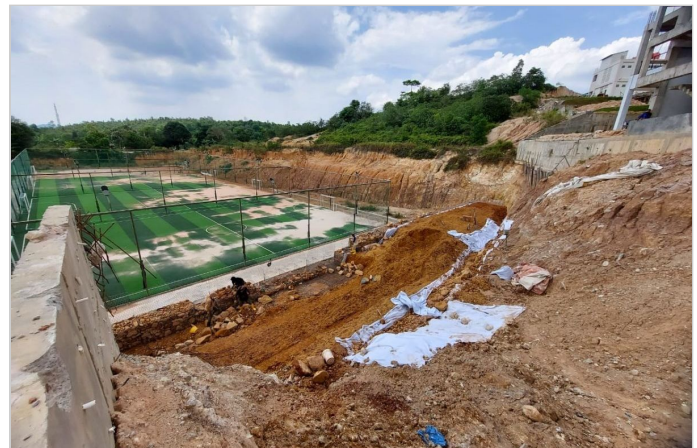
Before Construction

Due to rainfall, landslides occurred and caused some fractures in the existing retaining wall at Daarut Tauhid Mosque, Batam, Riau Islands. The landslide was eroded and made the foundation of the mosque exposed. The existing concrete retaining wall is 12 m high and located between the Daarut Tauhid Mosque at the top of the slope and the soccer field at the bottom of the slope. From the soil data obtained groundwater level at depth of 6m from the surface of the soil. Landslides endanger the activities of the people, so a solutive solution is needed.

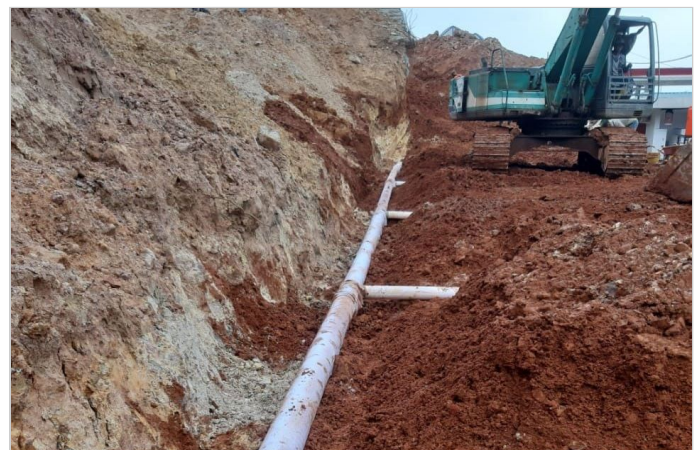
Under Construction

Maccaferri Indonesia recommends the innovation of retaining wall structure using Paramesh Wall because of its ability on permeability, flexibility, durability, environmentally friendly, easy installation method, and provide more added values. Paramesh Wall using Terramesh system material as facing, ParaGrid HF 150 Geogrid as primary reinforcement, MacTex N2 50 as separator and filtration geotextile, and drainage composite to accommodate groundwater flow. Paramesh Wall is able to be an alternative solution to the concrete retaining wall, able to accommodate loads and good at draining groundwater so the structure can be stable.

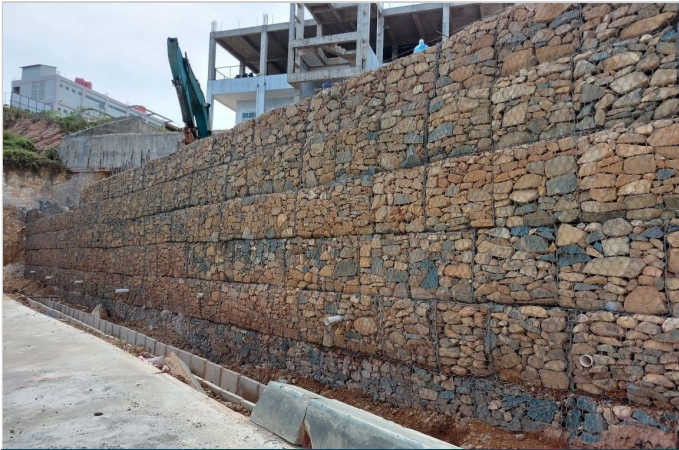
Facing

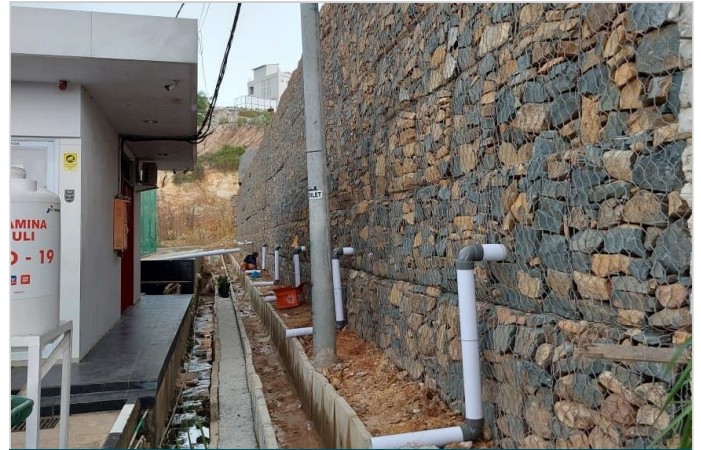
Facing

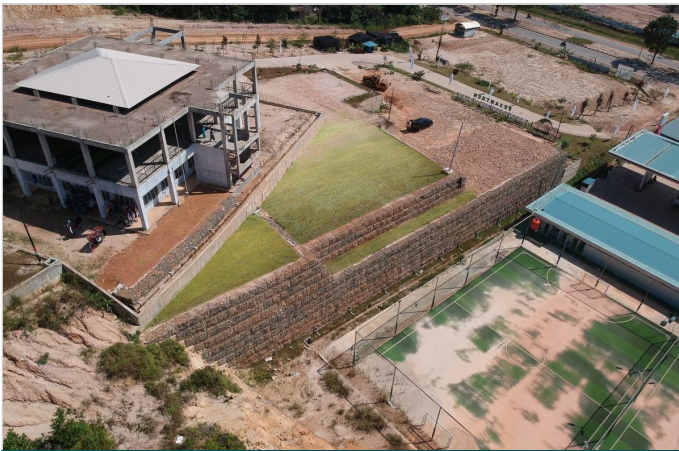
Finish Construction
