PAVEMENT STRENGTHENING AT AIRFORCE STATION, KALAIKUNDA KHARAGPUR, WEST BENGAL, INDIA

Asphalt Pavement Reinforcement

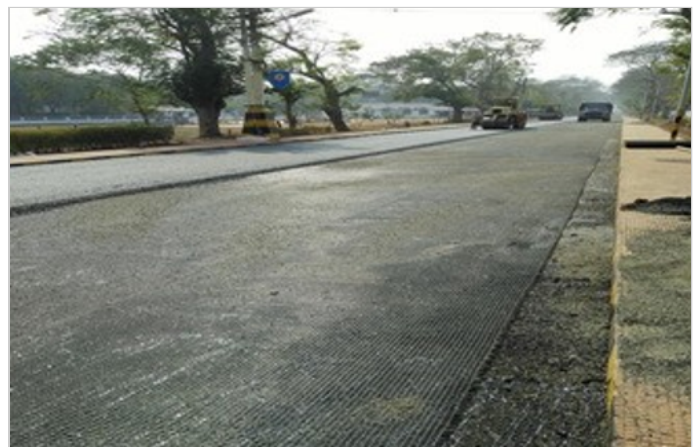
Photo 2: MacGrid® AR installation

For reinforcing the pavement, MacGrid® AR 10A.7 was suggested to be provided at the interface of the built up spray grout (BUSG) and bituminous macadam (BM) layer. For ensuring proper adhesion of the MacGrid® to the surface, tack coat is applied over the BUSG layer before laying the MacGrid®.

MacGrid® AR 10A.7 is a reinforcing geogrid material specially developed for pavements. It consists of glass fiber strands arranged in a grid structure with a pressure sensitive adhesive.

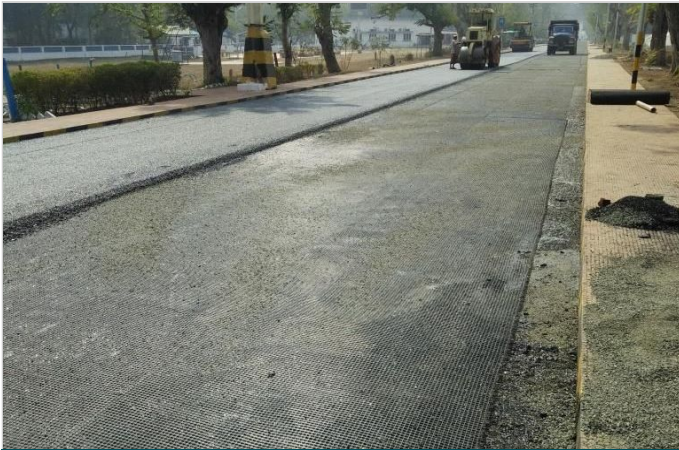
Photo 3: MacGrid® AR installation completed

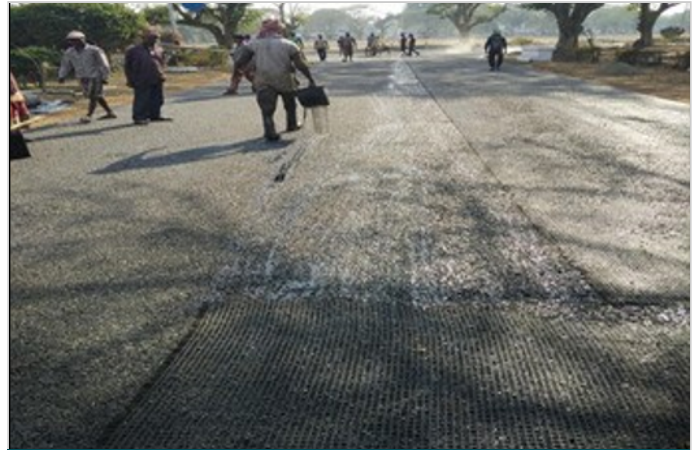
Photo 4: Photograph showing the tack coat application prior to overlay

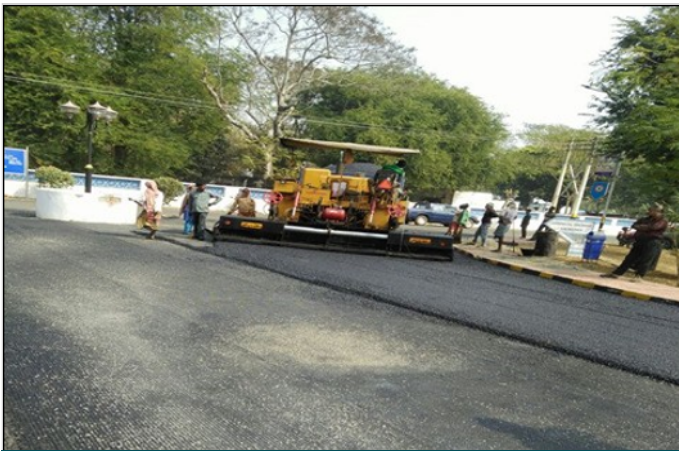
Photo 5: Construction of overlay

Damaged pavement was required to be repaired by placing an asphalt layer to increase the load carrying capacity of the pavement section so that it can take the design traffic and provide required serviceability. Overlays are still the most common option for extending the life of distressed pavements. While special asphalt mixes can be specified and thicker overlays improve performance, a geosynthetic interlayer can be placed over the distressed pavement prior to the overlay to create an economical, long-lasting overlay system.

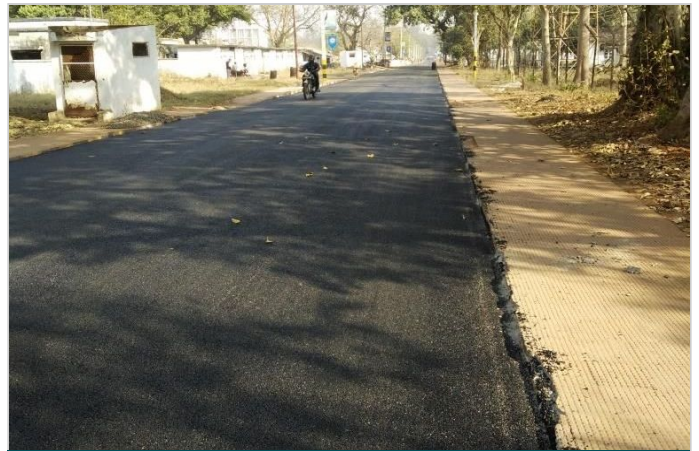
Photo 6: Finished pavement structure
