EROSION CONTROL TRIALS DONE ON RED MUD OB DUMP AT BELAGAVI BELAGAVI, KARNATAKA, INDIA

Slope Protection

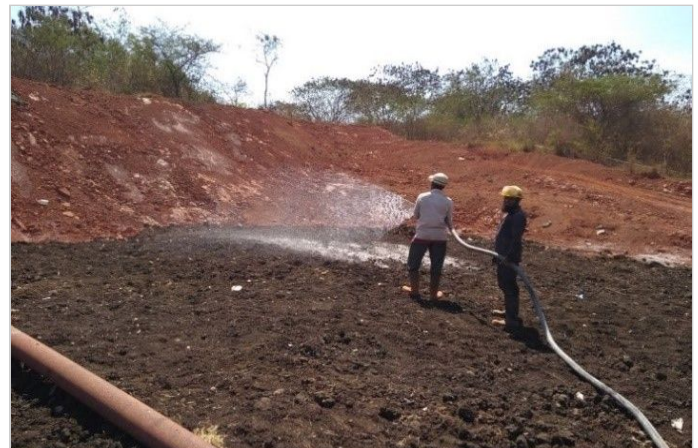
Photo 1: Pre-watering works

The seed species were selected based on the soil type present at site, pH, climate, type of planting, availability of local seeds and discussions with a horticulturist. The quantities of hydraulically applied erosion control materials, soil amendments were finalized before mixing in a hydroseeder along with seeds and water in a two step process. The slurry obtained after mixing was sprayed over the slope surface and maintenance was done by spraying water on the slope to avoid drying of the material.

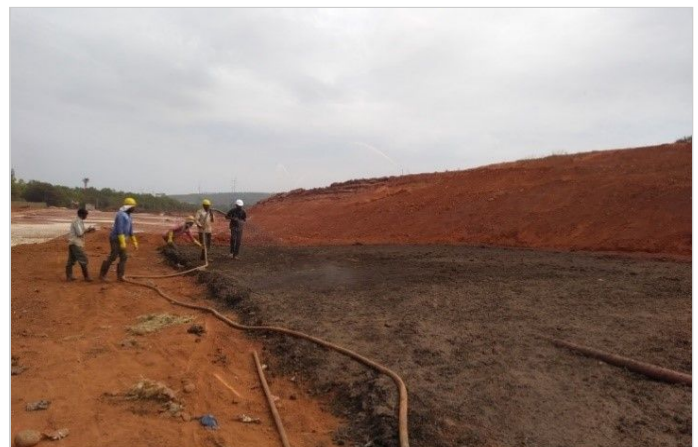
Photo 2: Application of MacGanics

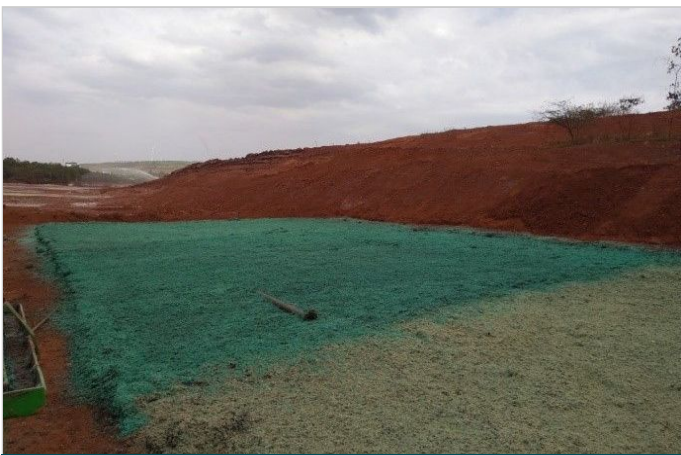
Photo 3: Application of MacFlex

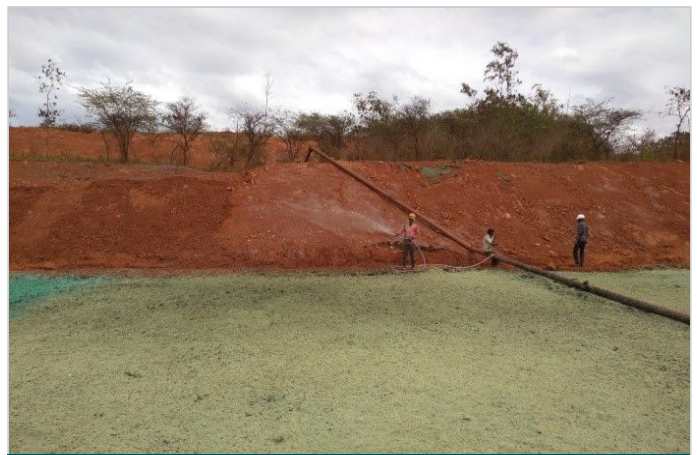
Photo 4: Watering after mulch application

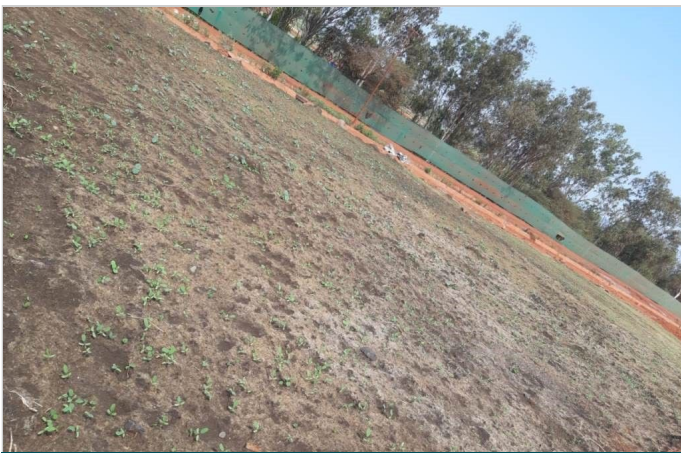
Photo 5: Establishment of Vegetation

Soon after the application of erosion control measures at site, the applied systems started showing the performance with respect to erosion control of the embankment slope (i.e. vegetation coverage). Germination started within few weeks and grasses were visible on the treated slope. Proper maintenance of the treated areas was mandatory to ensure the sustenance of the system.

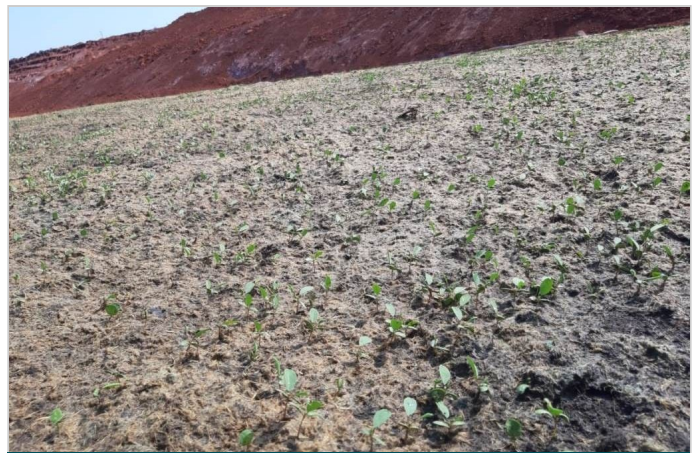
Photo 6: Establishment of Vegetation
