## SLOPE PROTECTION - ALONG PEDDAR ROAD NEAR MALABAR HILL, MUMBAI

### MALABAR HILL, MUMBAI, MAHARASHTRA, INDIA

#### Surface Strengthening and Support

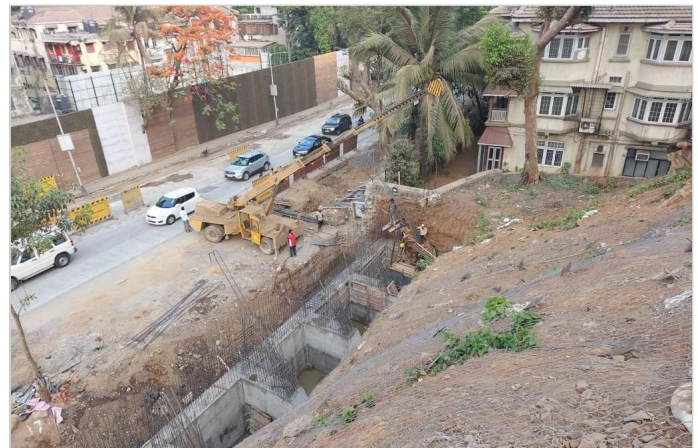
Figure-1 Construction in progress

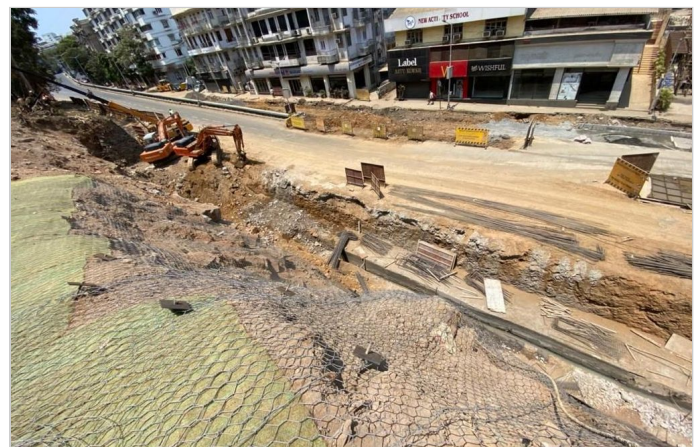
Figure-2 Construction in progress

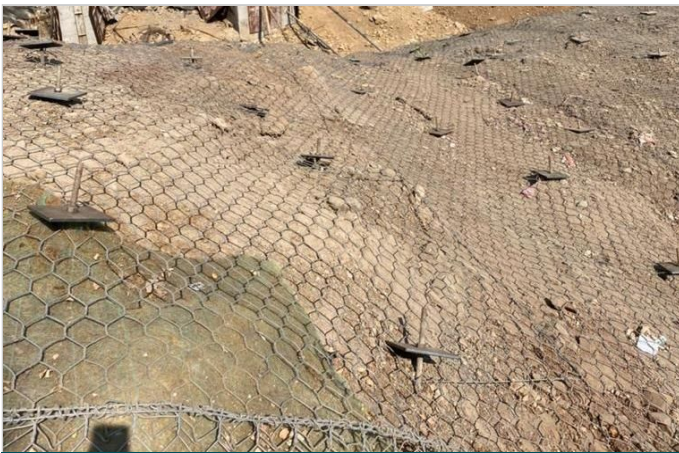
Figure-3 Construction in progress

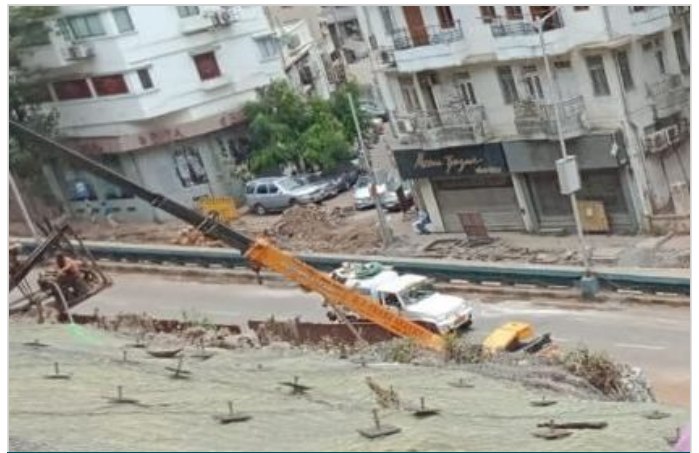
Figure-4 Construction in progress

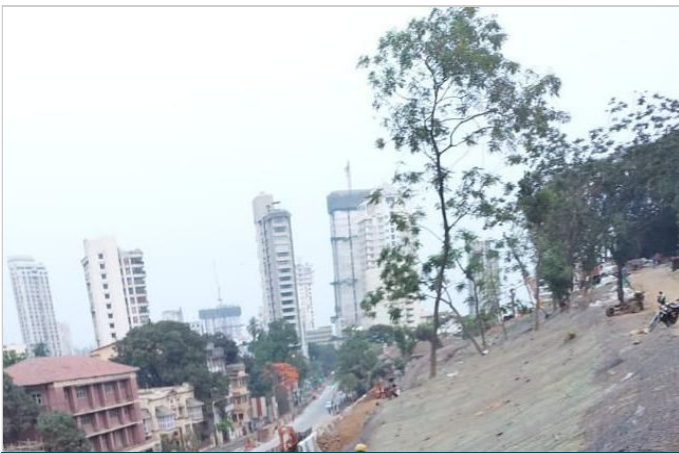
Figure-5 Meshes including DT Mesh installed over slope

Slope protection measures in the involving toe wall near the slope toe, biodegradable erosion control mat, mechanically woven double twist (DT) mesh with nails on slope have been proposed here. Maccaferri has supplied DT mesh for the same, which conforms to IS: 16014. Unlike Single Twist (chain-link) style mesh, the construction of DT mesh inhibits the propagation of tears in the mesh. Research shows that damage to a DT mesh remains local and the mesh does not unravel, due to the double twist 'locked yet flexible' connection between adjacent wires.

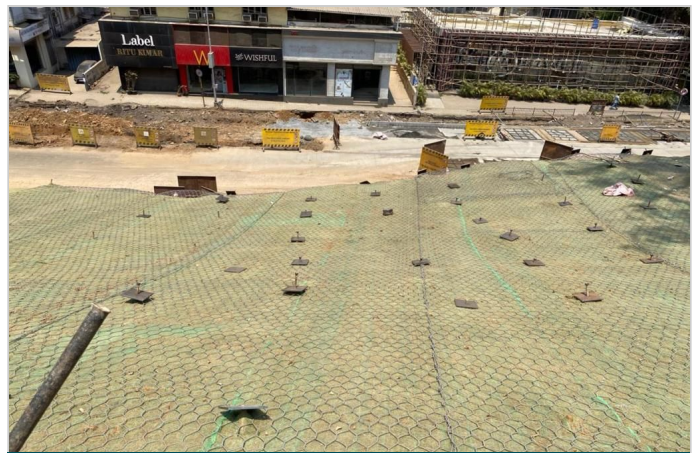
Figure-6 Meshes including DT Mesh installed over slope

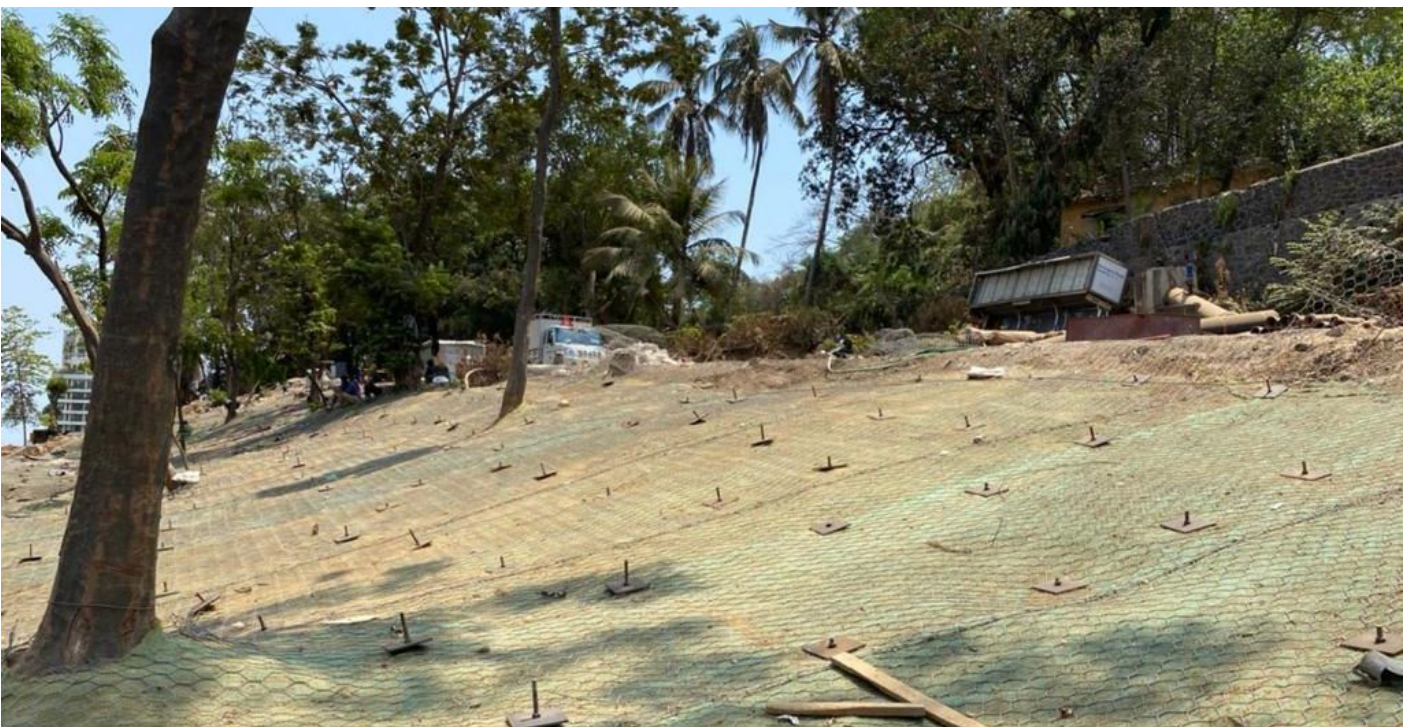
Slope after installation of meshes
