## ROCKFALL PROTECTION AT GOODVIEW HEIGHTS MSG LONG SG LONG, SELANGOR REGION, MALAYSIA

### Simple Drapery

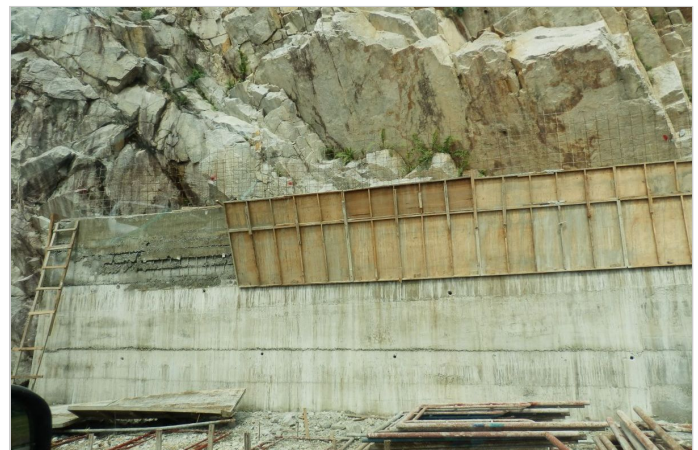
During Construction

Maccaferri Galfan Steelgrid™ G8/3.0 was laid on top of the rock slope, with rock bolts anchoring at every 3m spacing. This acted to strengthen and prevent detachment of any loose rocks from the rock surface. An estimated of 1800 m<sup>2</sup> with a height up to 30m are to be protected and covered. Galfan Steelgrid™ which is made of zinc-alluminium alloy coating to better corrosion protection is a netting consist of steel cables weaved longitudinally into wire mesh. This enhances the drapery stiffness, thus effectively transfers all heavy stress to the rock bolts.

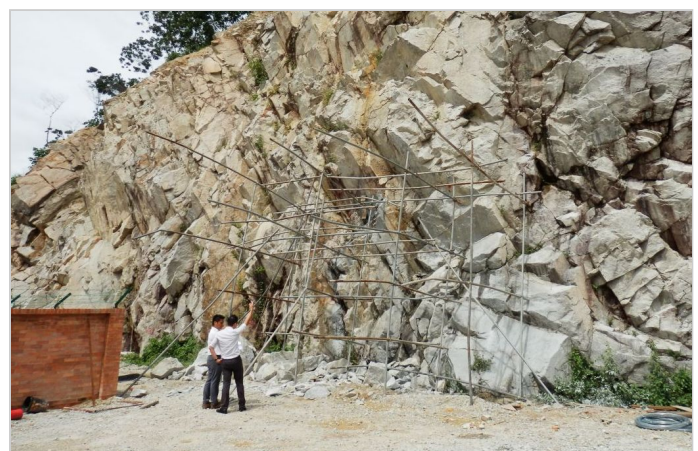
During Construction

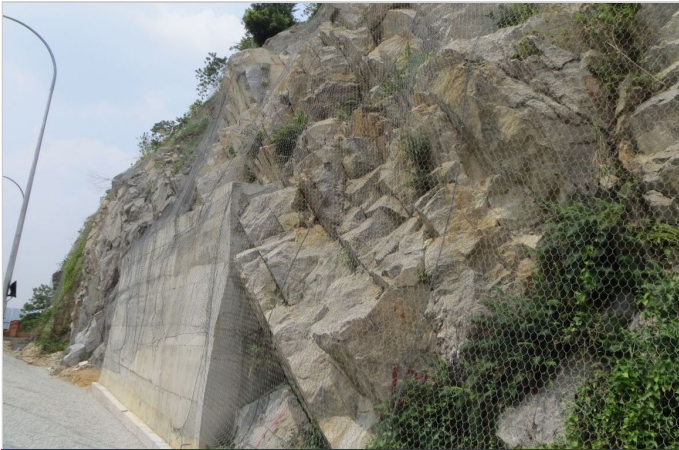
After Completion
