SLOPE REINSTATEMENT AT KUANTAN, PAHANG, MALAYSIA

Reinforced Soil Walls and Slope Reinforcement

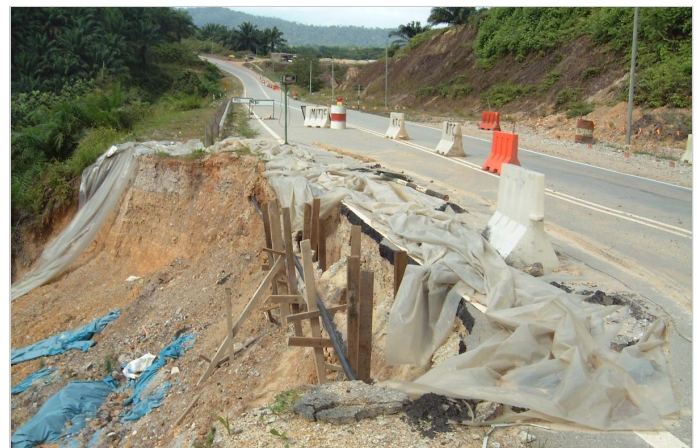
before construction

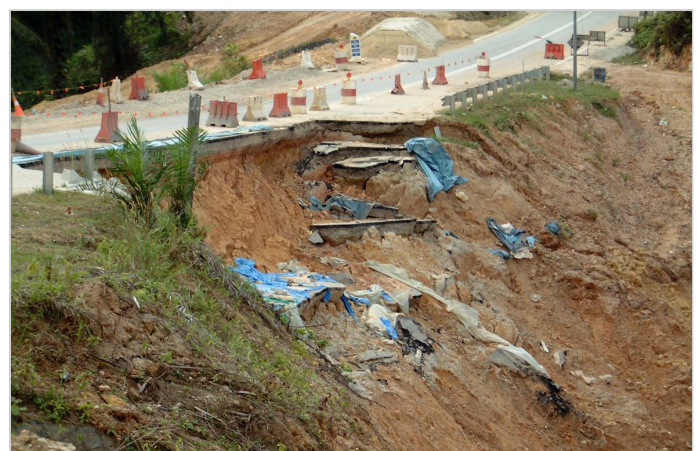
before construction

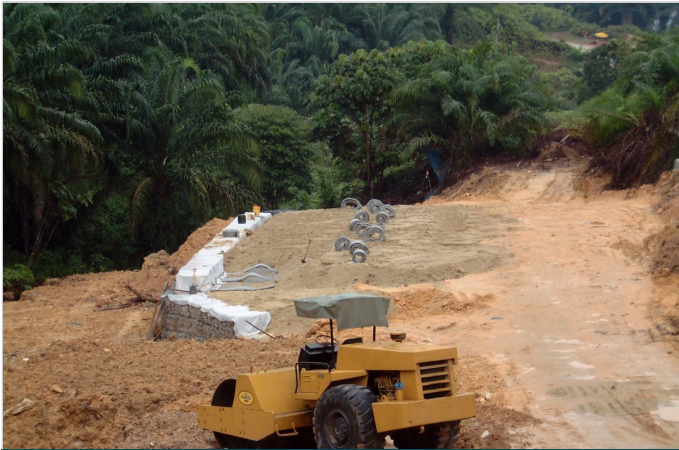
During Construction

The slopes were reinstated using a combination of three products. Firstly, Terramesh - Mechanically Stabilize Earth Wall was used at the bottom so that it can be constructed vertically and is flexible enough to be arranged around culverts. Additionally, Terramesh is a free draining structure and hence excess water flow from culverts can be easily drained out. The top structure was completed with Green Terramesh and Enkamat to provide a sturdy yet environmentally friendly front face.

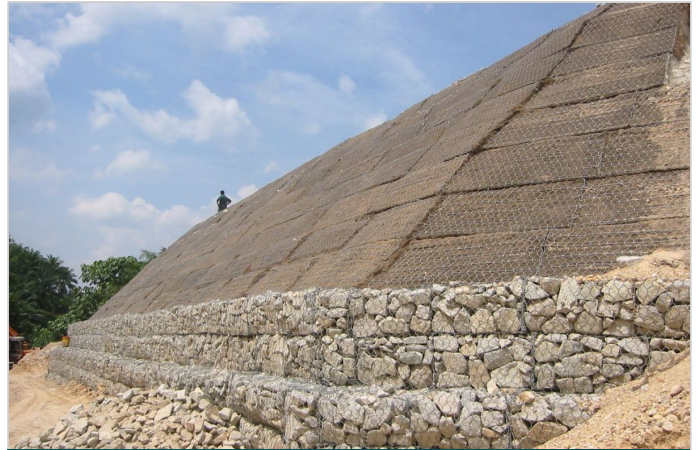
after construction

This solution was able to overcome further soil erosion and provide a strong base for that stretch of road to continue its safe function to road users.

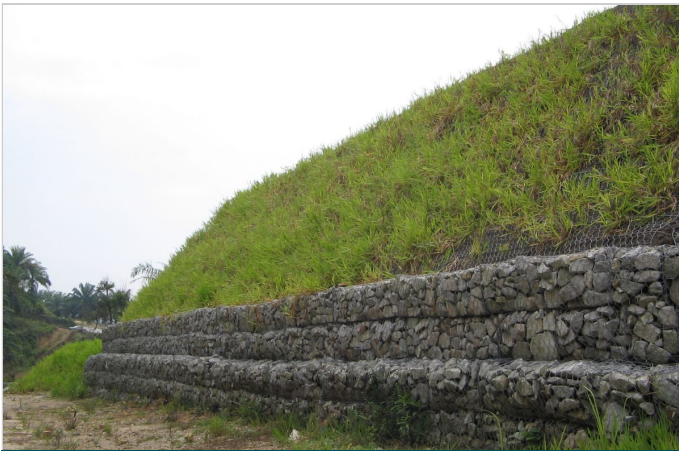
after construction
