## HILL SLOPE REINFORCEMENT AT KUALA KRAI, KELANTAN, MALAYSIA

### KUALA KRAI, KELANTAN, MALAYSIA

#### Reinforced Soil Walls and Slope Reinforcement

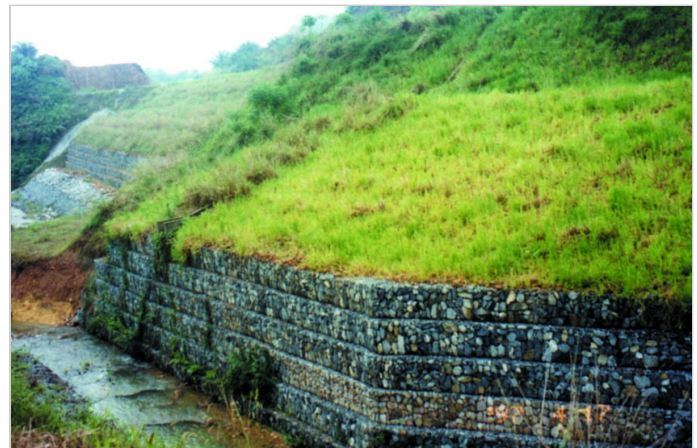
During Construction

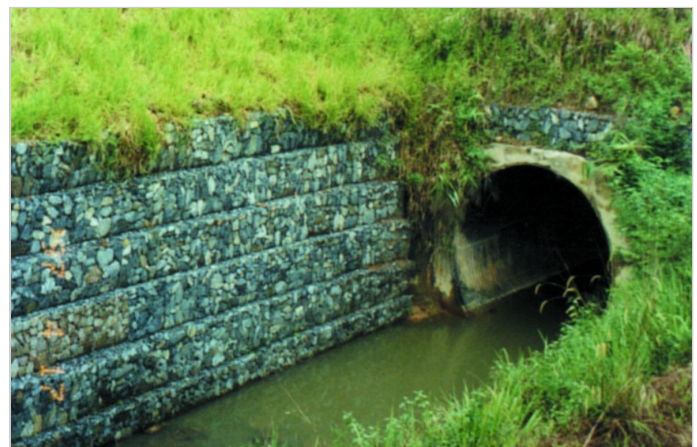
after construction

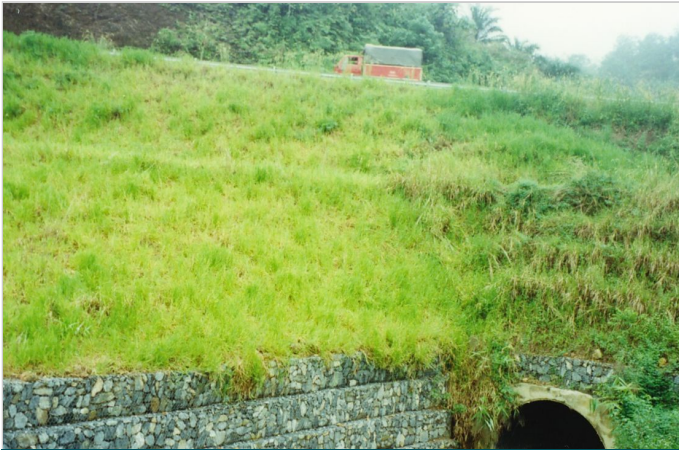
after construction
